Door Panel Leather Insert Creased on Arm Rest Near Handle

Service Category Vehicle Exterior

Section Door/Hatch

YEAR(S)	MODEL(S)	ADDITIONAL INFORMATION
2014 - 2016	Highlander, Highlander HV	WMI(s): 5TD

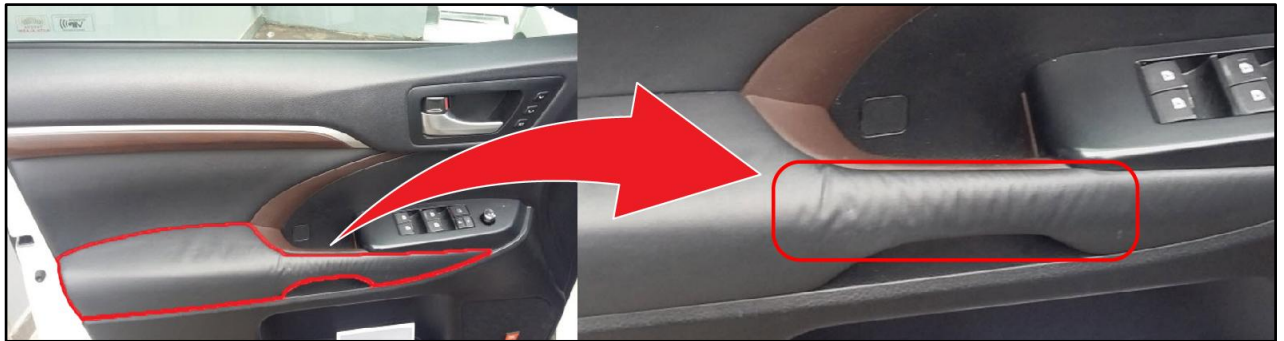
Figure 1.

Some 2014 – 2016 model year Highlander and Highlander HV vehicles may exhibit a condition in which the door handle material insert of the driver or passenger side door panels is creased, wrinkly, or has started peeling. This condition can occur on either the front or rear door panels and is NOT exclusive to any specific color code. This Service Bulletin ONLY applies to the door handle material insert. Follow the procedure in this bulletin to address this condition.

1. Confirm that the arm rest leather is showing a wrinkled or creased appearance.
2. Remove the front door panel.
Refer to the Technical Information System (TIS), applicable model and model year Repair Manual:

5. Reinstall the NEW rear door panel.
