Technical Bulletin

51 16 02 June 7, 2016 2039000 Supersedes Technical Bulletin V511403 dated December 16, 2014 to update Claim Processing statement.

Corrosion on the Roof in the Area of the Roof Rails

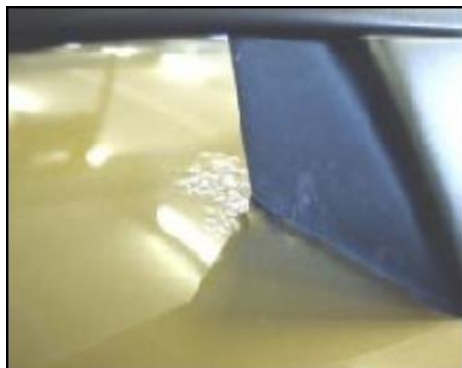
Corrosion on the roof (in the contact area of roof rail/roof rail base) - Figures 1 and 2.

Figure 1 (corrosion on the roof – B5/5.5 Passat shown)

Paint abrasion on the roof from contact and relative movement of the roof rail (Figure 1).

- Before removing the roof rails, visually check if the roof rail base is contacting the roof in the affected areas.
- Remove the roof rails. See Repair Group 66 in Elsa.
- Remove the corrosion with a pneumatic brush grinder. Make sure that the edges of the roof do not get damaged.
- Apply a VOC compliant epoxy primer as an anti-corrosion treatment and primer (locally sourced).
- Re-paint the roof according to the Volkswagen guidelines.

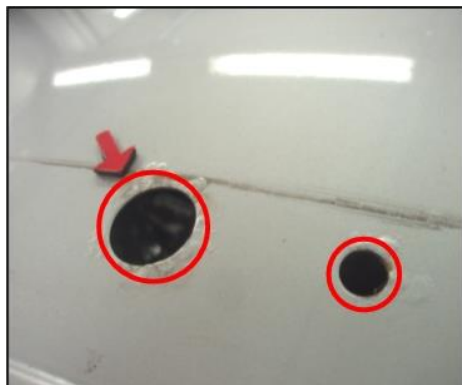
Figure 2 (corrosion around the roof openings – B6 Passat shown)

Humidity is absorbed into the seals on the roof rail base, this leads to corrosion in the roof openings / surface (Figure 2).

- Before removing the roof rails check for movement / free play in the rails.
- Remove the roof rails. See Repair Group 66 in Elsa.
- Remove the corrosion with a pneumatic brush grinder. Make sure that the edges of the roof do not get damaged.
- Apply a VOC compliant epoxy primer as an anti-corrosion treatment and primer (locally sourced).
- Re-paint the roof according to the Volkswagen guidelines.
- Remove the seals on the roof rail bases (left and right roof rails) and replace them with a new sealing kit (part number: **3C9 860 151** - Figure 4, Number 1).

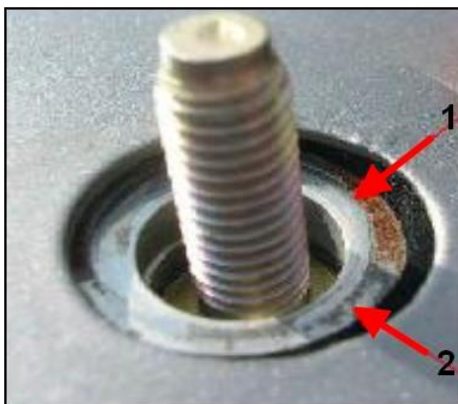
Figure 3

- Before installing the roof rail, increase the gap of the roof rails to the roof by installing a washer (Figure 3, red arrow 1), part number: WHT 000 808 over the threaded pin.

If the roof rail base was contacting the roof, the following step must be performed:

- Remove the seals on the roof rail bases (left and right roof rails) and replace them with a new sealing kit (part number: **3B9 860 151**).
- Re-install the roof rails. See Repair Group 66 in Elsa.

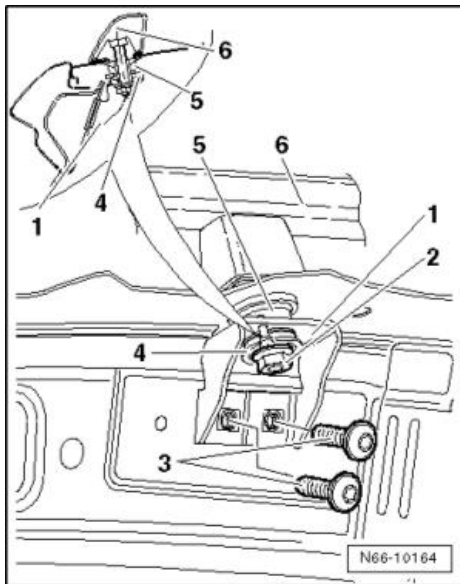
Figure 5

If the roof rails were loose, check and if necessary adjust and tighten the support bracket (Figure 5, Number 1). See Repair Group 66 in Elsa.
