# Seat Cover Material Loose at Front Edge

Service  
Category Vehicle Interior

Section Seat

Some 2012 – 2014 model year Camry/Camry HV and 2013 – 2014 model year Avalon/Avalon HV, Limited and XLE grade vehicles may exhibit a condition in which the front seat cover material has become loose at front edge of seat and is hanging below seat assembly. Reinstalling the seat cover does NOT permanently correct this condition. Follow the Repair Procedure in this bulletin to address this condition.

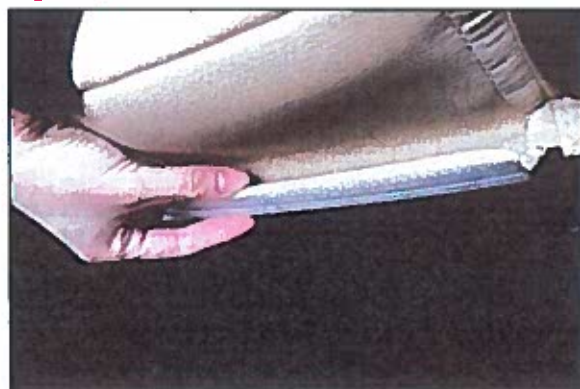
Figure 1.

1. Confirm seat bottom cover material has separated from flange.

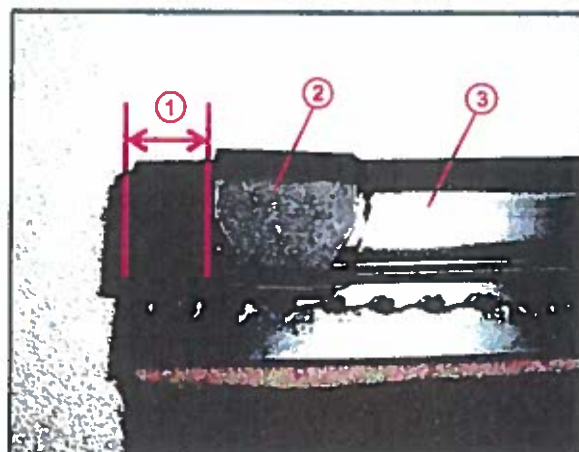
Figure 3.

| 1 | 10 mm |
| 2 | U-Clip |
| 3 | J-Hook |

4. Reinstall seat bottom cover material (J-Hook with additional U-clips) to seat frame flange.

Ensure that both the J-Hook and U-Clips are fully seated on the seat flange.
