Cruise Control Stalk Illumination Intermittent Operation

Service Category Vehicle Interior

Section Meter/Gauge/Display

Some 2014 – 2016 model year Highlander, Highlander HV and RAV4 vehicles may exhibit an intermittent cruise control stalk illumination flicker condition. Please follow the Repair Procedure below to address this condition.

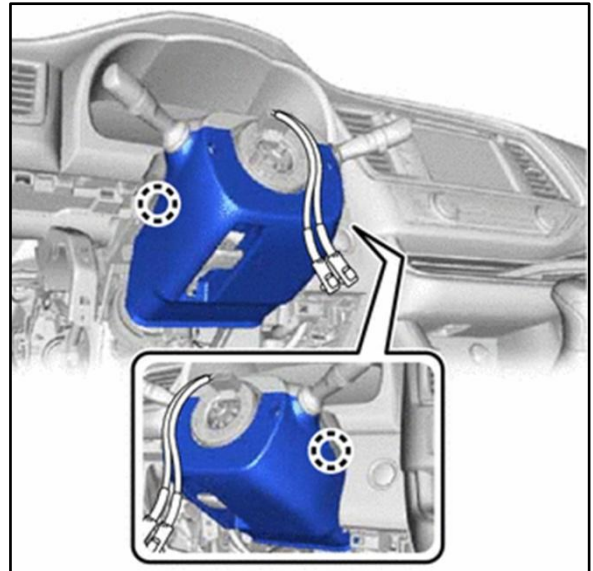
Figure 2.

5. Disengage the 2 claws.

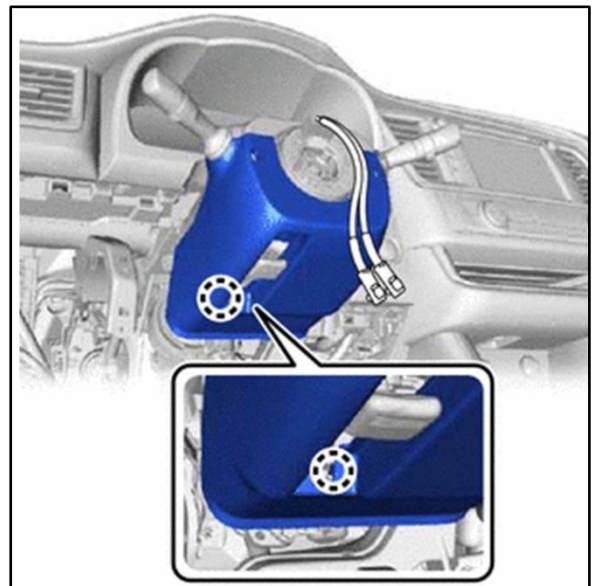
Figure 3.

6. Disengage the claw and remove the lower steering column cover.

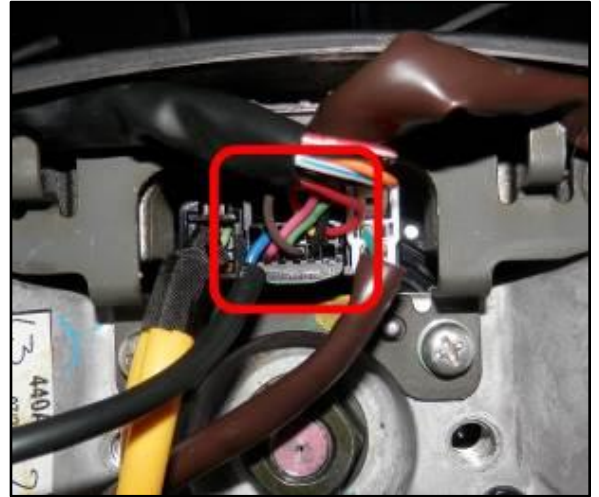
Figure 4. z4/z1

7. Disconnect switch harness connector z4 for Highlander/HV (connector z1 for RAV4) from the spiral cable at the steering wheel near the steering column shaft nut and cruise control stalk.

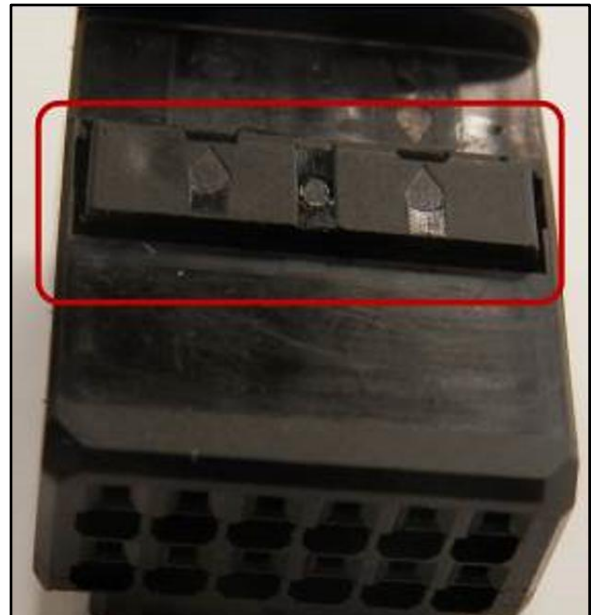
Figure 5.

8. Carefully lift connector lock tab and gently pry on indentations on top of locking tab.

The tab does NOT come out of the connector.

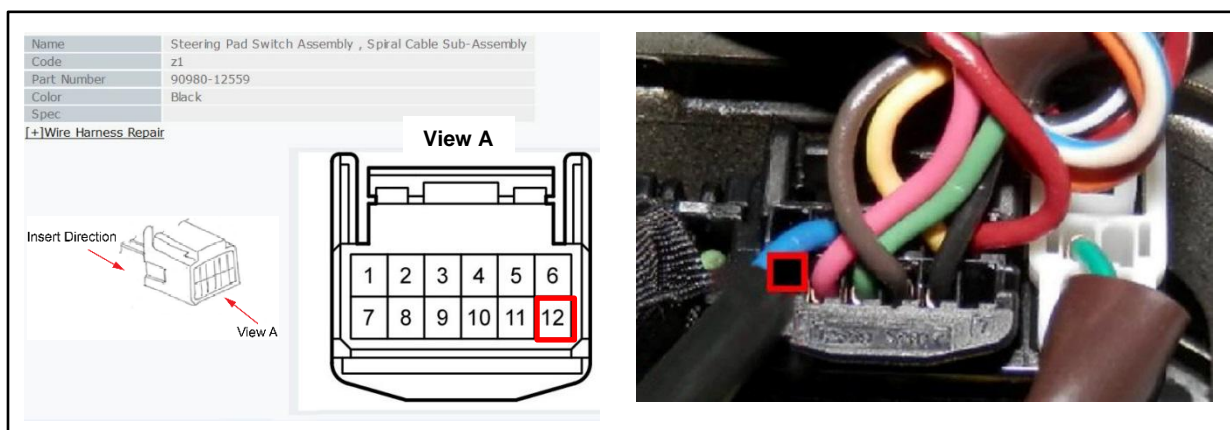
Figure 6. Connector z1

9. Insert part number 82998-0E010 pin terminal into cavity 12 of connector z4 for Highlander/HV (or connector z1 for RAV4).

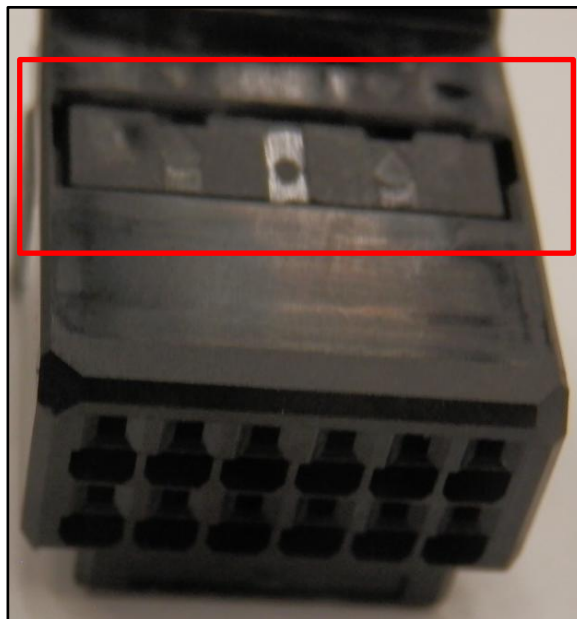
Figure 8.

10. Press lock tab down.

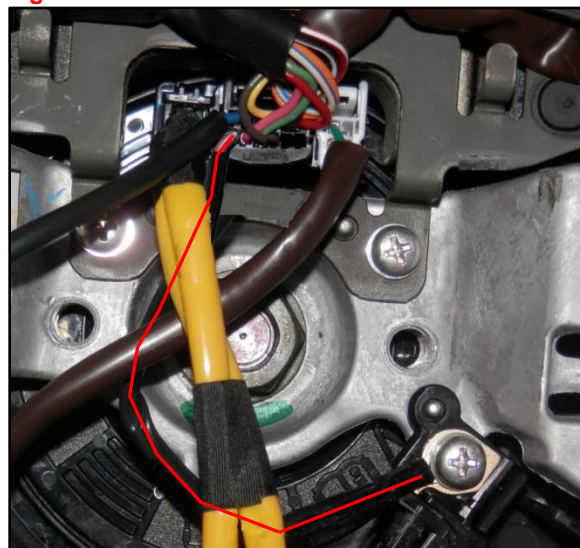
Figure 9.

11. Connect Highlander/HV connector z4 (connector z1 for RAV4) to spiral cable.
12. Route repair wire part number 82998-0E010 under existing harnesses as shown.

Do NOT attach ring terminal at this time.
(Ring terminal is attached in picture to show routing.)

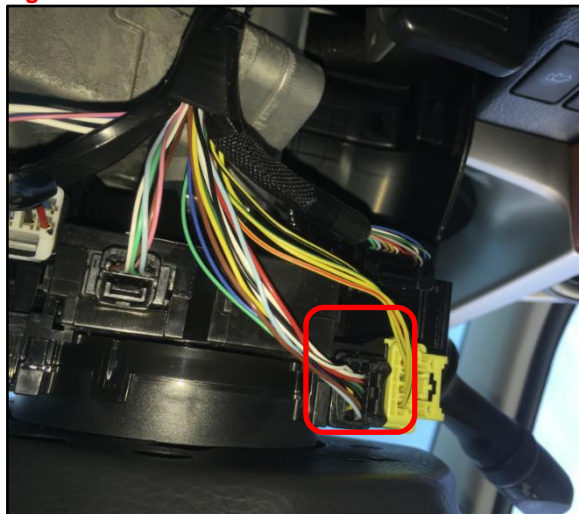
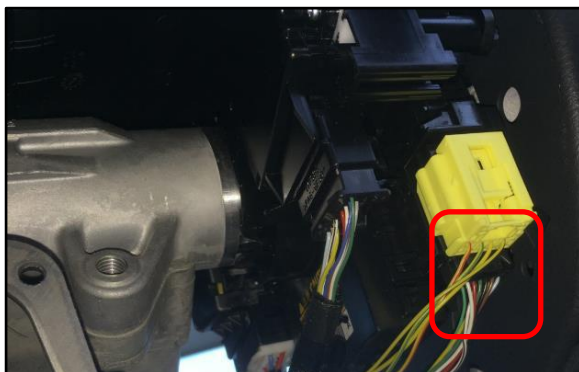
Figure 10.

13. Disconnect IP connector F61 on Highlander/HV (G8 on RAV4) from spiral cable rear of steering wheel.

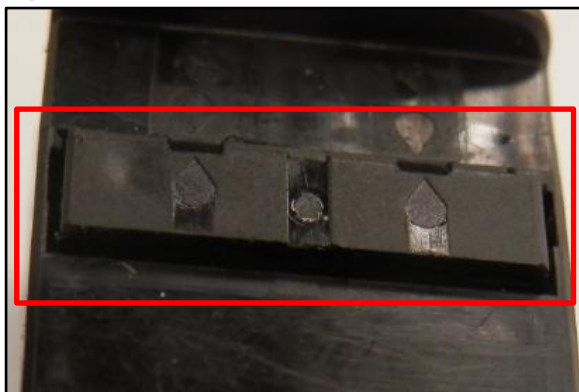
Figure 12.

14. Lift connector lock tab using same guidelines in step 8.

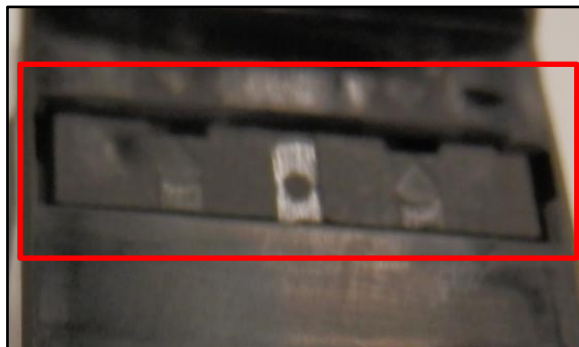
Figure 15.

16. Press lock tab down.

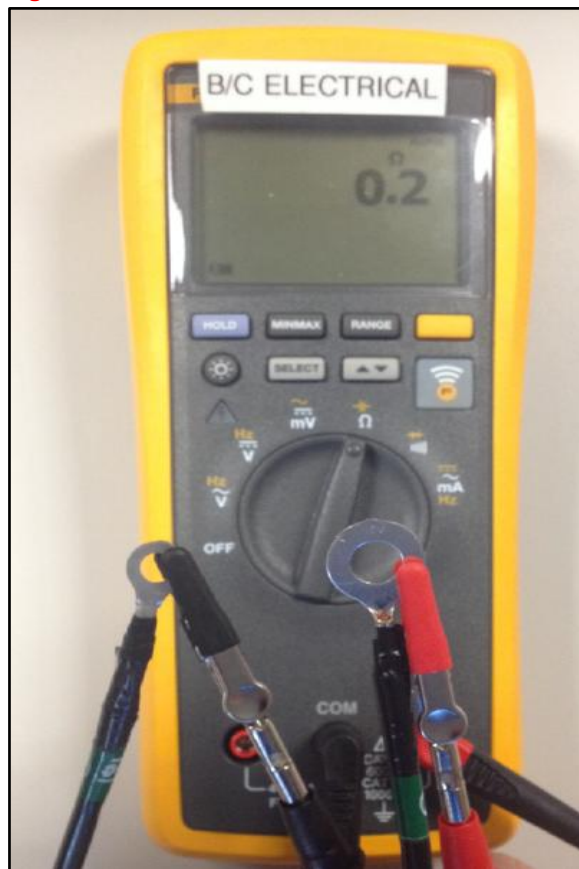
Figure 16.

17. Connect IP Highlander/HV harness connector F61 (connector G8 on RAV4) to spiral cable.
18. Check resistance between the ring terminals of both harnesses.

Both harness ring terminals should NOT be attached to the vehicle.

The standard resistance should be less than 1 ohm. If resistance is not as specified, check installation of both harnesses.

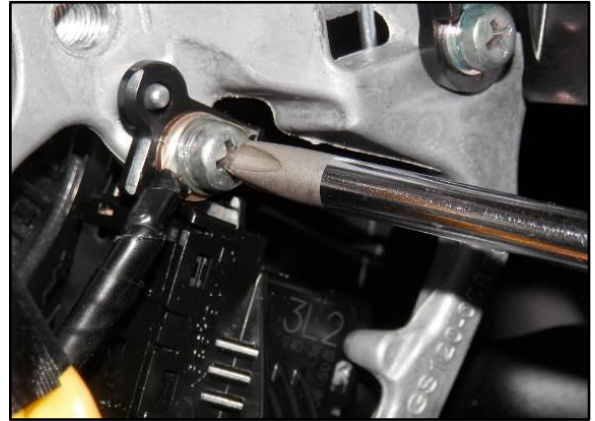
Figure 17.

19. Secure repair wire part number 82998-0E010 ring terminal to cruise control switch ground.

- A. Remove screw from cruise control switch.
- B. Place repair wire ring terminal over screw.
- C. Install screw.

Torque: 2.4 N*m (24 kgf*cm, 21 in*lb)

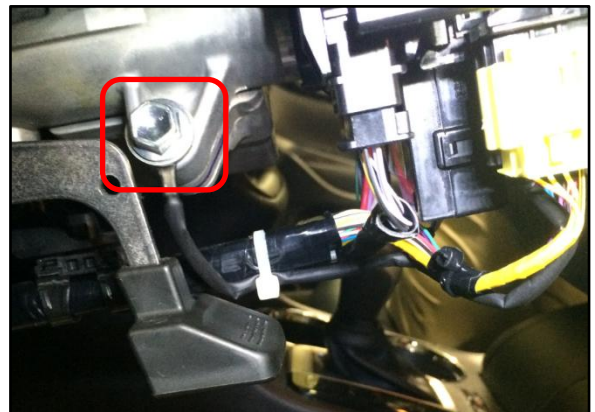
Figure 18.

20. Route repair wire part number 82998-0E020 to steering column.

- A. Insert bolt part number 91551-80801 and 2 washers onto ring terminal.
- B. Insert bolt into steering column as shown in figure.

Torque: 5 N*m (50 kgf*cm, 44 in*lb)

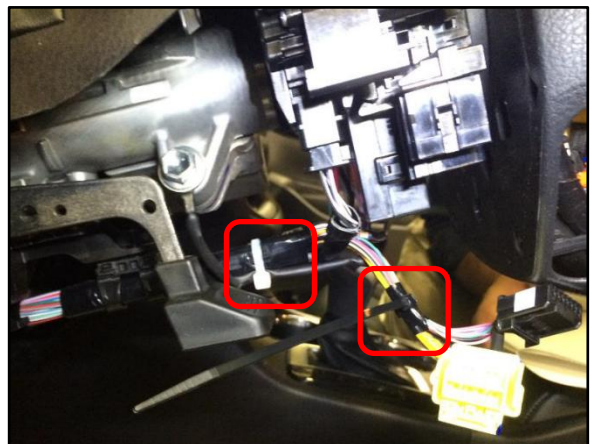
Figure 19.

21. Secure repair wires using cable ties in the indicated locations.

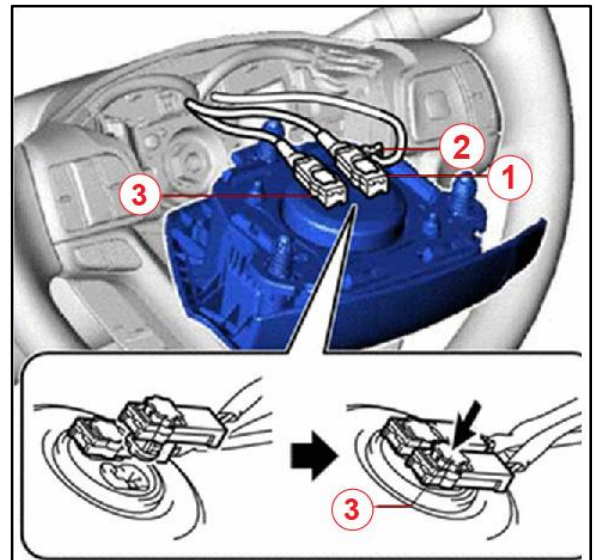
Figure 20.

- B. Connect the 2 airbag connectors to the horn assembly.

| 1 | Airbag Connector |
| 2 | Horn Connector |
| 3 | Airbag Connector Lock |

- C. Push in the 2 airbag connector locks to install the 2 airbag connectors.
 - D. Connect the horn connector to the horn button assembly.
 - E. Push the horn button assembly to engage the 3 pins carefully.

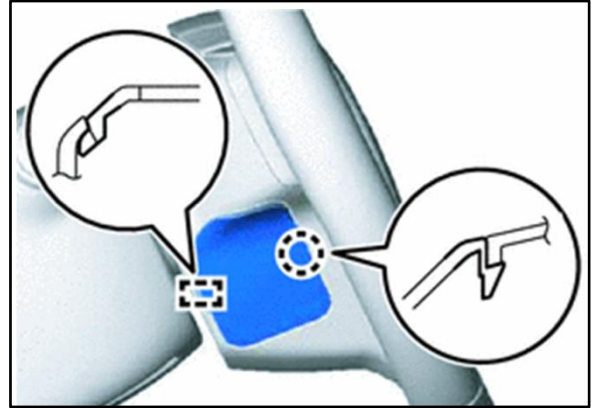
Figure 21.

24. Insert the guide and engage the claw to install the lower No. 3 steering wheel cover.

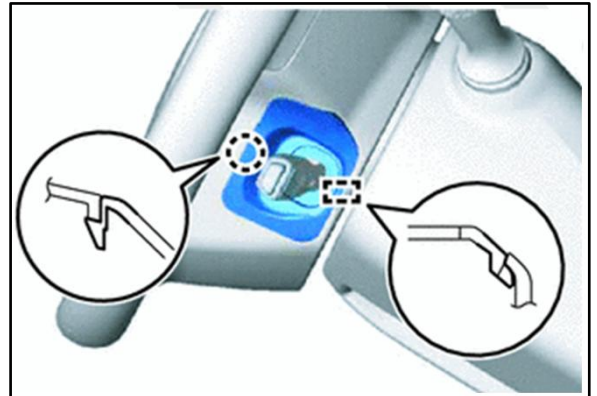
Figure 22.

25. Insert the guide and engage the claw to install the lower No. 2 steering wheel cover.
