Service Bulletin

Subject: Check Engine Light On with DTC P1101 Set

Models: 2013-2017 Buick Encore
2011-2016 Chevrolet Cruze
2012-2016 Chevrolet Sonic
2013-2017 Chevrolet Trax
Equipped with 1.4L Engine (RPOs LUJ, LUV)

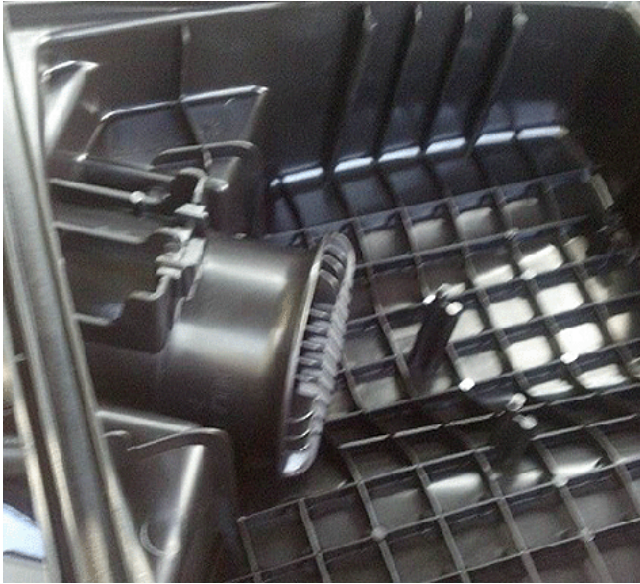
Chevrolet Cruze Only

For Chevrolet Cruze only, a missing or mispositioned air baffle in the air cleaner box could cause the TPS readings to be low and the vehicle setting P1101. Verify the air baffle is in the proper place before continuing with diagnostics. Refer to the pictures below.
