## Problems with film coating for A45 AMG, CLA45 AMG, GLA45 AMG, C63 AMG, AMG GT

| Topic number | LI88.00-P-063998 |
| Validity | All AMG model designations with film coating option |

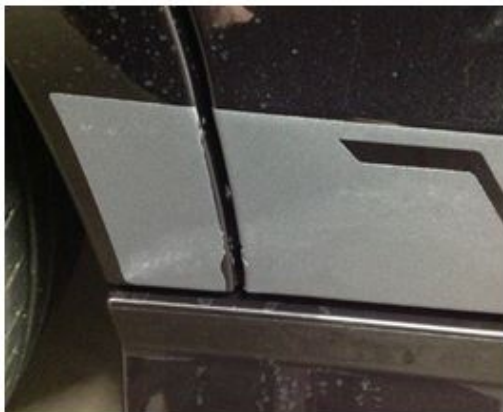
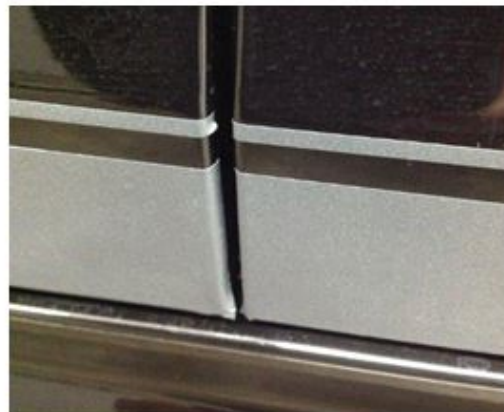
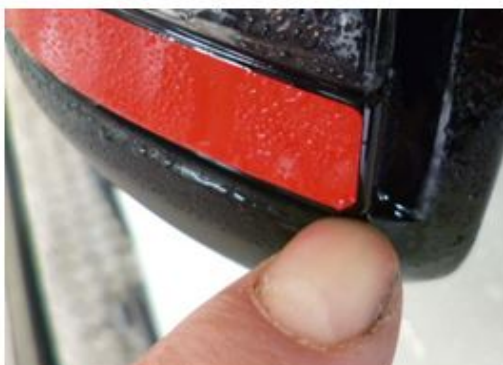
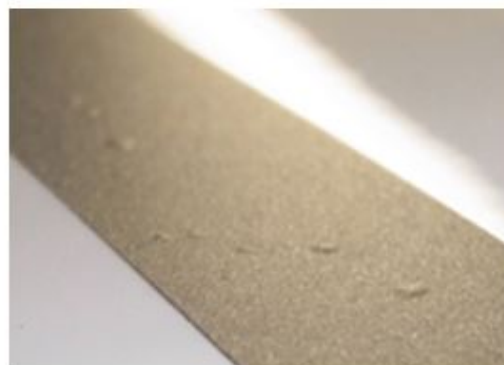
Beispielbilder 1.JPG:

Film detachment, blisters under film coating.

| Attachments | |
|---|---|
| Beispielbilder 1.JPG | Example pictures of film detachment 1 |

Case 1: The incorrect type of film coating may have been installed (see example pictures of film detachment 1).

Case 1: Ordering and replacement of films, cost settlement through warranty and goodwill.

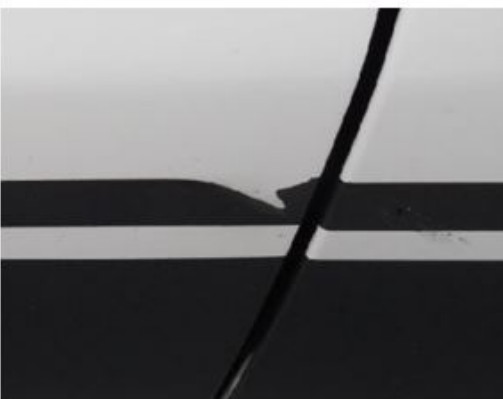
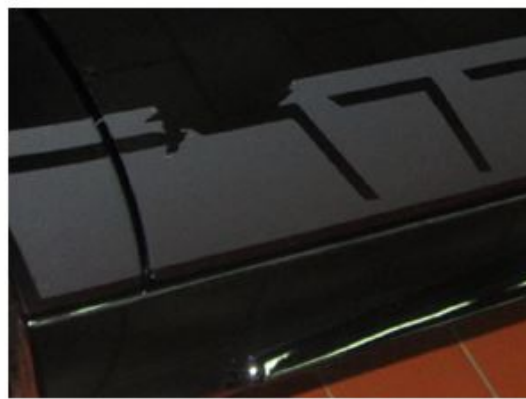
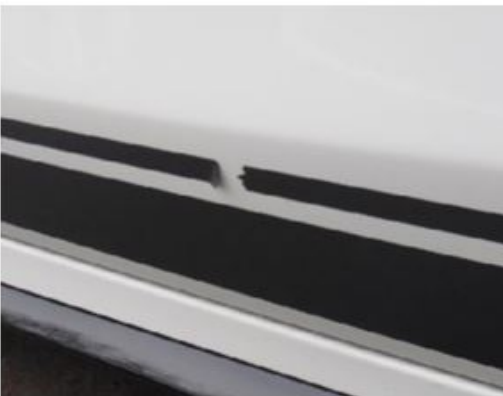
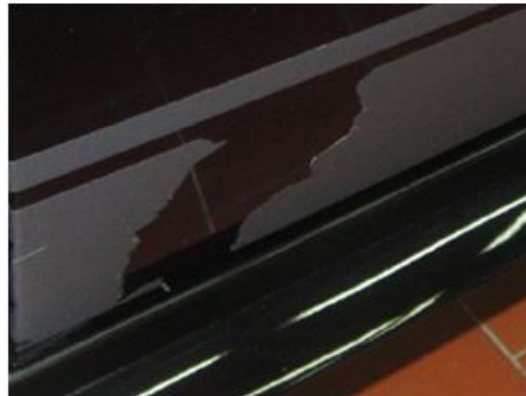
Beispielbilder 2.JPG:

| Attachments | |
|---|---|
| Beispielbilder 2.JPG | Example pictures of film detachment 2 |

Case 2: Customer fault, caused by improper cleaning, for example, steam cleaning (see example pictures of film detachment 2).

Case 2: Cost settlement through warranty and goodwill not possible, costs for ordering and replacement of films to be borne by customer.
