Clearcoat peeling / flaking / bubbling

Topic number	LI98.00-P-058914
Version	4
Design group	98.00 General
Date	05-10-2016
Validity	All vehicles with 590 - Mars Red only, production date up to Feb 2015
Reason for change	Remedy modified
Reason for block

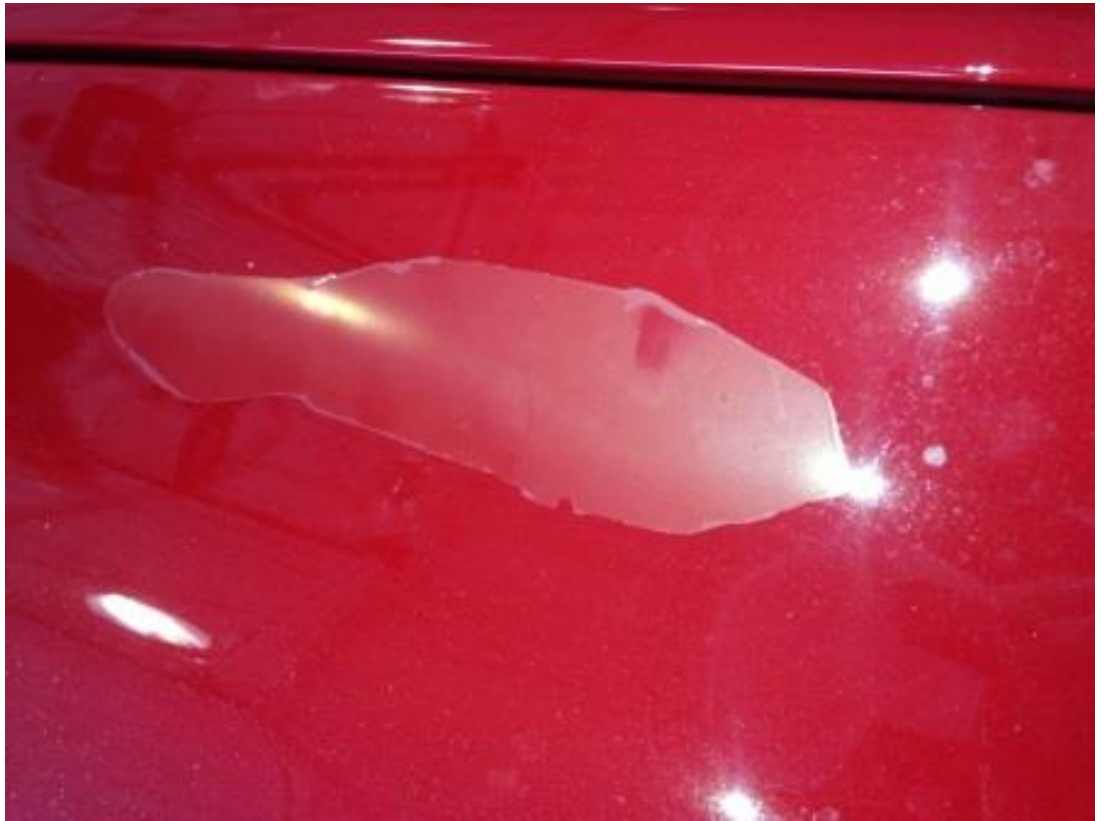
Peeling clearcoat.jpg:

Exterior clearcoat finish is peeling, flaking, or exhibits bubbles under the surface

Improper adhesion of clearcoat

Refinish affected areas only according to WIS and approved paint manufacturer instructions.
