## Reset function of backrest adjustment

| Topic number | LI91.10-P-064557 |
| Design group | 91.10 Front seats |
| Validity | Smart SOP - WME4533442K116667 (April 2016) |

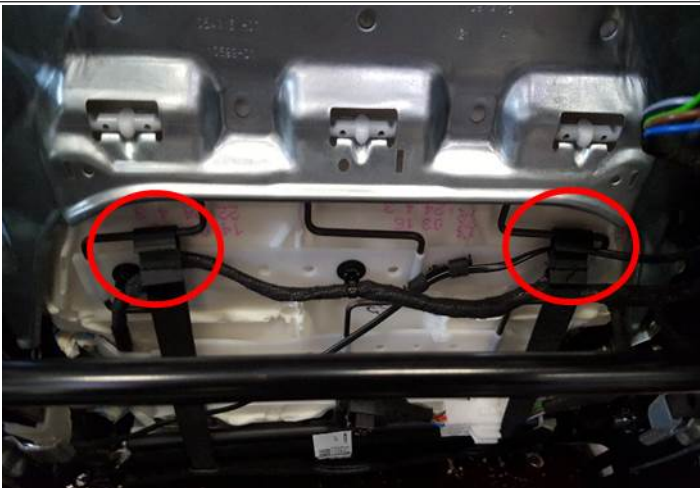
Pic 1.jpg:

1. Tilt the front seat forwards as far as possible.
2. Reach under the seat from behind and unhook the 2 hooks of the backrest cover. (Pic.1)
3. Unhook the remaining seat cover clips in the surrounding area. (Pic.2)

| Attachments | |
|---|---|
| Pic 1.jpg | Step 1 |

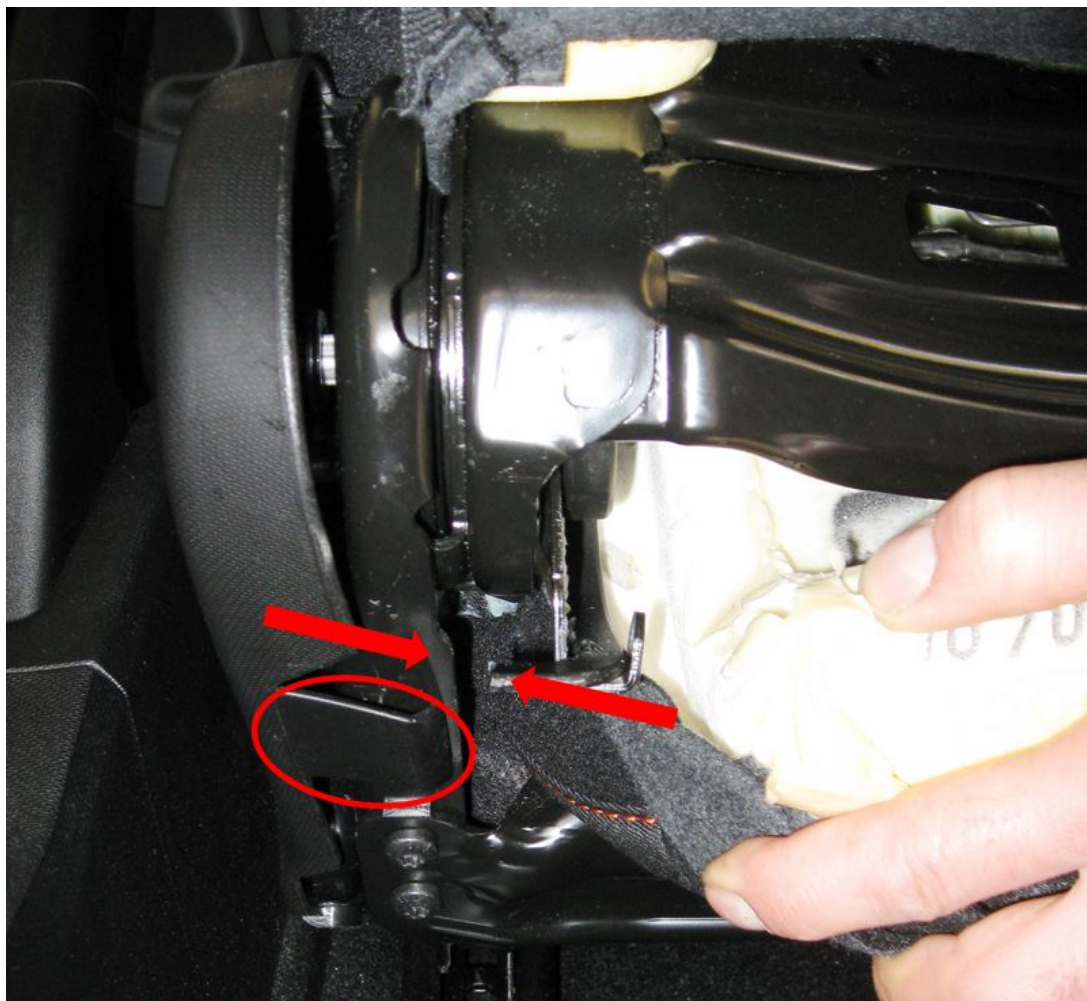
Pic 3.jpg:

4. Undo the clips of the side cover and tilt the backrest forwards until the spring is opposite the metal structure of the backrest frame. (Pic.3)
5. Use pliers to gently bend the U section in the direction of the end stop. Keep a distance of 4 to 5mm between the spring and the backrest frame to avoid overbending. (Pic.4)

| Attachments | |
|---|---|
| Pic 3.jpg | Step 3 |

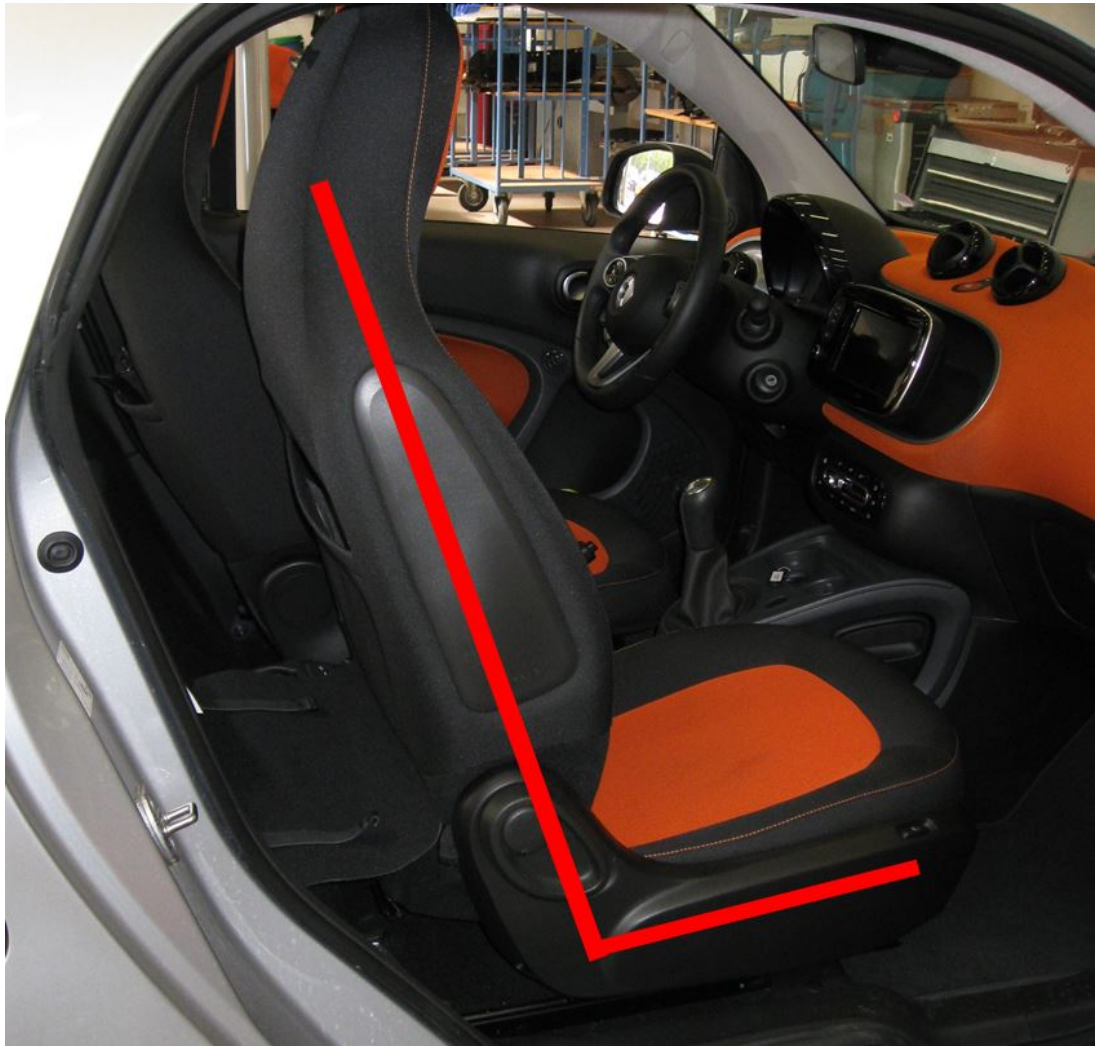
Pic 5.jpg:

6. Straighten the backrest to about a right angle. (Pic.5)
7. Check whether the spring protrudes 4 - 6mm over the end stop; readjust the bend if necessary. (Pic.6)

| Attachments | |
|---|---|
| Pic 5.jpg | Step 5 |

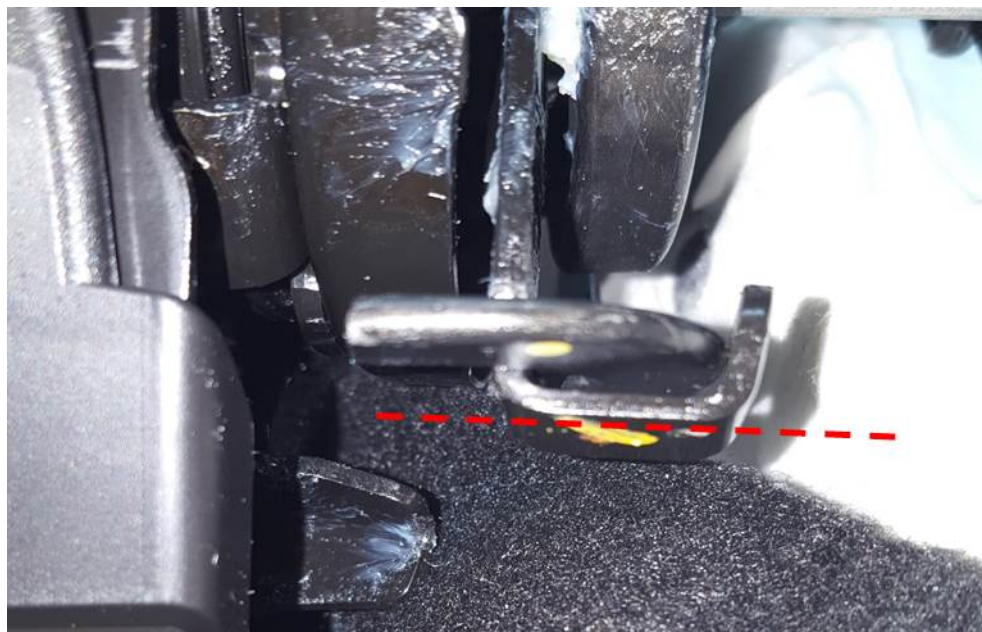
Pic 7.jpg:

8. Check whether the U section is still straight; adjust the bend if necessary. (Pic.7)
9. Check the function of the adjusting lever by tipping the seat forwards and backwards three times. (Pic.8)

| Attachments | |
|---|---|
| Pic 7.jpg | Step 7 |
