| RE: <b>Service Campaign 2016030008</b><br><b>Model 117, Model Year 2014</b><br><b>Replace Automatic Transmission</b> | DATE: July 29, 2016 |

# Service Campaign Bulletin

Campaign No. 2016030008, July 2016

SUBJECT: **Model 117, Model Year 2014**  
**Replace Automatic Transmission**

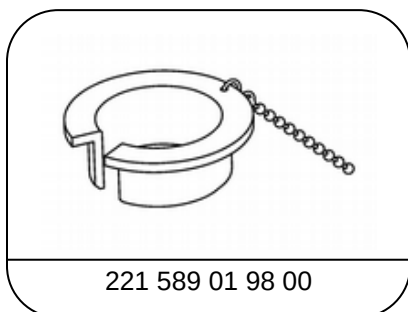
Assembly tool
