# Service Bulletin

**Subject:** Creak or Snap Noise Above Windshield from Removable Roof Lift Off Panel While Driving

Brand:	Model:	Model Year:		VIN:		Engine:	Transmission:
		from	to	from	to		
Chevrolet	Corvette	2014	2015			All	All

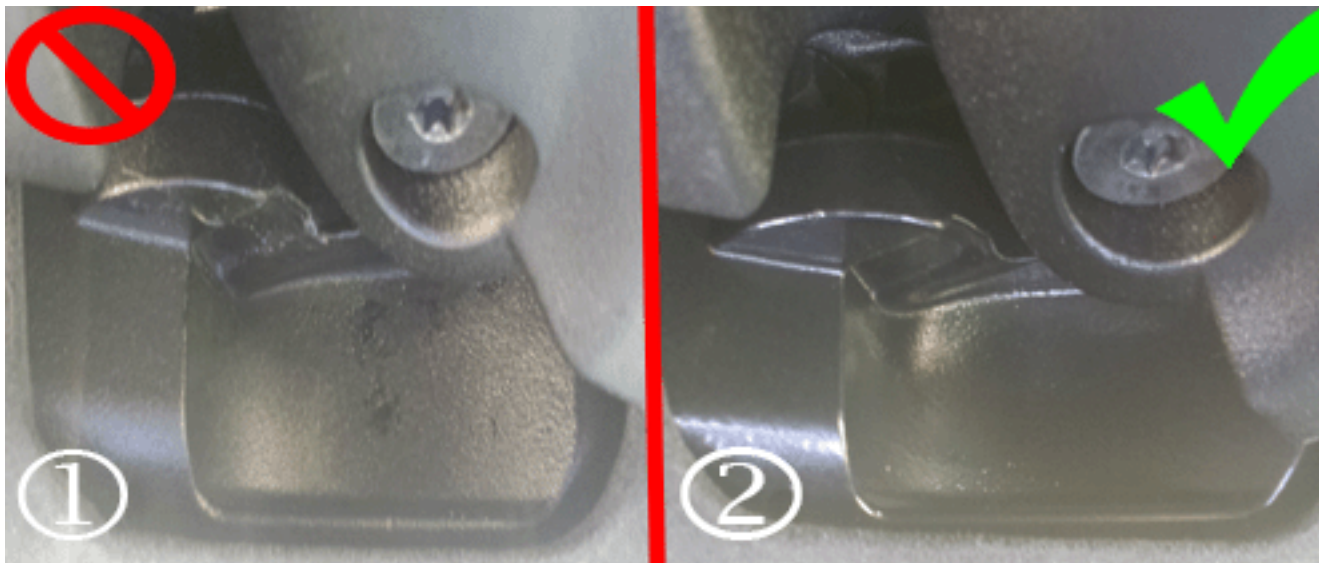
1. Example of a bad striker
2. Example of a good striker

1. Visually inspect the front roof lift off panel strikers finish.

- If the finish is rough as illustrated above, replace the strikers.
- If the finish is smooth, continue on to Step 2.

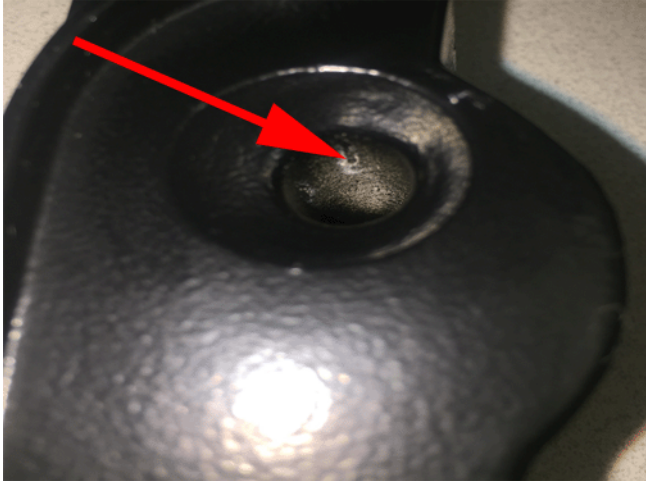
2. Visually inspect the front roof lift off panel strikers for missing paint in the cavity for the front alignment pins as illustrated above.
  - If paint coverage in the cavity for the front alignment pins is less than 9 mm (3/8") from edge of the hole, replace the front roof lift off panel striker with insufficient paint coverage. Refer to *Roof Lift Off Panel/Window Front Striker Replacement* in SI.

**Important:** Be sure to visibly inspect new front roof lift off panel strikers for missing paint before installation.

- If paint is visibly applied throughout the cavity for the front alignment pins, continue onto Step 3.

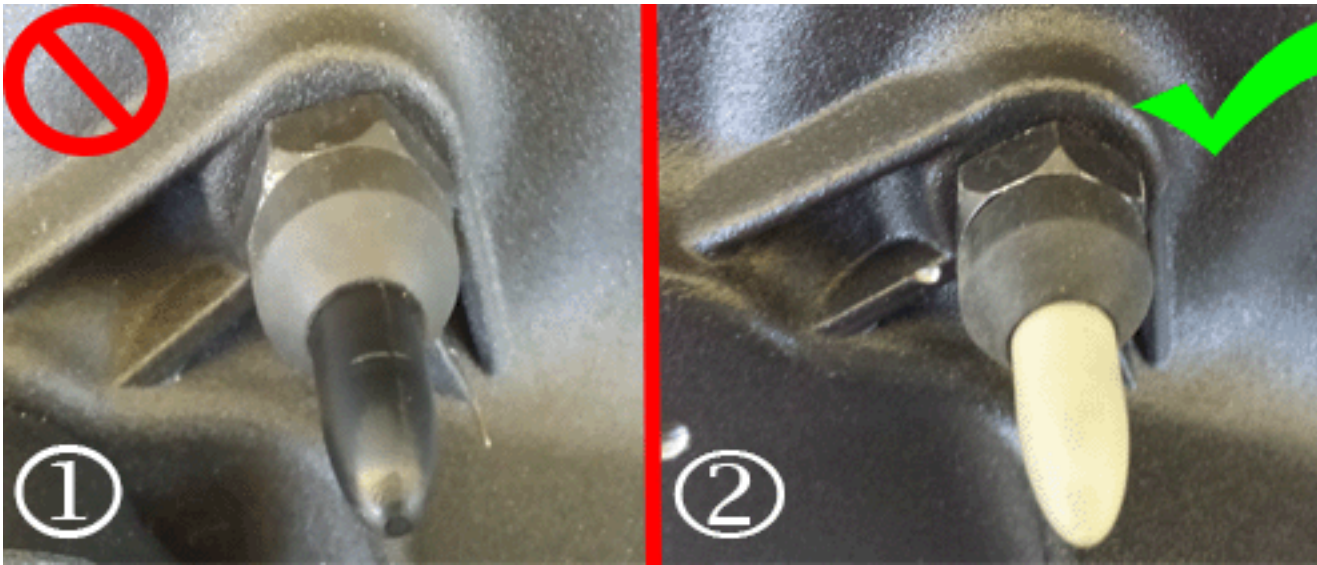
1. Example of a bad front locating pin
2. Example of a good front locating pin
3. Visually inspect the front locating pins.
  - If pins are black in color as illustrated above, replace the locating pins. Refer to *Removable Top Locating Pin Replacement* in SI.
