Service Bulletin

Subject: Rattle or Buzz Noise from Rear of Vehicle and/or Rear Wheel Liner Hanging Down

| Brand: | Model: | Model Year: | | VIN: | | Engine: | Transmission: |
|---|---|---|---|---|---|---|---|
| Cadillac | CT6 | 2016 | 2017 | | | All | All |

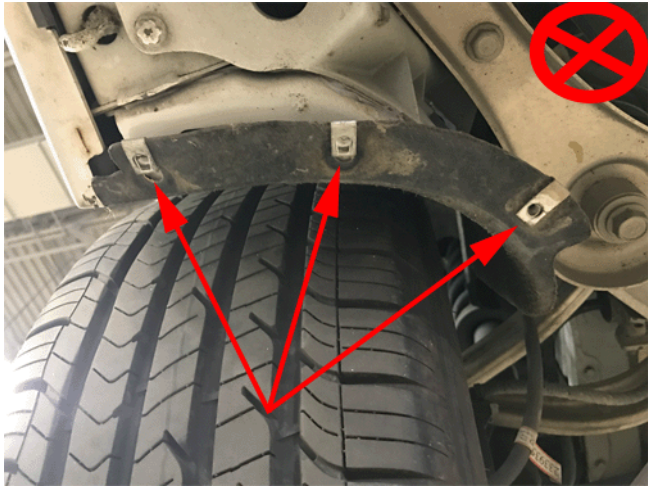
| Cause | <p>This may be due to incorrect installation of the j-clips installed onto the wheel liner and not onto the sheet metal.</p> |
