Service Bulletin

Subject: Coolant Smell and/or Slight Leak at Radiator

Models: 2015 Cadillac Escalade Models

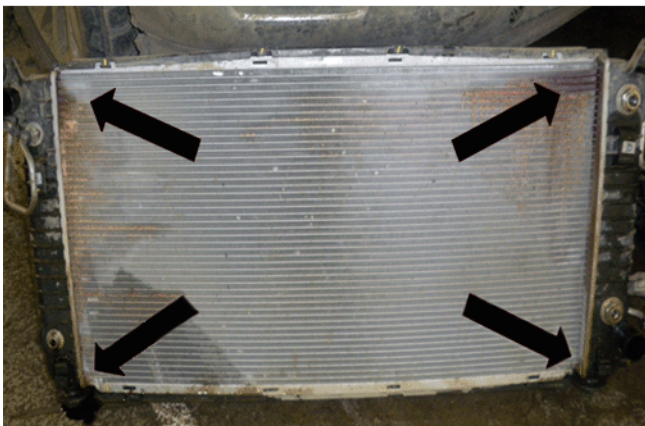
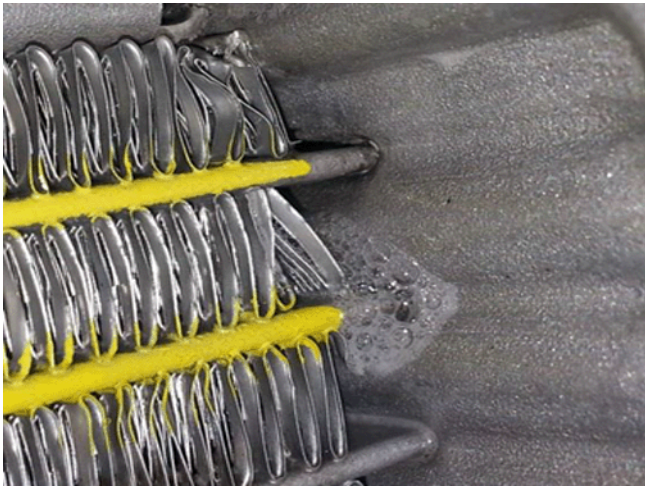
Technicians should start by inspecting the radiator for signs of leaks. Normally, signs of leaks can be found where the tubes attach to the headers.

This condition may be the result of excessive thermocycles within the cooling system caused by excessive cycling of the thermostat. These excessive thermocycles within the coolant system may cause the tubes to fatigue, crack and leak at the radiator headers. To correct this condition, a new thermostat has been designed that eliminates the thermostats excessive cycling.

If this condition is found, in addition to replacing the radiator, the engine coolant thermostat housing (w/thermostat) must also be replaced. Refer to *Engine Coolant Thermostat Housing Replacement* in SI, which is located in the Engine Heating and Cooling section.
