**SERVICE BULLETIN**

**APPLICABILITY:** 2014-15MY XV Crosstrek Hybrid Electric Vehicle (HEV) **NUMBER:** 16-94-15R

**SUBJECT:** Diagnosis and Repair of DTCs P172A and P0B0B

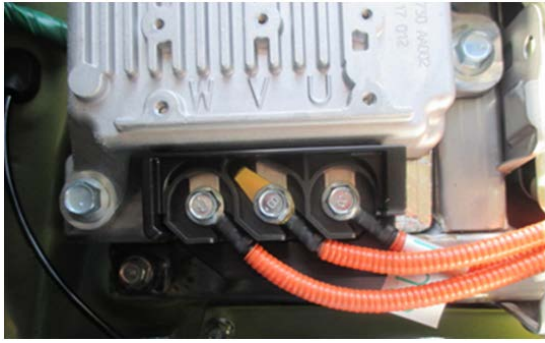
- Remove the rear cargo area floor mat and the sub-trunk (storage tray).
- Remove the orange HEV Service Disconnect plug and put it in your pocket.
- Remove the TORX screws and necessary trim clips securing the aluminum battery cover.
- **ONE AT A TIME**, remove the 3 bolts securing the orange “W”, “V”, and “U” cables to the electric oil pump inverter. As each cable is removed, cover each terminal end with one piece of electrical tape to insulate it. Connect the RED (+) test lead from the DVOM to the “U” cable end and BLACK (-) lead to the “V” cable end as shown. Confirm the “W” cable end is wrapped with insulating tape.

- Reinstall the orange HEV Service Disconnect plug.
- Turn on the DVOM and set it to measure AC Voltage.
- Start the engine and with the transmission in PARK, hold the engine at 1800 RPM.
- Read the AC voltage on the DVOM display and record your result.

**IF THE DVOM SHOWS 0.5V OR MORE:** the o-ring and drive motor are damaged. The drive motor / case assembly must be replaced. Remove the CVT assembly following the procedure in the applicable Service Manual.

**IF THE DVOM SHOWS LESS THAN 0.5V:** the root cause of the DTC is elsewhere. Continue with the DTC diagnostic procedure in the applicable Service Manual.

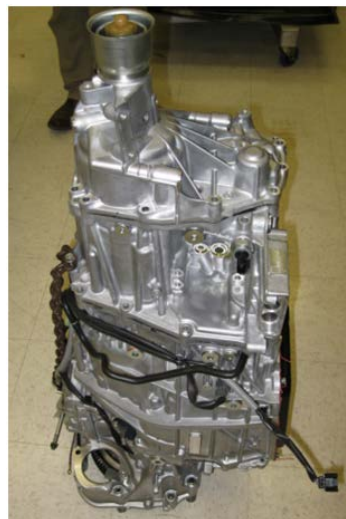
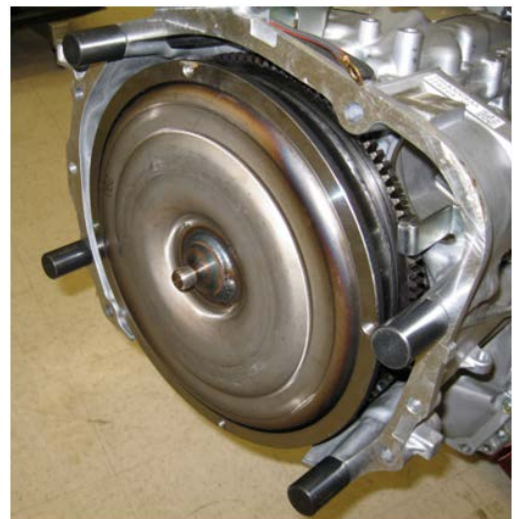
The bulk of this procedure is best performed with the transmission assembly standing vertically. Use the 4- 6M/T stands (S/T# 18632AA000) pictured below for support.

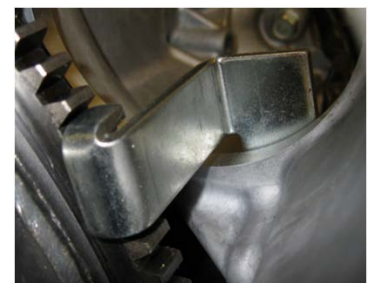
- The torque converter can also be left in place. Either support it from the underside after standing the unit up with a block of wood or use a retainer strap / bracket included with remanufactured and replacement transmission assemblies to keep the torque converter in place.

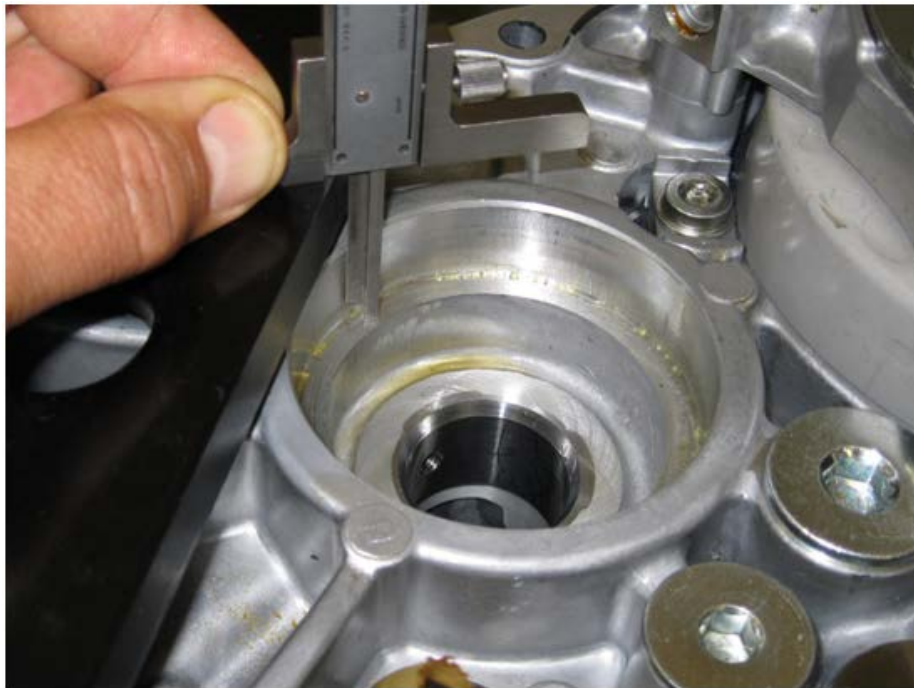
2) Measure the height "A" from the Gauge Block upper face to the ball bearing catch surface.

4) Obtain the thickness of reduction driven gear shim using the following formula to select zero to three reduction driven gear shims.

$$T \text{ (mm)} = A - B - (0.05 \text{ — } 0.25)$$

A: Height from the Gauge Block upper face to the ball bearing catch surface

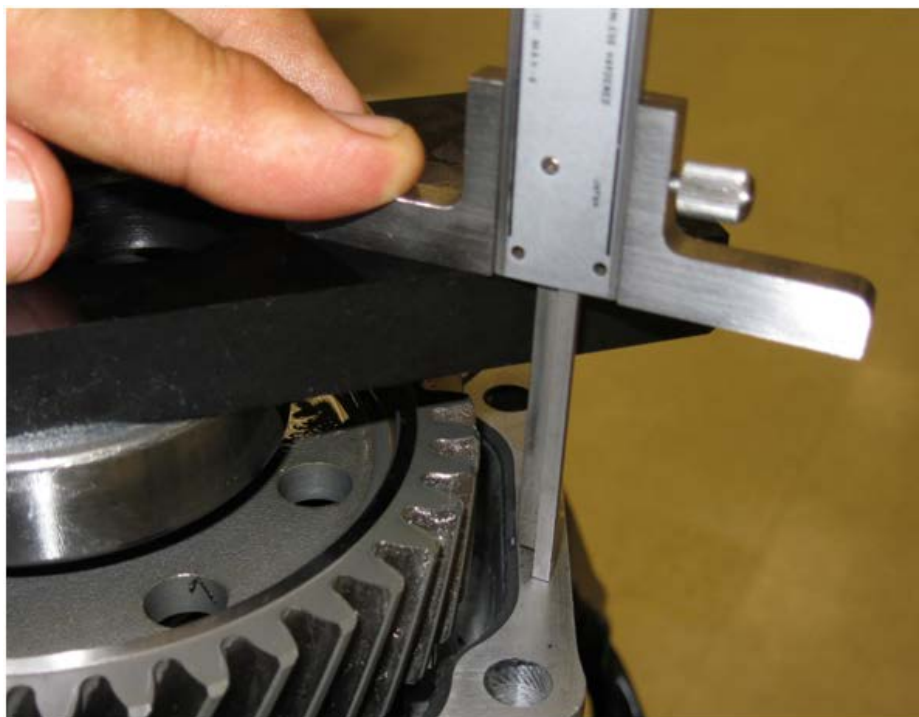
0.05 — 0.25 mm (0.002 — 0.01 in): Clearance

Transfer driven gear shim	
Part No.	Thickness mm (in)
33280AA060	0.3 (0.012)
33280AA070	0.4 (0.016)
33280AA080	0.5 (0.020)

Once all of the proper shim thicknesses have been determined, proceed with reassembly following the procedure outlined in the applicable Service Manual.

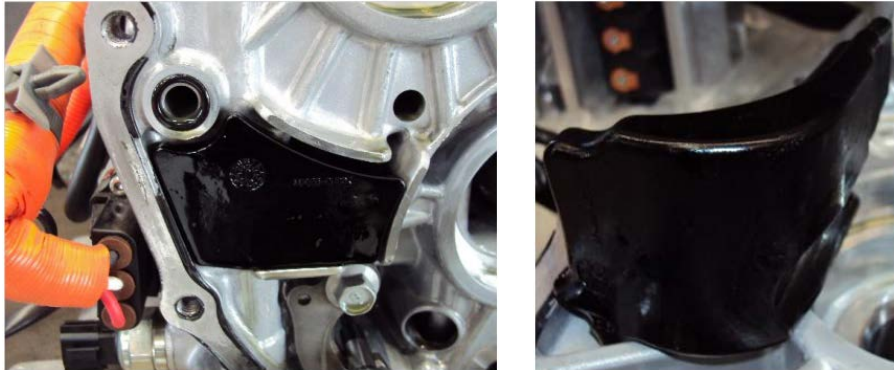
- When installing the secondary pressure sensor and inspection plugs, **ALWAYS** install a new o-ring (with some CVT fluid applied to it) and follow the proper torque specifications as they do vary.
- Remember to transfer both of the oil baffles shown below over to the new assembly.
