BUZZING NOISE HEARD COMING FROM STEERING WHEEL

F06 (M6 Grand Coupe), 5AD or 5AS	F10 (M5 Sedan), 5AD or 5AS	F12 (M6 Coupe), 5AD or 5AS	F13 (M6 Convertible), 5AD or 5AS
----------------------------------	----------------------------	----------------------------	----------------------------------

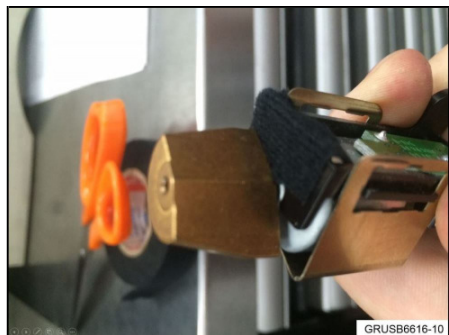
Install the felt tape as shown

Install felt tape as outlined in the "Procedure" below

Attention: All parts for the steering wheel assembly must be ordered individually. Do not replace the airbag. Be careful not to damage the parts during the removal process.
