SLOSHING NOISES/WATER IN REAR PASSENGER COMPARTMENT

F33 (4 Series Convertible)	F83 (M4 Convertible)
----------------------------	----------------------

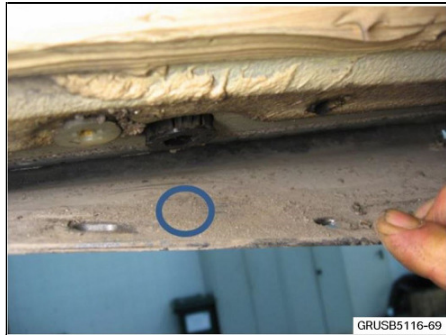
6. Below the water drain, drill a max. 10 mm hole through the side sill and underbody paneling.

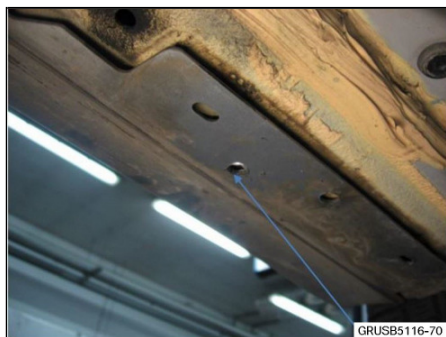
7. Properly deburr both sides of the drilled hole.
