SERVICE ACTION: N63T ENGINE - CHECK AND REPLACE THE CRANKCASE VENTILATION HOSES

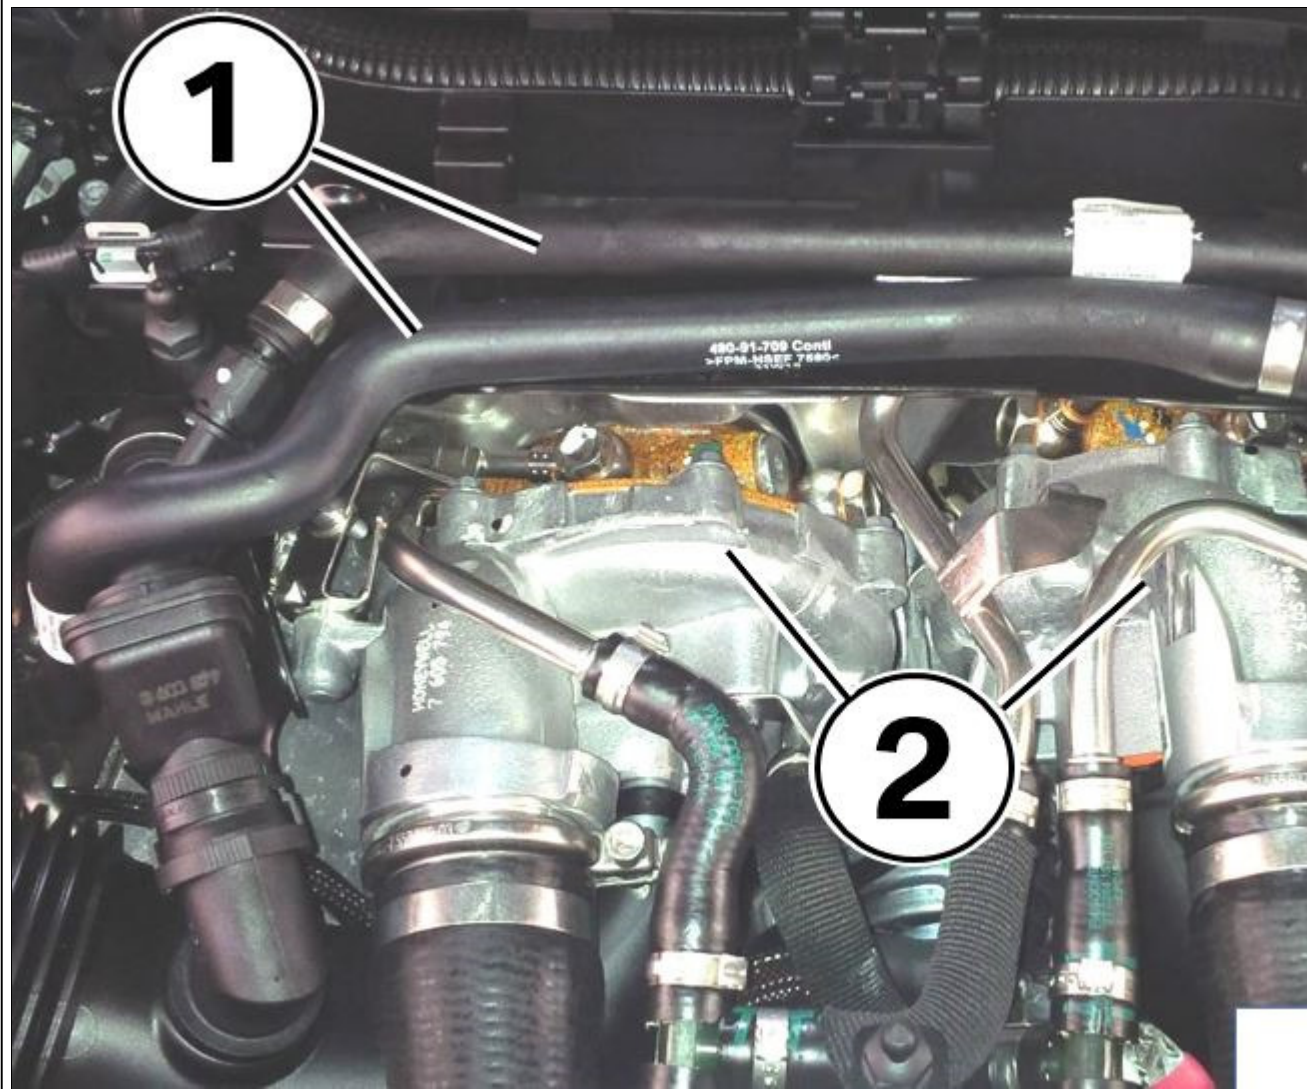
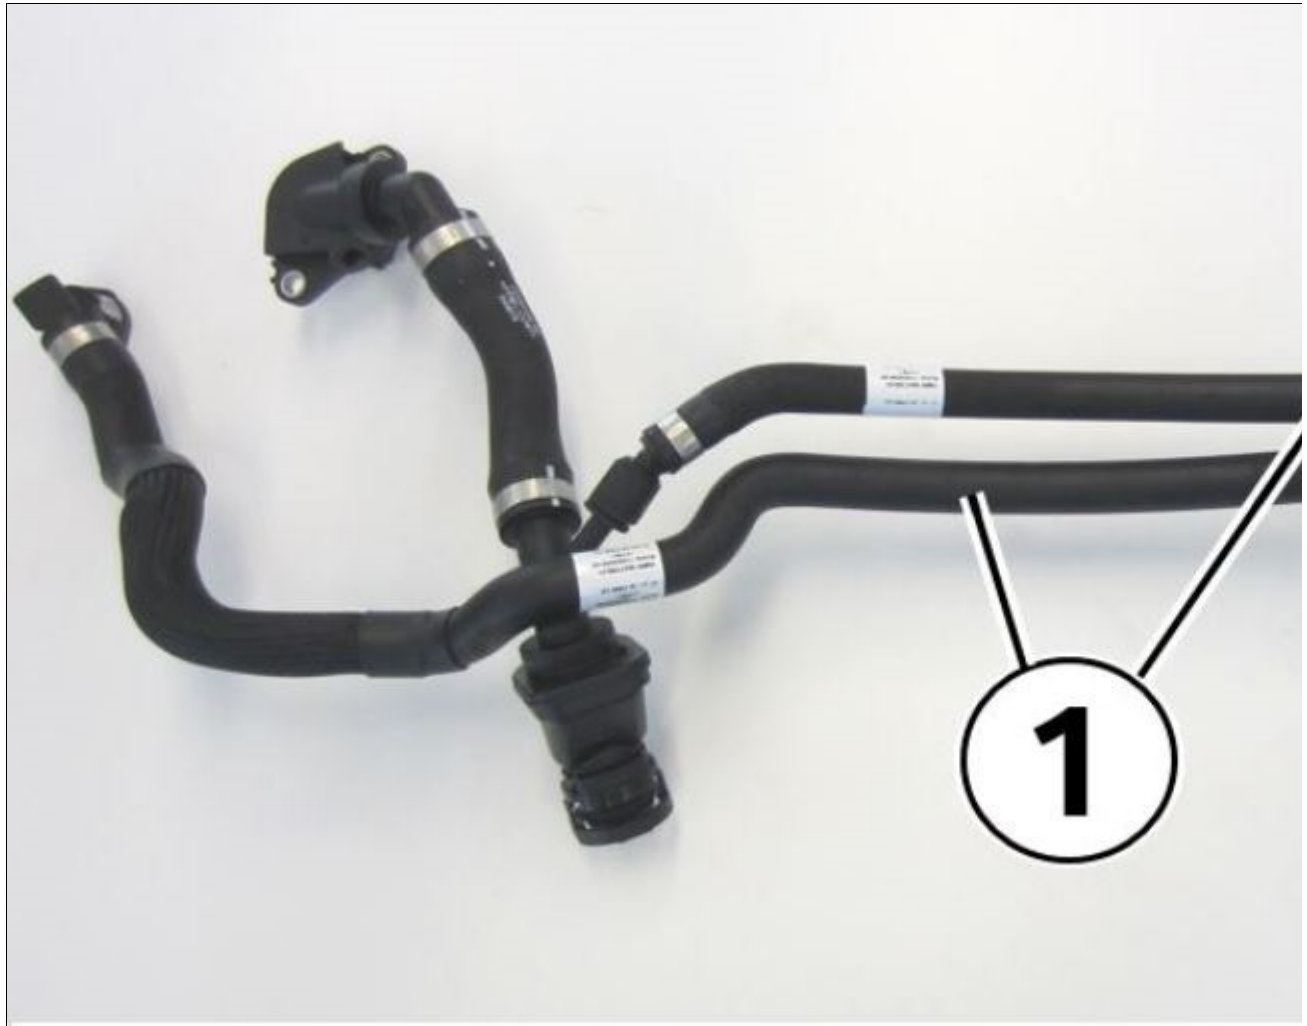
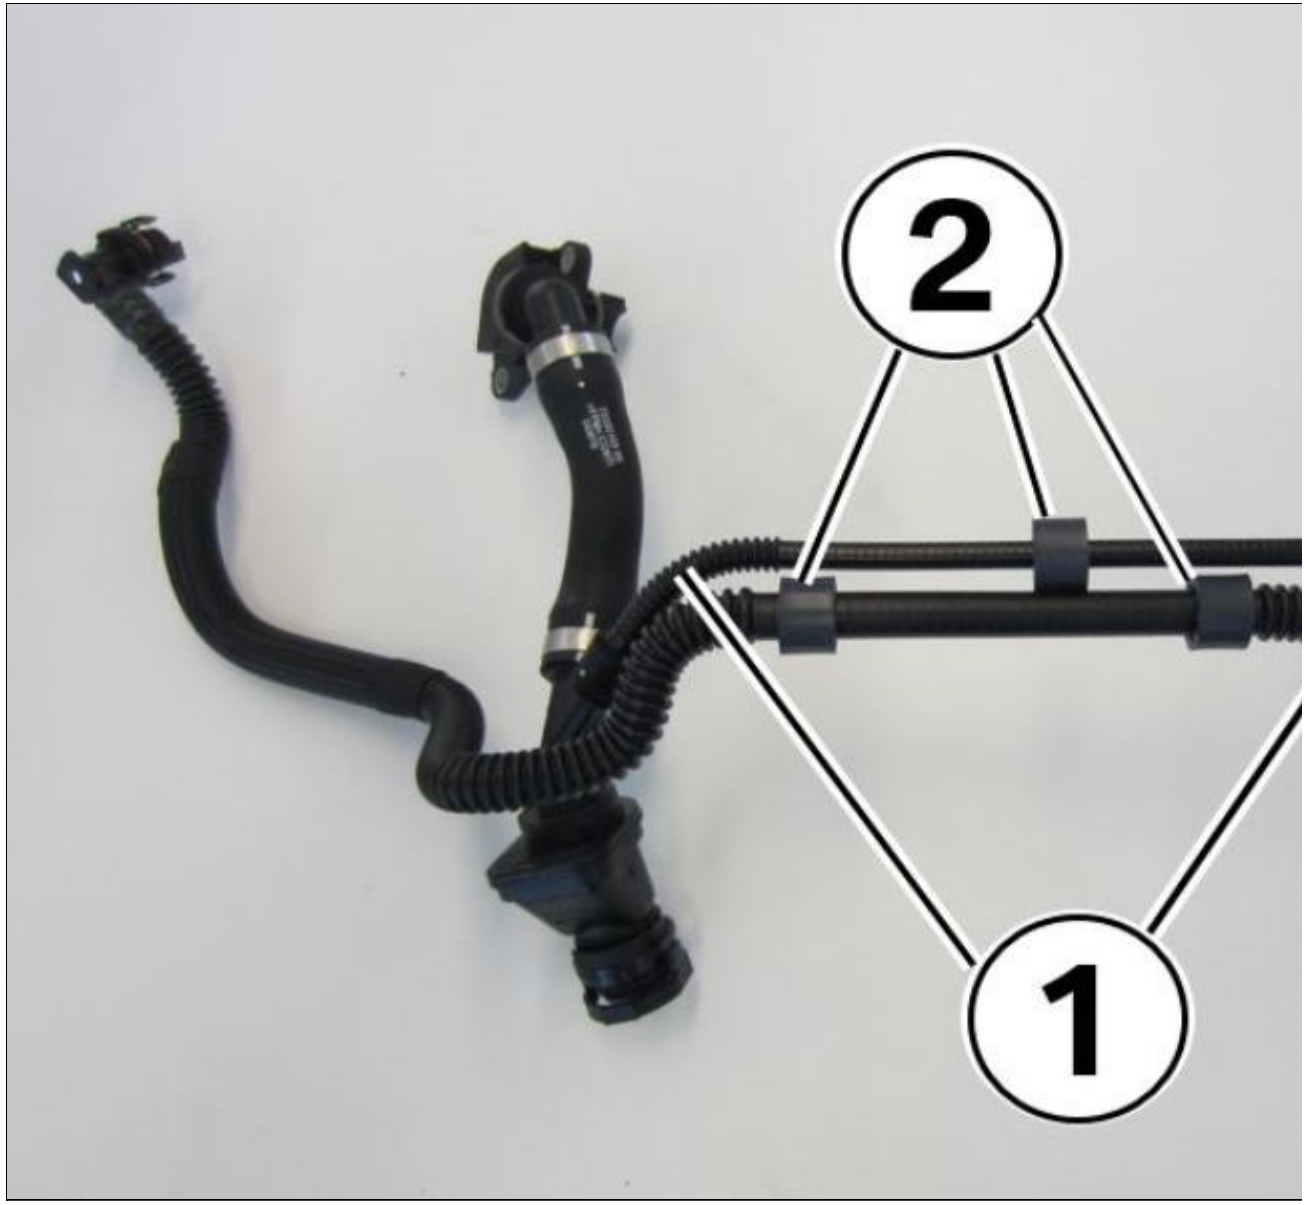
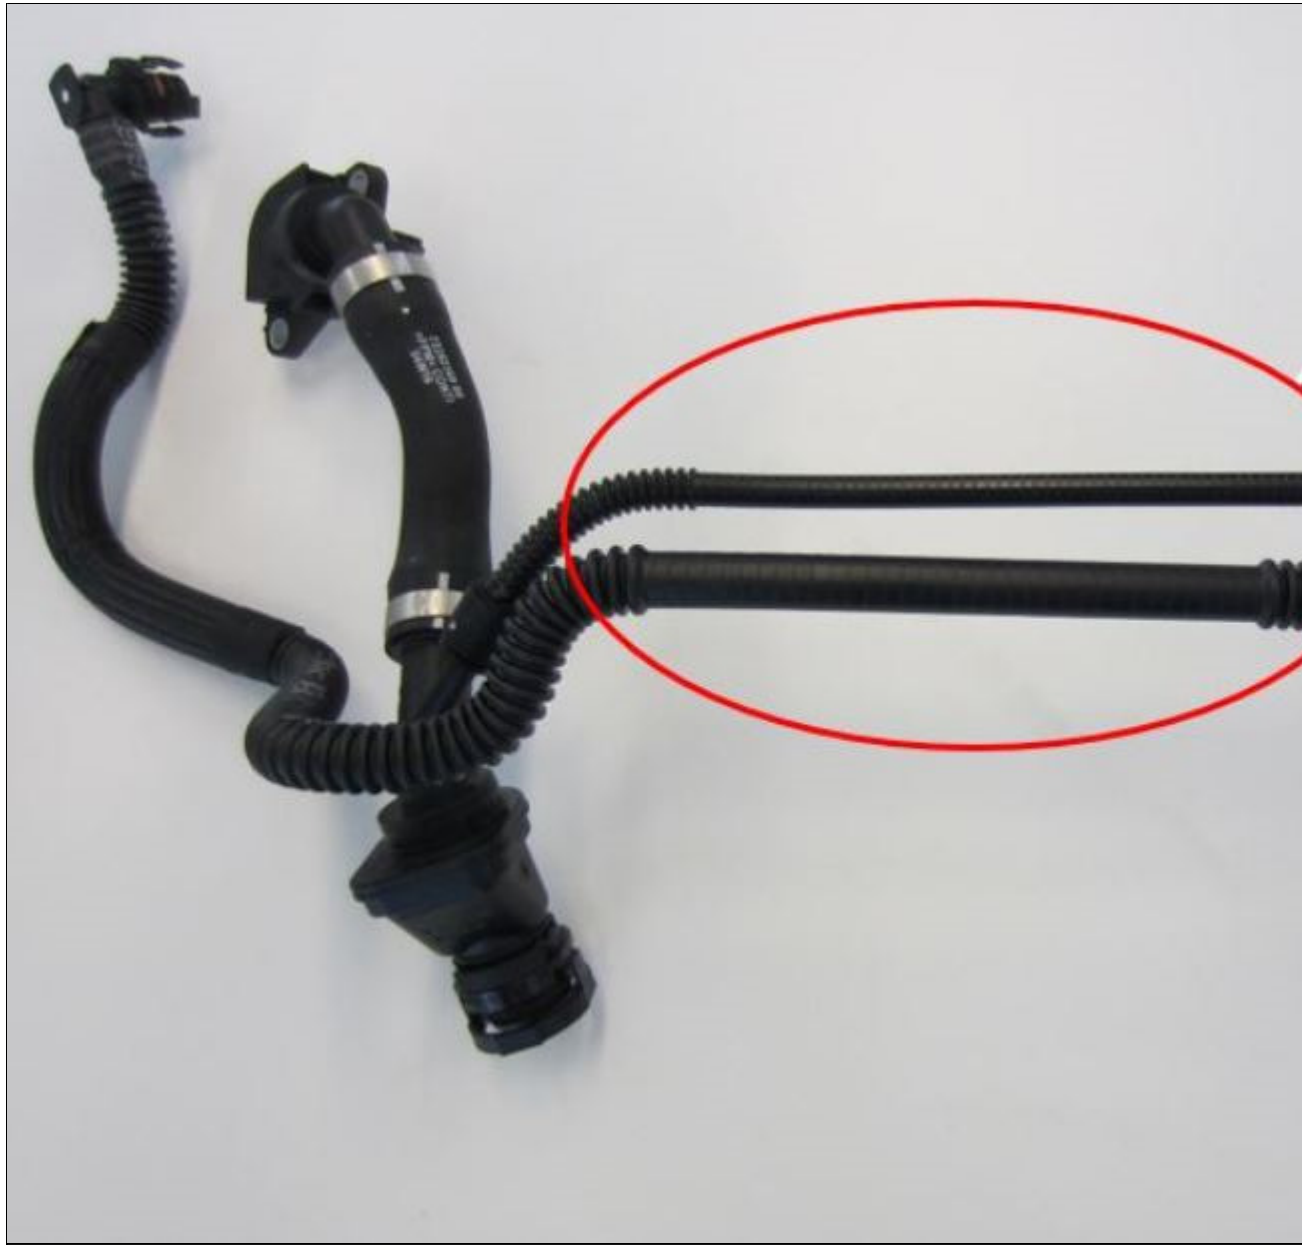
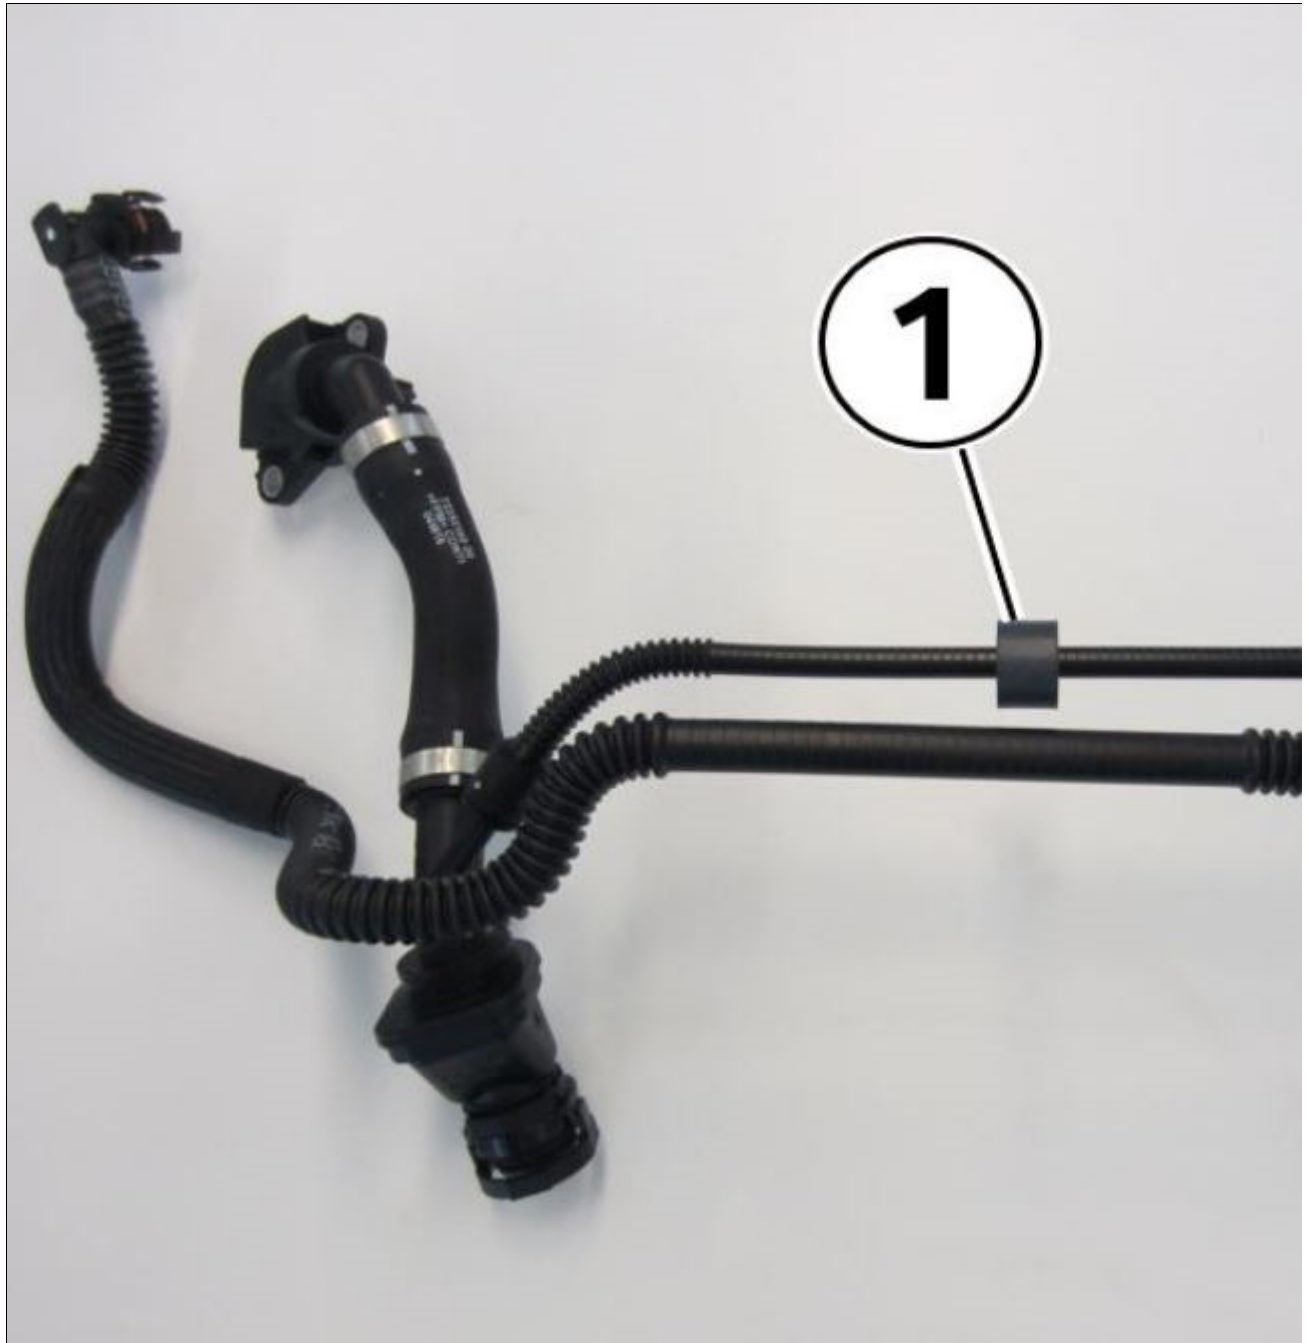
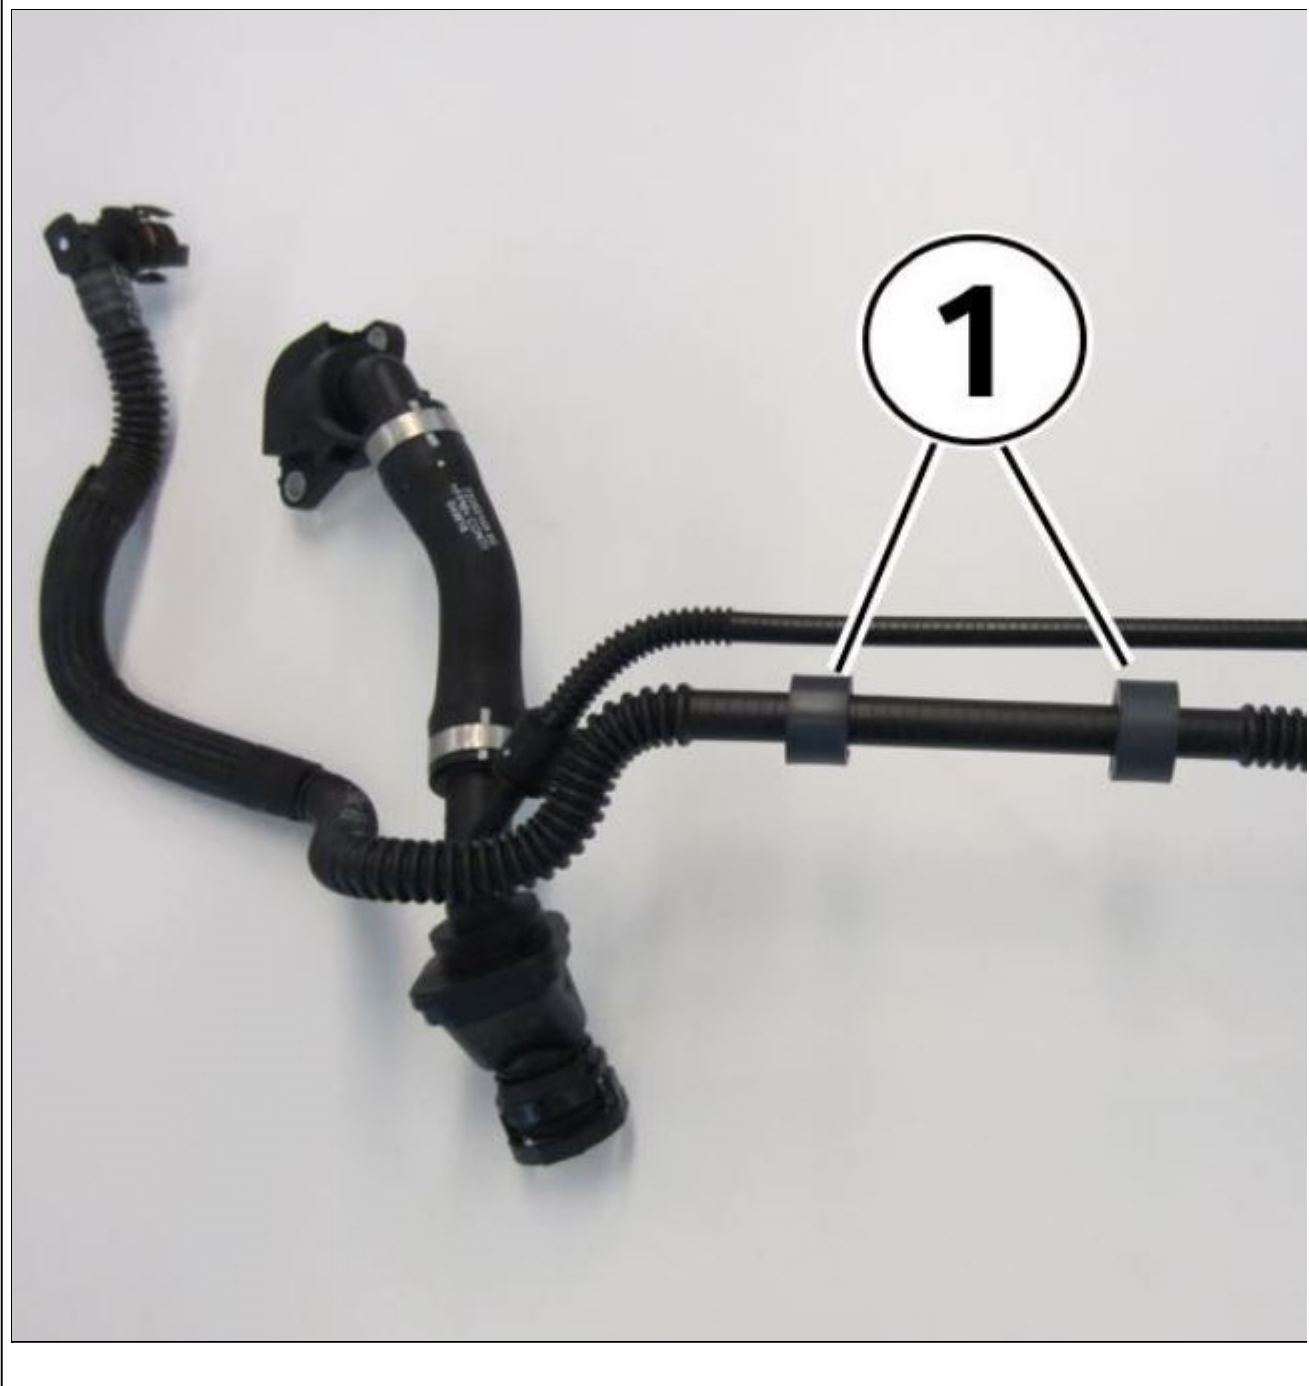
The crankcase ventilation hoses may become brittle and break when they come in contact with hot engine components.

One or more of the crankcase ventilation hoses are not FPM rubber material. The FPM rubber material is engine heat resistant.

The plastic coggurated hoses are not fitted with the self-locking spacers. The self-locking spacers maintain an air gap between the hoses and the hot engine components.

Inspect and if necessary replace the crankcase ventilation hoses.

1. Remove the acoustic engine cover as per repair instruction 11 00 ... "Removing and Installing Acoustic Cover".
