July 2016 **Technical Service**

HALOGEN HEADLIGHT ADJUSTMENT PROCEDURE

F30 (3 Series)	F31 (3 Series Sport Wagon)
----------------	----------------------------

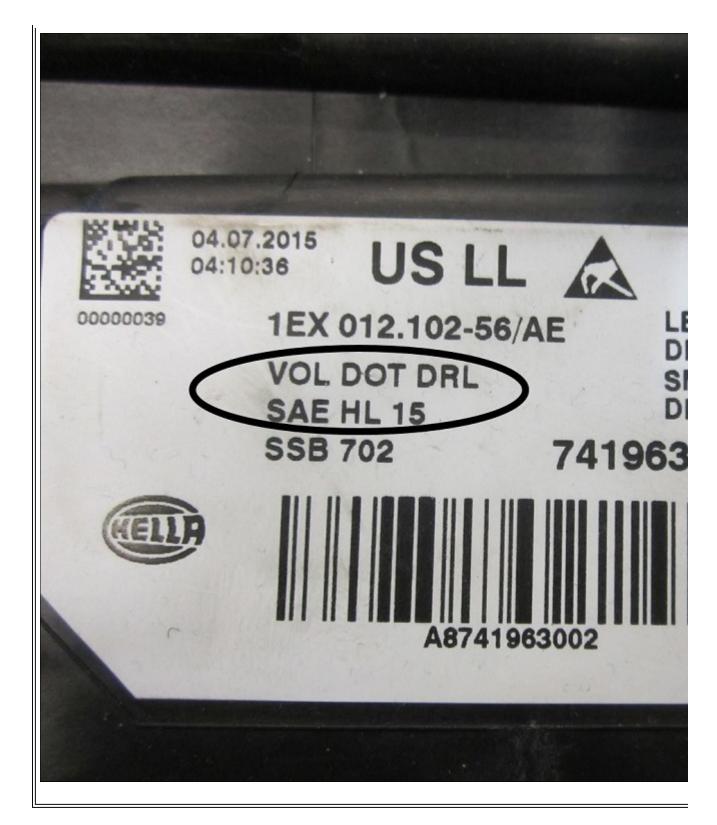
1.	To perform the headlight alignment you can use a headlight aligner or follow the attached procedure.

- 2. Adjust the headlight by following ISTA procedure:
 - REP 6310PRF "Test requirements for headlights vertical aim adjustment"
 - REP 6310004 "Adjusting headlights"
