This Service Information bulletin supersedes SI 12 33 14 **dated December 2015**.

Fault Code 1D2008 Stored in DME

The Service Engine Soon light is on. Fault Code 1D2008: Map thermostat: jammed open is stored in the DME. There may also be a complaint of low heat output with lower outside temperatures.

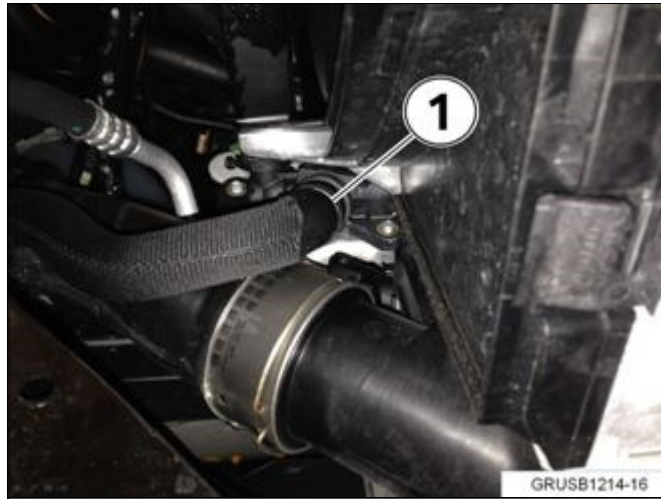
<p>Remove the front underbody protection panel (tightening torque of screws is 3Nm) to access the cooling lines to the transmission oil heat</p>
--	--

exchanger (1).
(Note: All illustrations were taken on an F30 328xi N20).

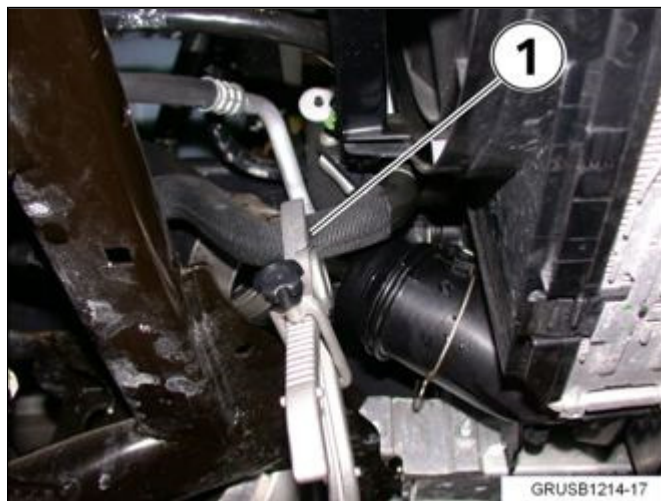
Clamp off the outflow hose (1) on the cooler with special tool 81 64 2 184 117 (SI B04 07 11). The outflow hose is the softer (rubber) of the two cooling lines on the heat exchanger.

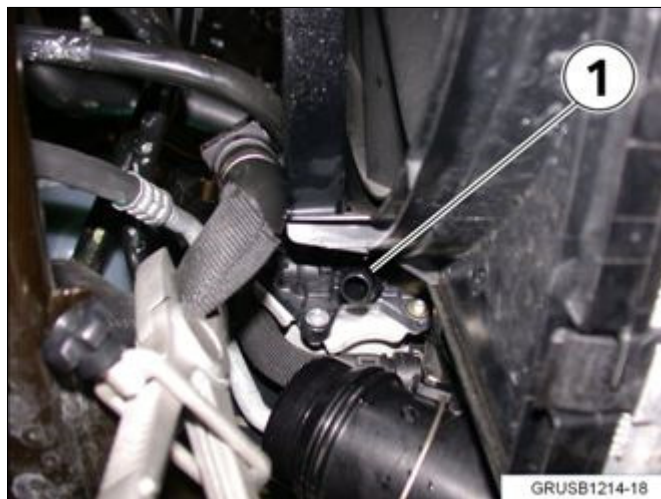
After clamping, remove the outflow hose from the heat exchanger (1).

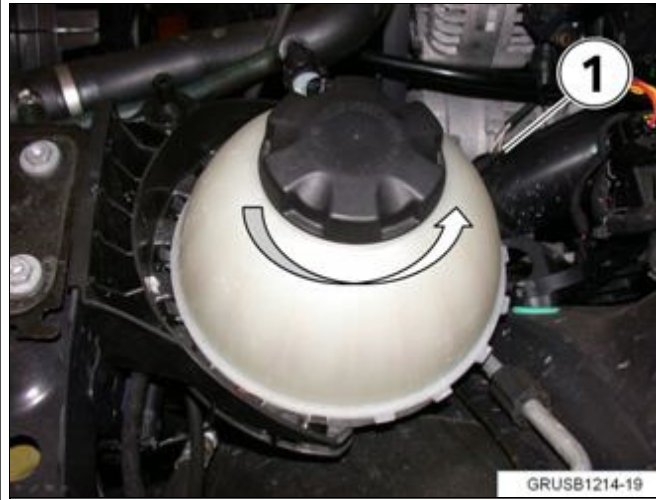
Loosen the cap on the coolant expansion tank (1).

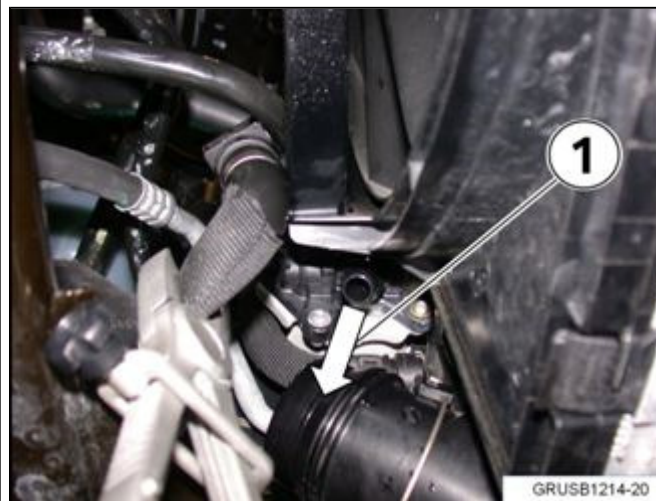
If any coolant starts leaking out of the transmission heat exchanger (1), the internal thermostat is jammed and the heat exchanger will need to be replaced.

Follow Repair Instruction RA 17 22 010, “Removing and installing/replacing transmission oil cooler for automatic transmission (N20, N26, N55).”

If there is **no coolant loss** out of the heat exchanger, replace the engine coolant thermostat.

Follow Repair Instruction RA 11 53 000, “Removing and installing/replacing coolant thermostat.”
