SI B35 01 15
Pedals

Brake Pedal Cover Falls Off

F48 (X1)

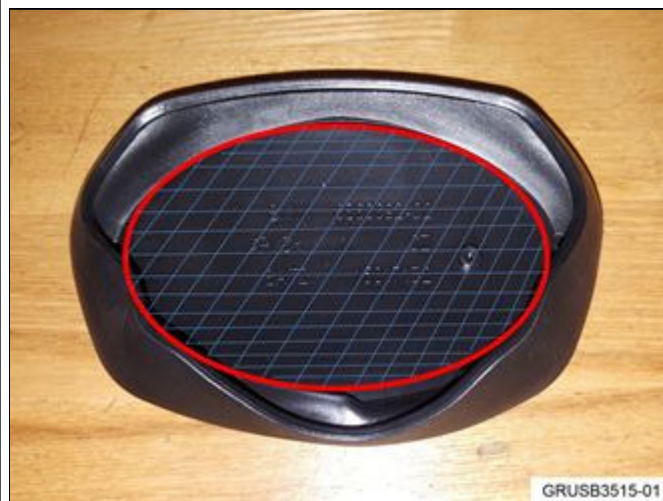
The brake pedal cover can come off of the brake pedal

The geometric shape of the brake pedal tread plate and pedal cover do not match exactly. This can cause the pedal cover to detach.

The pedal cover must be bonded with BMW Super Glue S1 P/N 81 22 2 351 255

1. Lightly roughen the inner surface of the pedal cover with sandpaper. Clean out any remaining debris.

2. Coat the pedal cover inner surface or the front of the brake pedal with the Super Glue S1.
