SI B51 03 16
Body Equipment

Noise from the Power Window

F07(5 Series Gran Turismo)

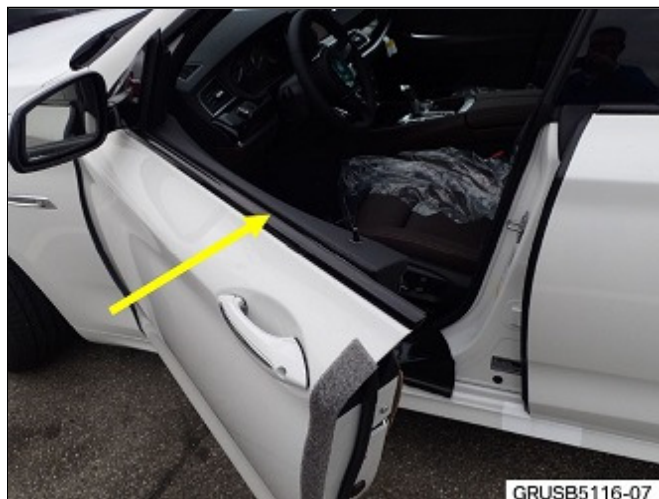
1. Move front window all the way down.

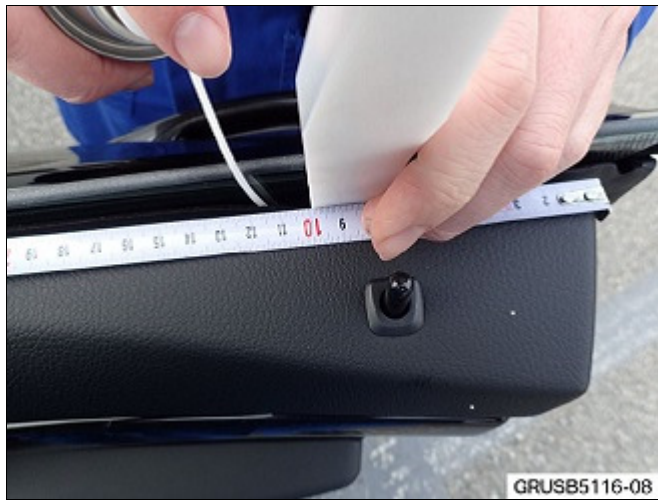
2. Use an appropriate tool (inflatable bag, nylon wedge) to pry open the gap and access the top of the regulator.
3. Use a tape measure to locate the area (120mm from back edge of

trim panel) to be lubed.
