SI B51 06 16
Body Equipment

Whistling Noise from the B-pillar

F34 (3 Series Gran Turismo)

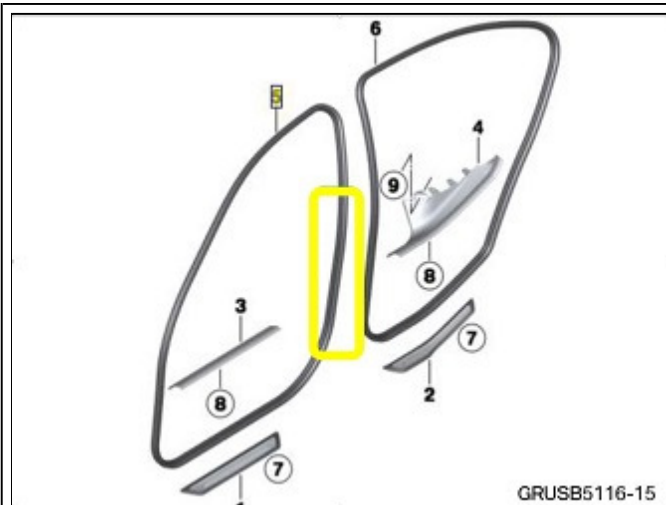
1. Remove the edge protection seal in the area of the B-pillar at the height of the door lock.

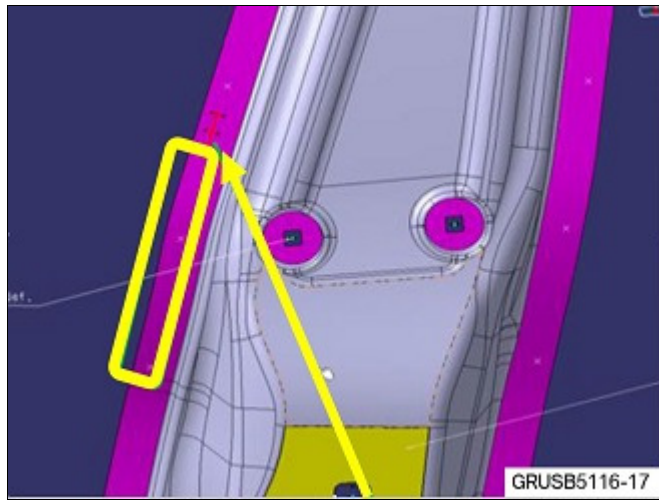
- The drawing shows the approximate area where the

whistling noise can occur.

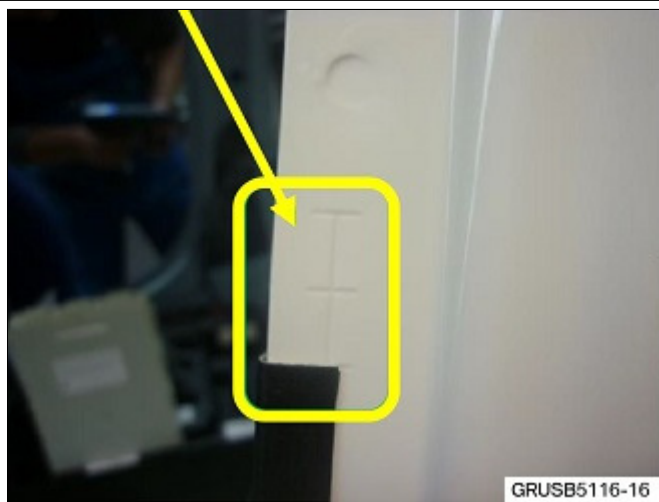
- The exposed area can create a whistling noise a higher speeds and various sunroof openings.

2. Prepare four self-adhesive strips (150 mm long x 15 mm wide) and stack on top of each other and apply to the lowest marker line of the side panel as shown.

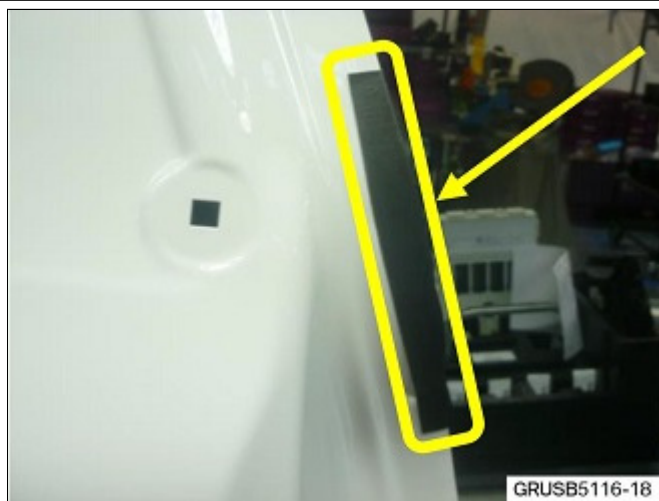
- The finished felt process should look like the picture.
