**SUBJECT****CSC Communication Errors****MODEL**

I01 (i3 and i3 REx)

I12 (i8)

Vehicles produced from 12/16/13 to 10/15/14

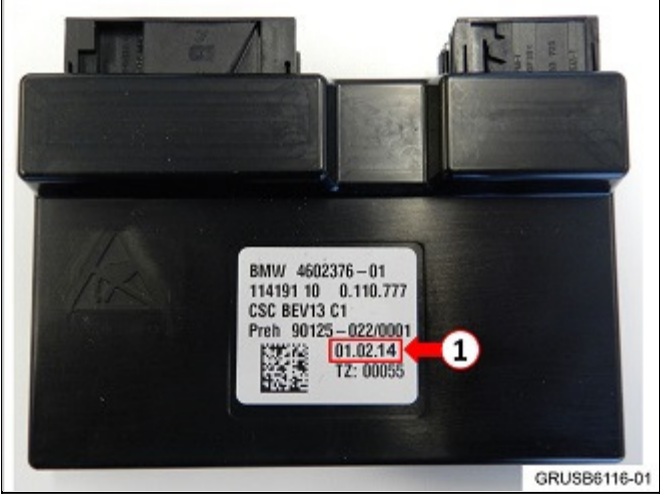
| | <p>2. Check the production date on the diagnosed CSC (1) to see if it falls within the following production period:</p> <p>I01 - 12.13.13 to 09.22.14</p> <p>I12 - 01.20.14 to 04.30.14</p> <p>Does the production date on the affected CSC(s) fall within</p> |

the range specified above?

YES- ignore the instructions of the test plan and **replace all CSC's** per repair instructions:

I01 - 61 27 540 - Removing and installing/ replacing cell supervision circuit.

I12 - 61 27 540 - Removing and installing/ replacing cell supervision circuit (top) & 61 27 542 - Removing and installing/replacing cell supervision circuit (bottom)
