Service Advisory

Article: VSA-15-01 A-D

2010-2016 Victory Cross Country / Cross Roads / Magnum / Hard-Ball – Saddlebag Lock Wear

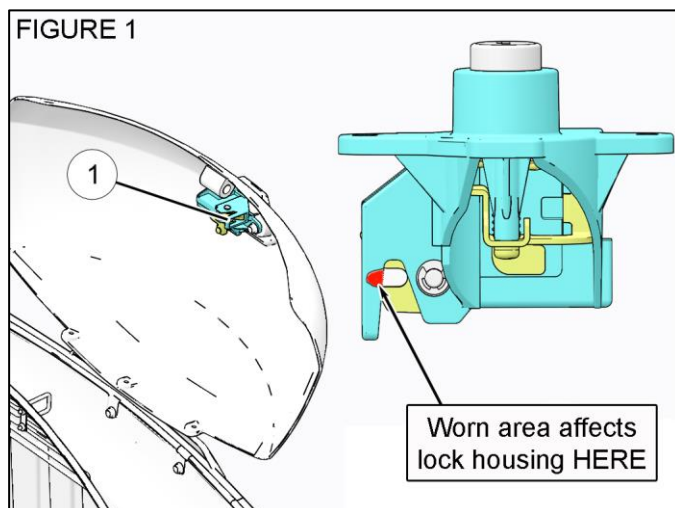
1. Park the motorcycle on a flat surface and rest securely on the side stand.
2. Open the right side saddlebag lid and locate the lock assembly ①.
3. Inspect the lock housing guide area shown in FIGURE 1.

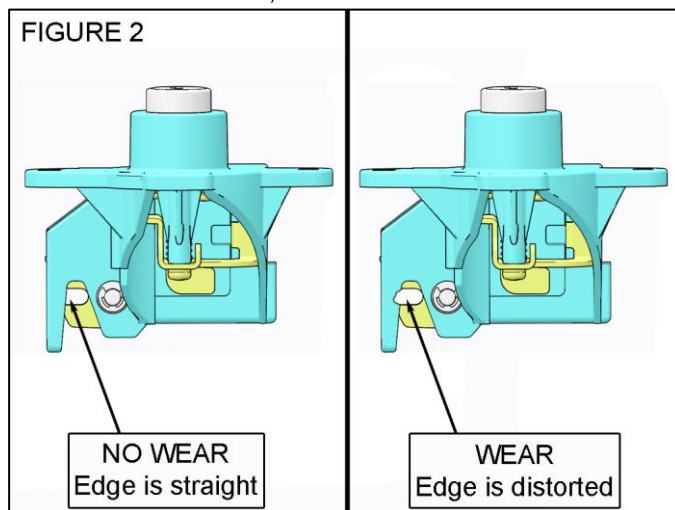
4. Verify that the lock housing guide has a straight edge as shown in FIGURE 2, and that wear has not caused the lock housing guide to become distorted.

Lock housing guide should not have an indentation exceeding **0.5 mm** where it contacts the lock hoop while in the closed position. **Scuffs and scratches should be considered normal wear.**

NOTE: If excessive wear is found, replace the lock housing and the hoop.

5. Repeat steps 2-4 for the left side saddlebag.
6. If lock housings are **not worn**, install an ALIGNMENT KIT in the right bag and file a claim for VSA-15-01A.
7. If a lock housing **is worn**, proceed to LOCK HOUSING REPLACEMENT

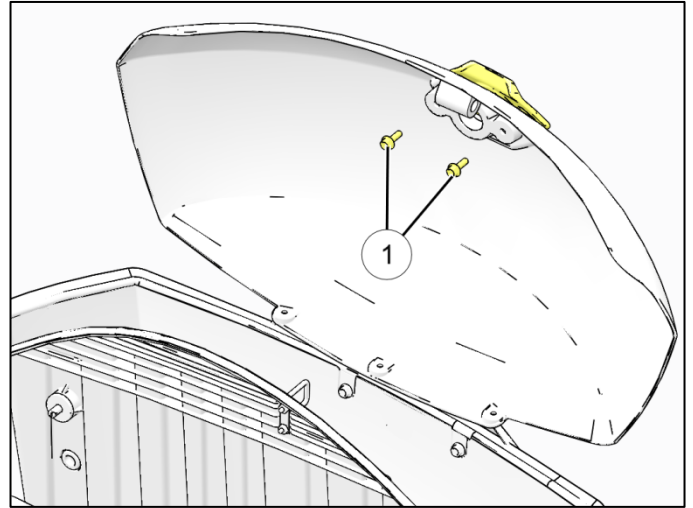
1. Remove lock and handle from saddlebag lid by removing M6 fasteners ①. Discard fasteners.

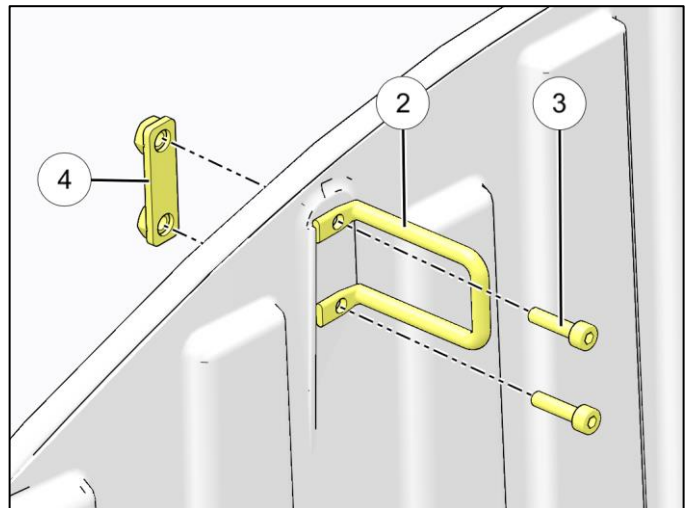
2. Using 3mm hex drive, remove lock hoop ② from saddlebag. Keep fasteners ③ and nut plate ④ for installation of hoop.
3. Remove saddlebag from bike and place it on a blanket or other soft surface to prevent cosmetic damage.

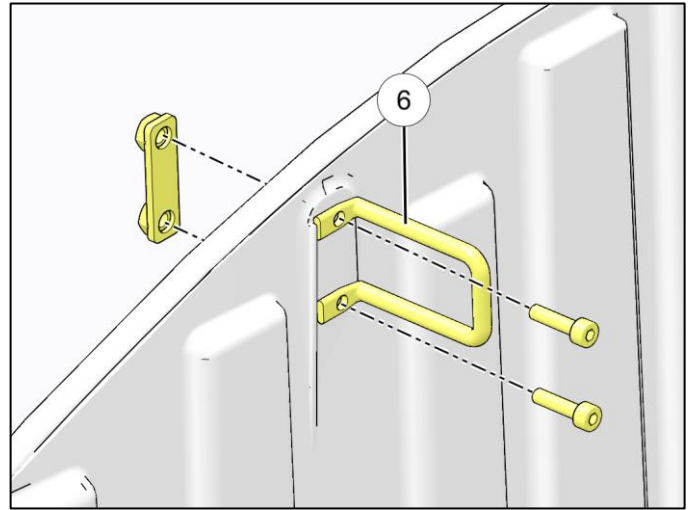
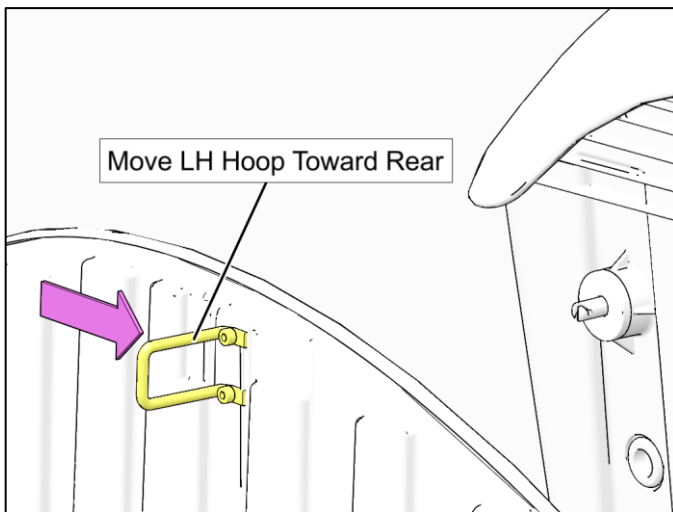
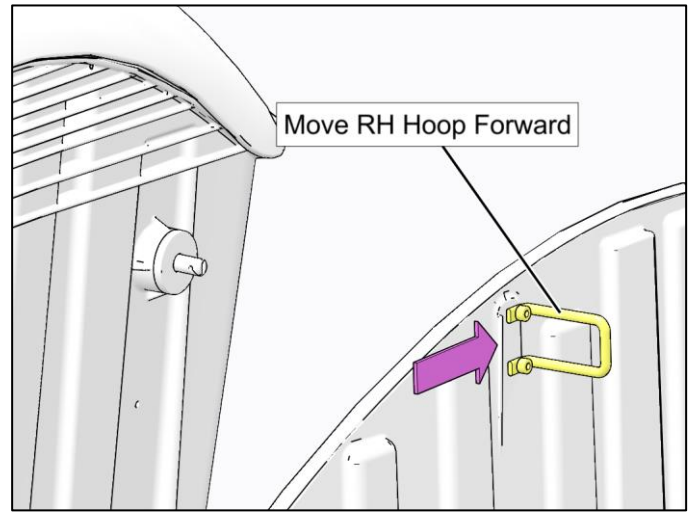
5. Install hoop ⑥ using removed bolts and nut plate. Loosely install fasteners, biasing the hoop and nut plate toward the front of the bike for right hand saddlebag installation. Bias the hoop and nut plate toward the rear of the bike for left hand saddlebag installation. See images below.
6. Torque fasteners to specification.

Saddlebag Lock Hoop: **43 in-lbs (4.8 Nm)**

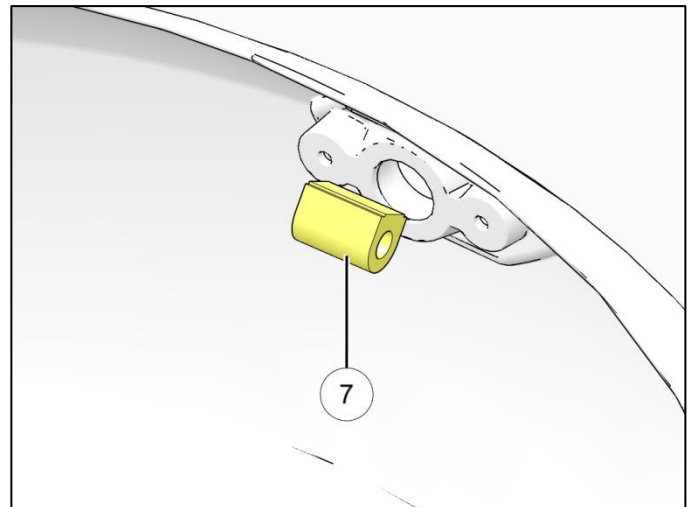
7. Remove foam bumper ⑦ from lid. Ensure adhesive tape from bumper is removed from lid.

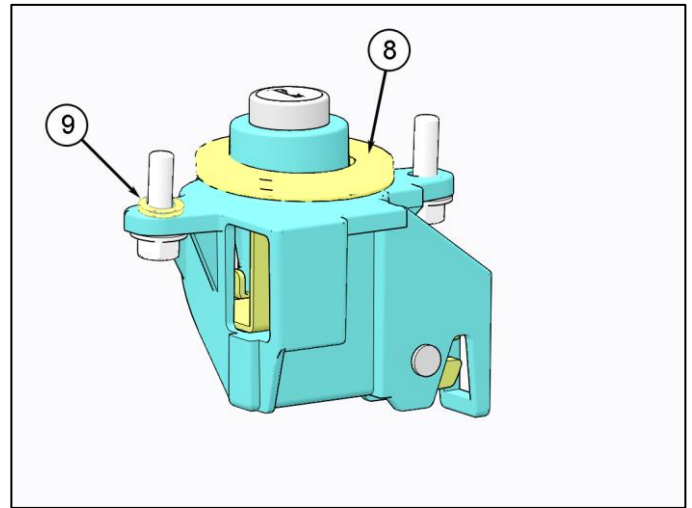
8. Remove rubber seal from latch housing and discard. Install thicker foam seal (8) from kit onto latch.
9. Run new M6 fasteners through mounting holes on the latch. Slide 2 plastic washers (9) from kit onto fastener as shown.
10. Position latch onto lid with plastic washers between latch and lid. With lid handle in place, hand-start M6 fasteners. Tighten the fastener without the washers first, next tighten the fastener with the washers. Torque both fasteners to specification. 84 in-lbs.

Saddlebag Lock: **84 in-lbs (9.5 Nm)**

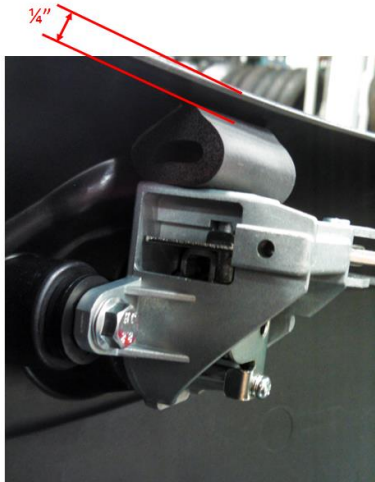
11. Close lid and check for binding or interference between latch and hoop. If no issues, proceed to step 13.
12. If the lid is not closing properly due to binding or interference between latch and hoop, remove latch and handle by removing M6 fasteners. Reinstall latch using 1 plastic washer instead of 2. Test closing the lid. If latch is once again interfering with the hoop, reinstall latch without any washers.
13. After latch has been aligned successfully, remove adhesive liner from bumper and install as shown. Note that bumper location is different when saddlebag audio is installed.

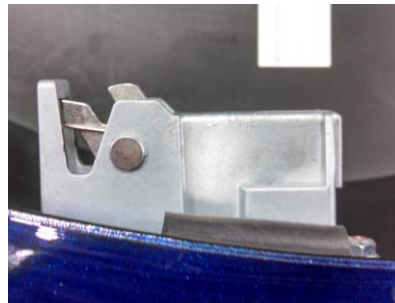
Bumper location
(without saddlebag audio)

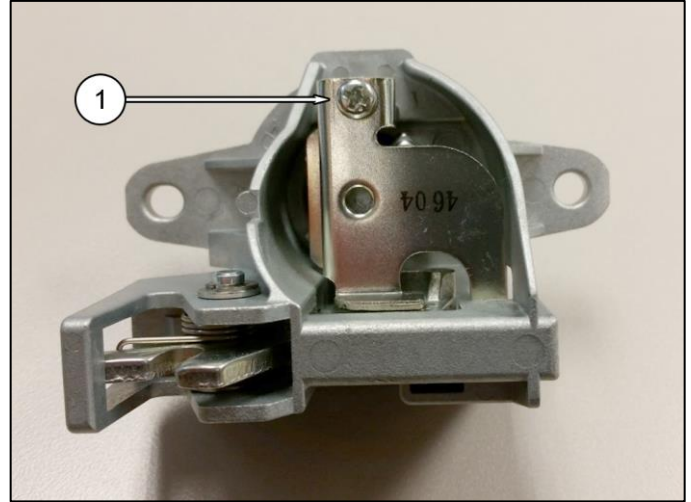
1. Remove screw ① from the lock assembly.

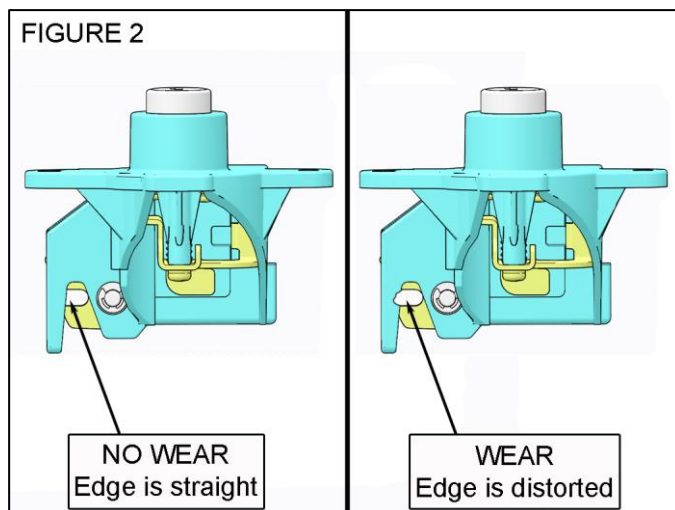
4. Verify that the lock housing guide has a straight edge as shown in FIGURE 2, and that wear has not caused the lock housing guide to become distorted.

Lock housing guide should not have a visible indentation where it contacts the lock hoop while in the closed position. **Scuffs and scratches should be considered normal wear.**

5. Repeat steps 2-4 for the left side saddlebag.
6. If the lock housing is **not worn**, no further action is required and you may continue to use your motorcycle.
7. If the lock housing is **worn**, please contact your authorized Victory dealer and make arrangements to have the lock(s) evaluated and, if necessary, replaced at no cost to you.
