**Attention:** ABS wire routing

**Models:** 2016 Toyota Tacoma 4WD, Tacoma PreRunner 2WD

**Affected Pro Comp Kit numbers:**  
57397B, K5089B

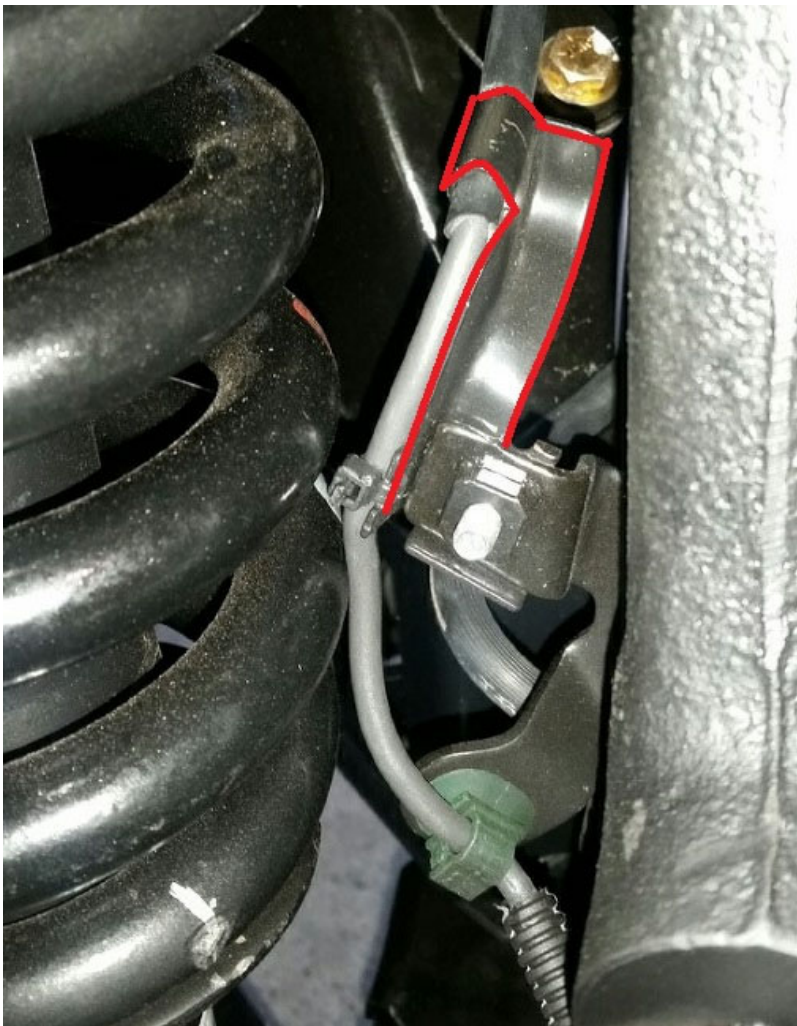
**Figure A**

**Overview:** In monitoring our technical service inquiries we have identified the potential for routing issues that allow the ABS wire to be pinched between its retention bracket and the coil spring at full steering lock. **See figure A**

**Solution:** The following instruction is offered to improve the ABS wire routing for new lift installations. Carefully remove the ABS wire from its upper retention bracket, outlined in red in **figure A**. Remove the upper retention bracket and secure the ABS wire with an Adele clamp using the previously removed bolt. See **figure B**. Repeat these steps for the other side. Make certain there is no pinching, rubbing, or stretching of the ABS wires.
