**NUMBER:** 21-020-16

Manual Transmission Shifter Noise

This bulletin involves greasing or replacing the manual transmission rear shifter bushing.

2009 - 2014	(LC)	Dodge Challenger
2015 - 2016	(LA)	Dodge Challenger

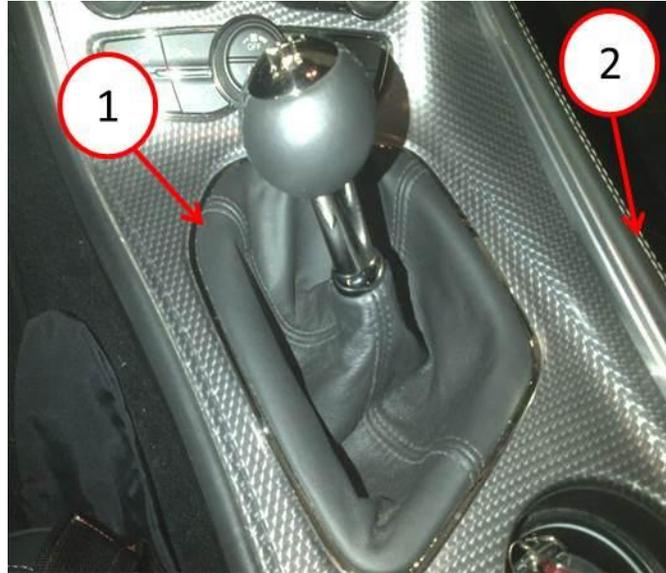
**Fig. 1 Shifter Boot**

- 1 - Shifter Boot
- 2 - Console

1. Disconnect the negative battery cable.
2. Place transmission shifter in neutral.
3. Using a suitable trim stick, separate the shifter boot with bezel (1) from console (2) (Fig. 1).

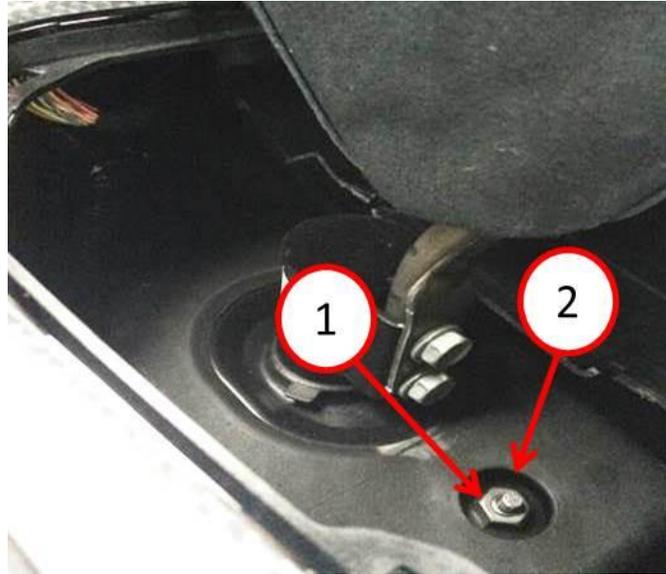
**Fig. 2 Shifter Retaining Nut**

- 1 - Nut
- 2 - Closure Panel

4. Remove the shifter bushing retaining nut (1) from closure panel (2) (Fig. 2).

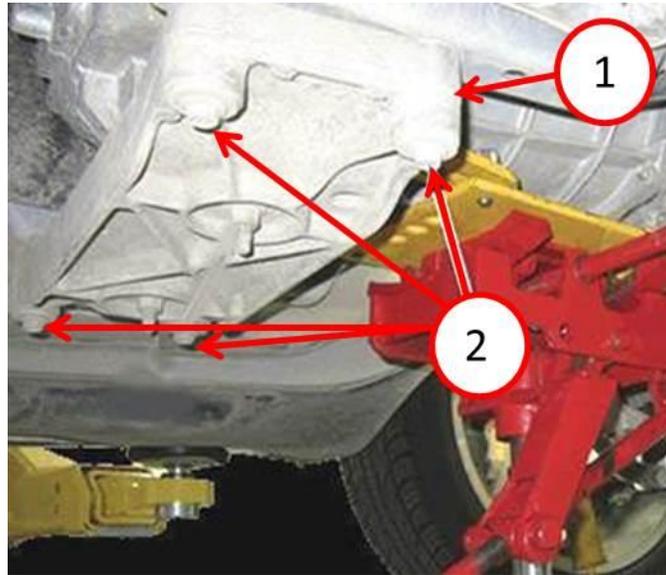
**Fig. 3 Crossmember Mount**

- 1 - Crossmember
- 2 - Bolts

7. Remove the four transmission crossmember mount bolts (2) from crossmember (1) (Fig. 3).

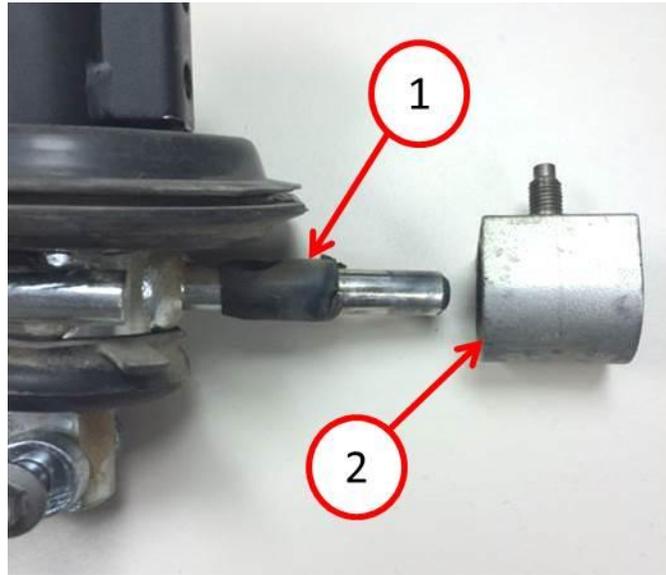
**Fig. 5 Bushing Separation**

9. Remove and inspect shifter bushing (Fig. 5). Is the bushing inner sleeve (1) separated from the outer housing (2)?
- a. YES >>> Replace the bushing. **Continue to Step #11.**

- 1 - Bushing Inner Sleeve  
2 - Housing

**NOTE: If shifter bushing is defective, replace just the bushing. It is not necessary to replace the entire shifter linkage.**

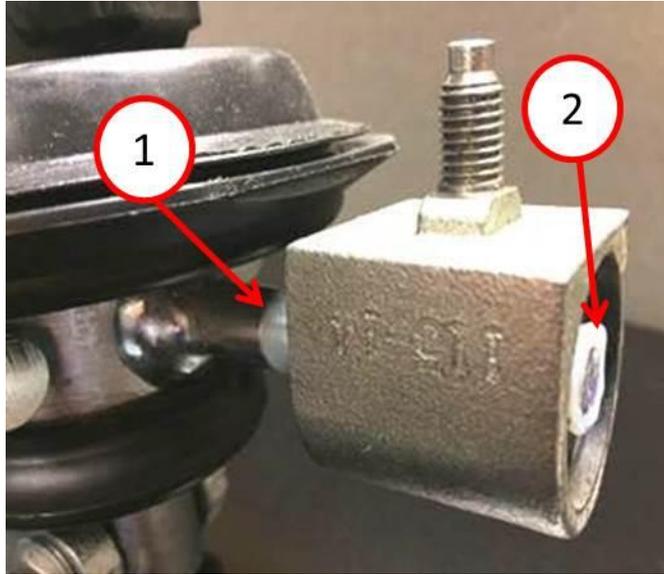
***Fig. 7 Shifter Rod And Bushing Greased***

1 - Shifter Rod

2 - Bushing

10. Install bushing (2) onto rear shifter rod (1) (Fig. 7). **Continue to the Step #13.**

12. Install bushing (2) onto rear shifter rod (1) (Fig. 7). **Continue to next step.**

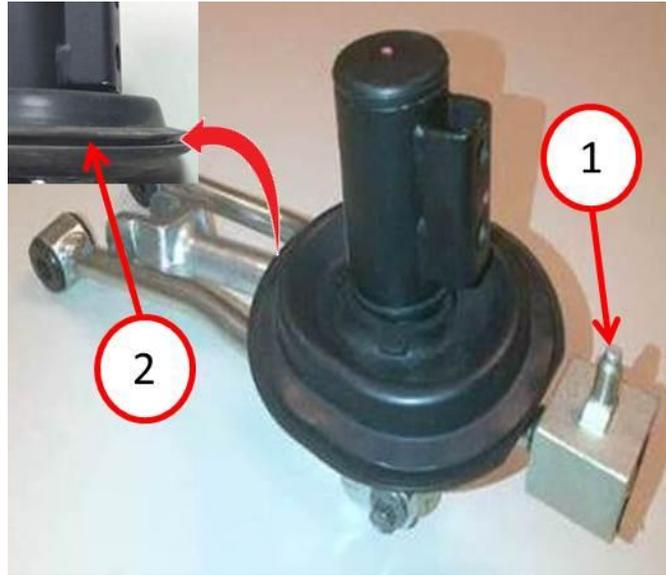
**Fig. 8 Rubber Grommet**

1 - Stud

2 - Grommet Lip

**CAUTION: Failure to install rubber grommet lip above tunnel plate may result in a sealing issue.**

13. Install shifter bushing stud (1) into tunnel plate from below. Make sure that the shifter linkage double-lip rubber grommet is installed so that the grommet has one lip (2) above the tunnel plate and one lip below the tunnel plate opening for proper sealing (Fig. 8).
