# Service Bulletin

## 5.75" Diameter Trailer Axles With P89® Integral Disc Brakes

### Rotor Replacement Procedure

October 2016

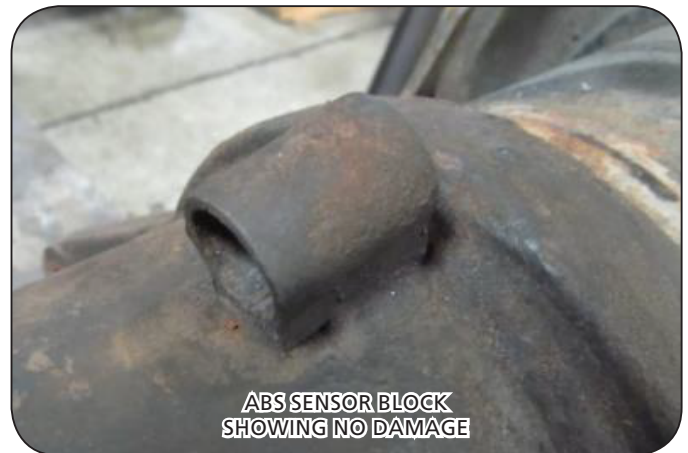
Figure 1

1. Remove the head unit. Refer to Section 7 of the XL-SA20018UM-en-US for the P89. Refer to Section 8 of the XL-SA20024UM-en-US for the P89 Plus.
2. Modify the ABS sensor block (**Figure 1**). Your ABS sensor block MUST be modified to provide clearance for your replacement rotor and ABS ring assembly. If your ABS sensor block is damaged, refer to SAF-HOLLAND® ABS sensor replacement manual XL-SA20030SB-en-US.

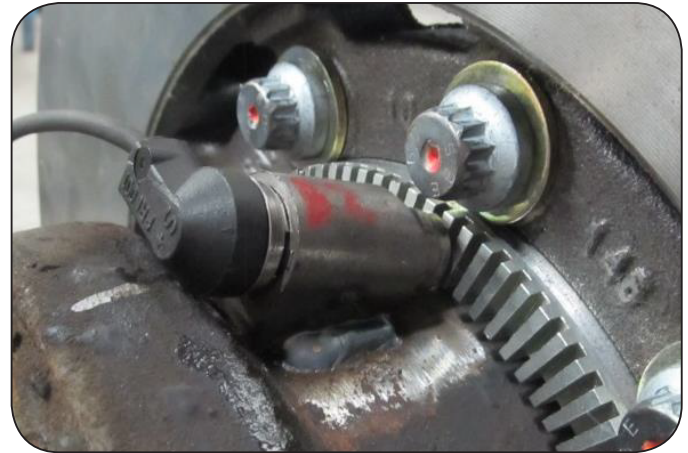
**Figure 10**

**IMPORTANT:** Rotate the wheel end to ensure there is no interference between the rotor attachment bolts and the ABS sensor block and sensor (**Figure 10**).
