SERVICE BULLETIN

APPLICABILITY: 2014-15MY XV Crosstrek Hybrid Electric Vehicle (HEV) **NUMBER:** 16-94-15R

SUBJECT: Diagnosis and Repair of DTCs P172A and P0B0B

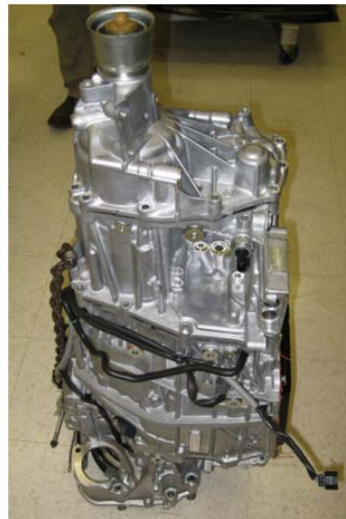
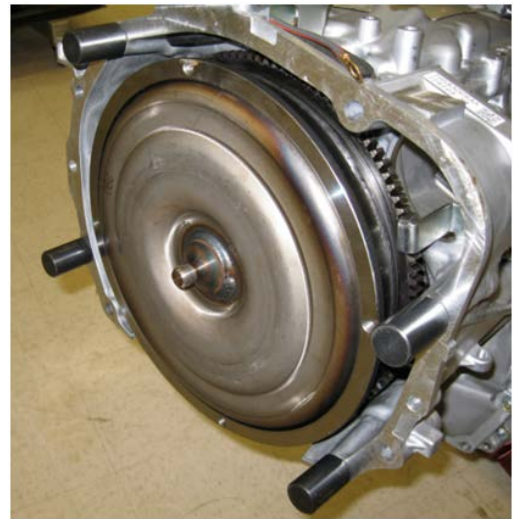
The bulk of this procedure is best performed with the transmission assembly standing vertically. Use the 4- 6M/T stands (S/T# 18632AA000) pictured below for support.

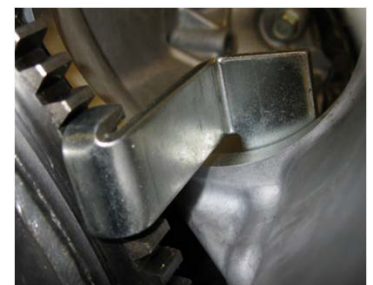
- The torque converter can also be left in place. Either support it from the underside after standing the unit up with a block of wood or use a retainer strap / bracket included with remanufactured and replacement transmission assemblies to keep the torque converter in place.
