Highlander water intrusion grommet damaged during accessory installation

REVISION NOTICE

12/09/2016 Added 2015 model year to applicable vehicles.
Any previous printed versions of this bulletin should be discarded.

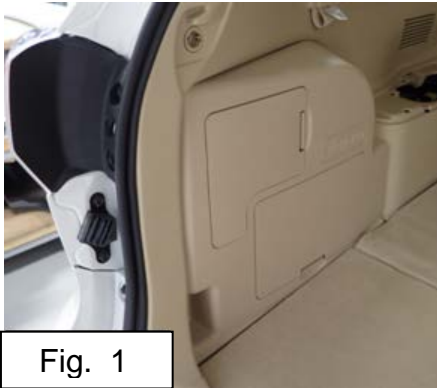
- Port installed Onboard Vacuum (Fig. 1) can be identified by "SV1000" option code appearing in TIS VIN inquiry vehicle accessory codes.
- Dealer installed units can be identified by reviewing service history for 00016-48017-0X.

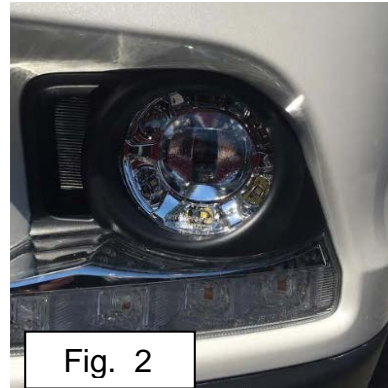
- Port installed LED Fog Light & DRL 2n1 (Fig.2) can be identified by "LD4000" or "LD4010" option code appearing in TIS VIN inquiry vehicle accessory codes.
- Dealer installed units can be identified by reviewing service history for 00016-00081 or 00016-48011

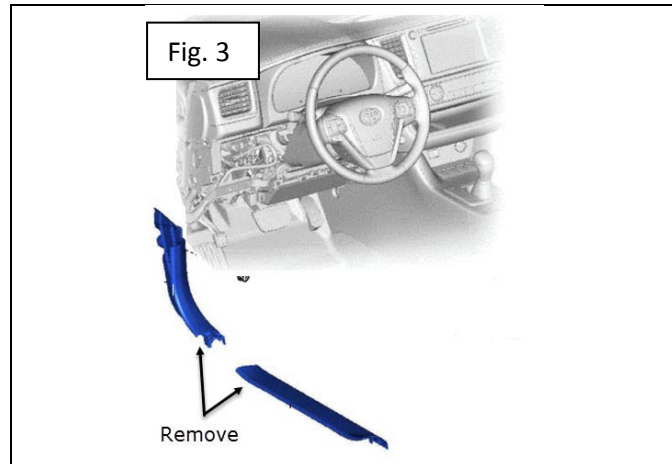
Fig. 3

1. Remove front door scuff plate LH and cowl side trim sub-assembly.

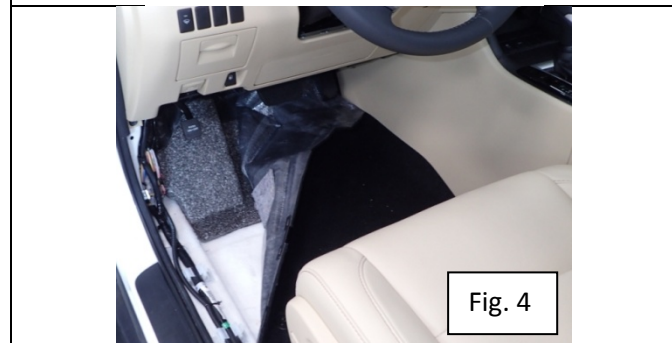
Fig. 4

2. Pull carpeting away from floor board in area behind parking brake pedal.

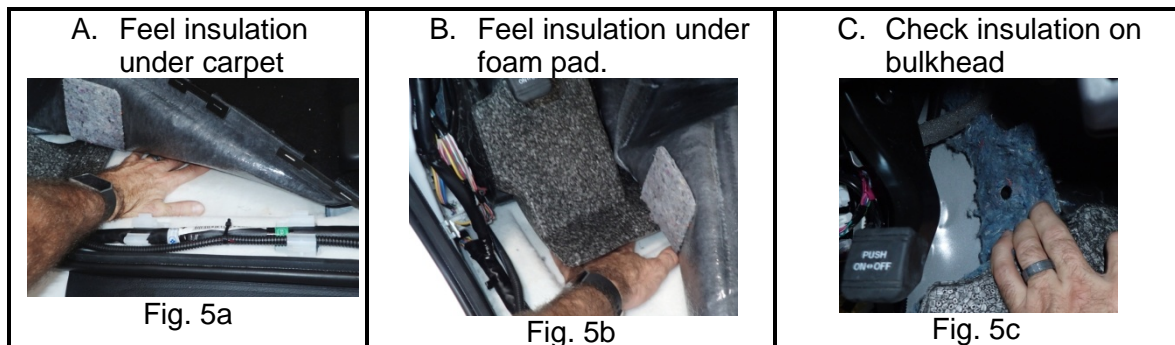
3. Check Driver's floor board for dampness.

Note: If uncertain of water intrusion, perform water leak test while monitoring the area behind the parking brake in the area of the hood release cable grommet.

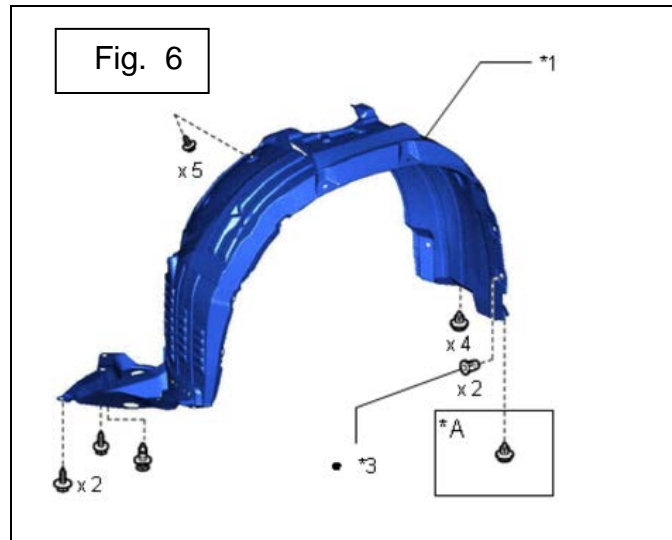
Fig. 6

4. Remove left front tire.
5. Remove front fender wheel opening molding sub-assembly LH.
6. Remove front fender liner LH.

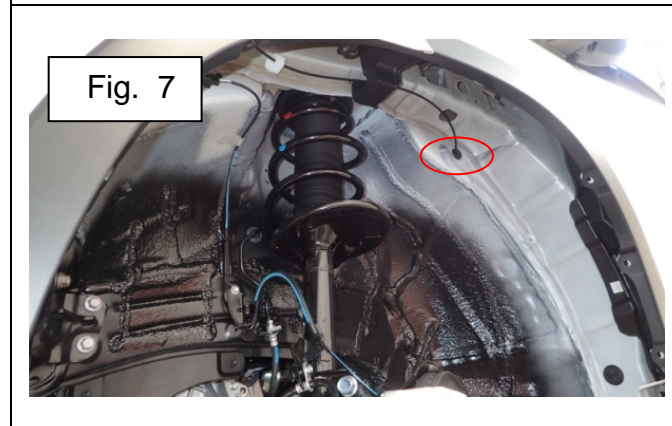
Fig. 7

7. Inspect the hood release cable grommet. Grommet should be:

- Correctly positioned in fender well.
- Not ripped or torn.
- Sealed with silicon.

- If water intrusion is detected or Grommet is damaged proceed to **Section B** starting on page 6 for repair instructions.
- If Water intrusion is not found and the grommet is not damaged, inspection is complete. No repairs required.

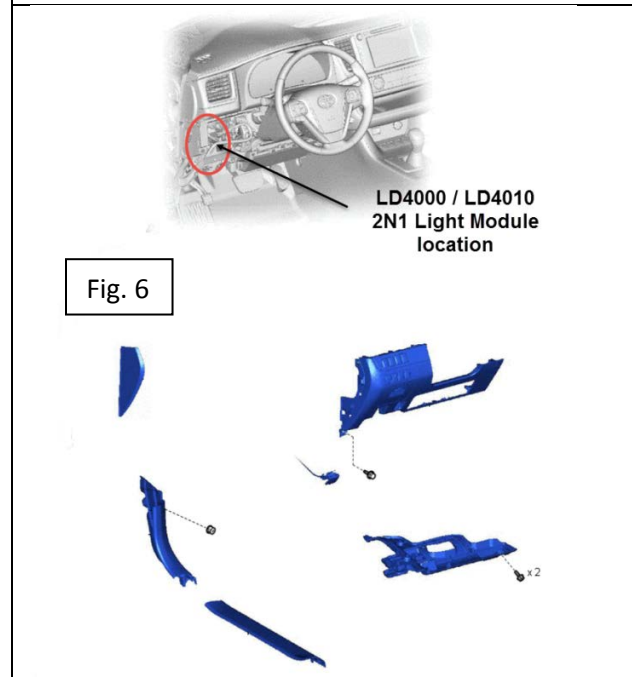
Fig. 6

9. Locate DRL module behind left side of lower instrument panel finish panel sub-assembly.

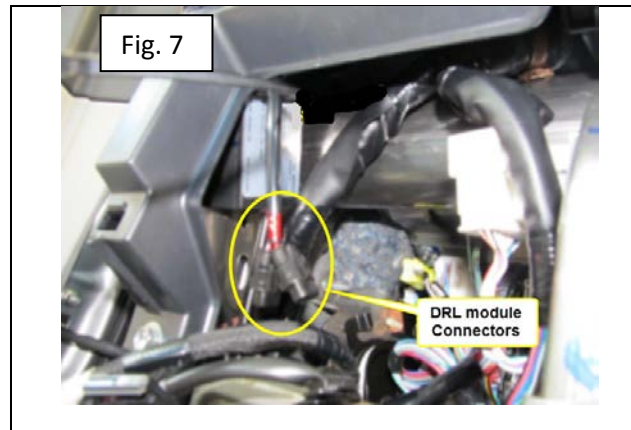
Fig 7

10. Disconnect DRL harness from module.

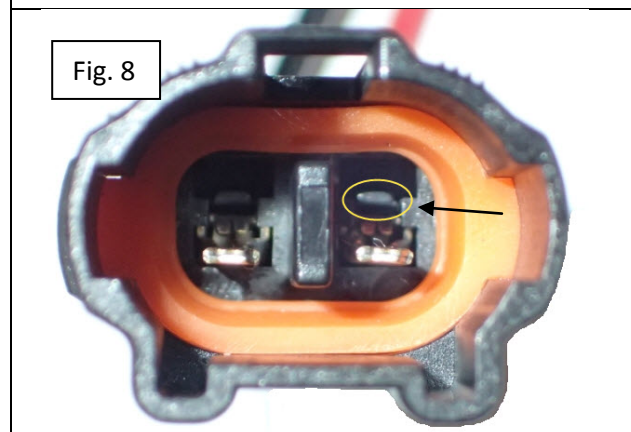
Fig 8

- a. Locate the plastic terminal locking tab in the connector housing.

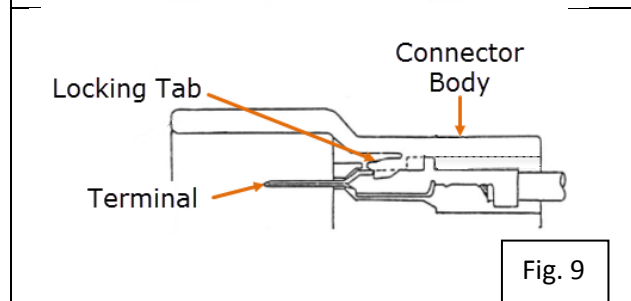
Fig. 9

- b. Using a terminal release tool, disengage locking tab from terminal to release from connector body.

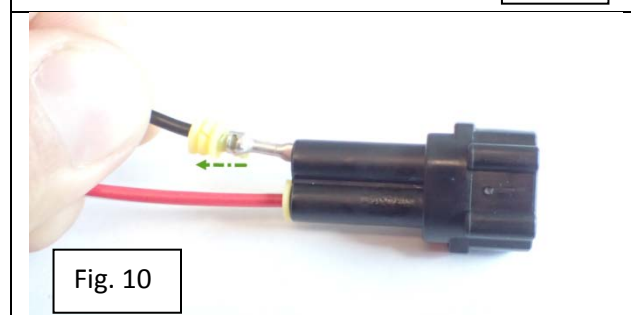
Fig. 10

- c. With locking tab disengaged, lightly pull wire with terminal from rear of connector body.

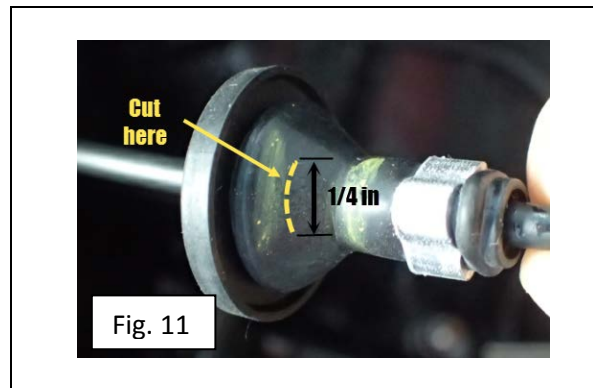
Fig. 11

16. Make a ¼ inch long incision in the hood release cable grommet in the area shown.

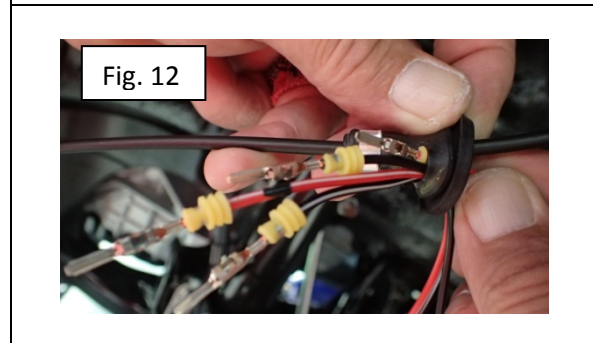
Fig 12

17. Route accessory wiring harness through grommet. One Terminal at a time.

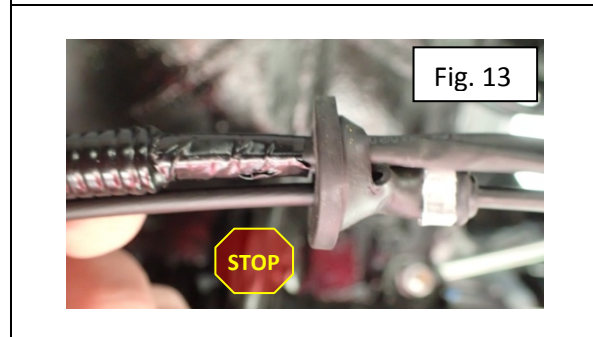
18. Pull harness through grommet. Do not let existing electrical tape or harness conduit to pass through grommet.

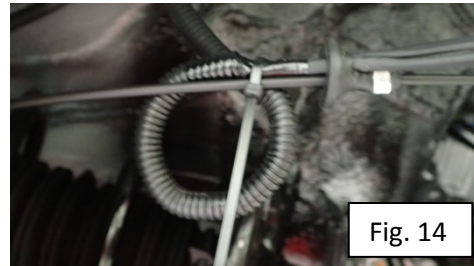
Fig. 14

19. Make a small loop in accessory wire harness and wire tie to hood release cable.

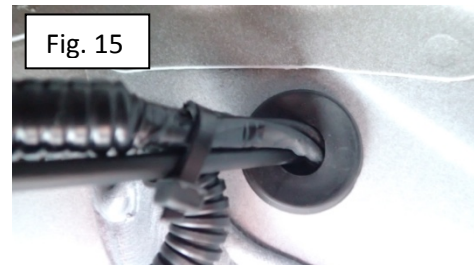
Fig. 15

20. Push Hood Release cable into position. Ensure grommet is flush against bulkhead.

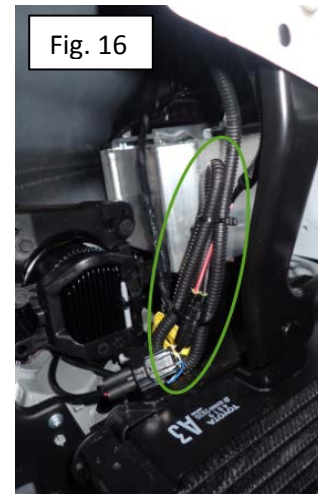
Fig. 16

21. Extra harness can be pulled to the front of the wheel well and secured near left front fog light housing.

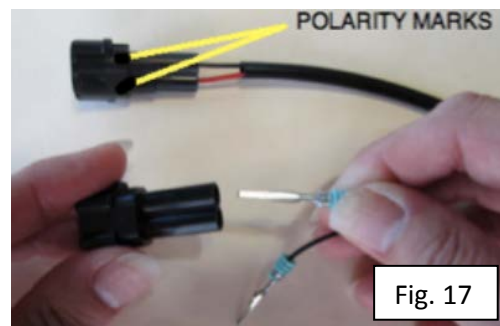
22. Reassemble connectors under dash. Note: Connectors have polarity markings. Push terminals into connector as shown. Fig. 17

- Red wire goes to “+” connector cavity.
- Black wire goes to “-” connector cavity.

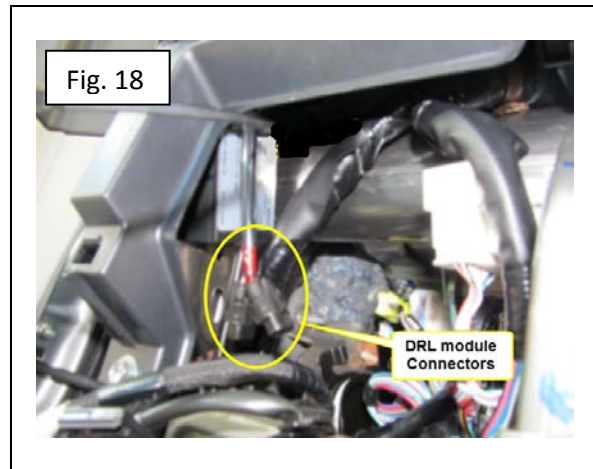
23. Connect accessory harness to DRL module. Fig. 18

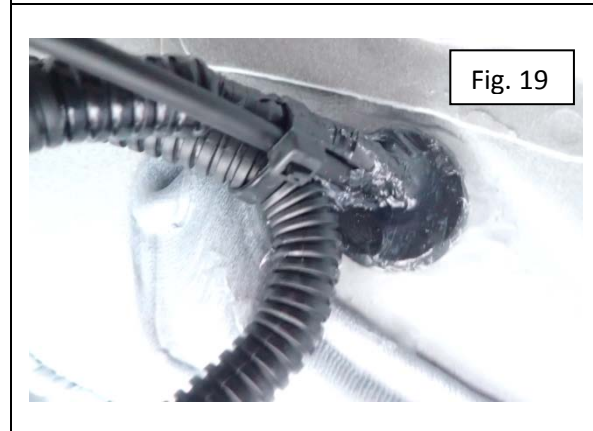
24. Seal Grommet with 3M silicone or equivalent. Fig. 19

- Apply silicone between harness and release cable.
- Ensure incision made to grommet is completely sealed.
- Apply silicone around edges of grommet

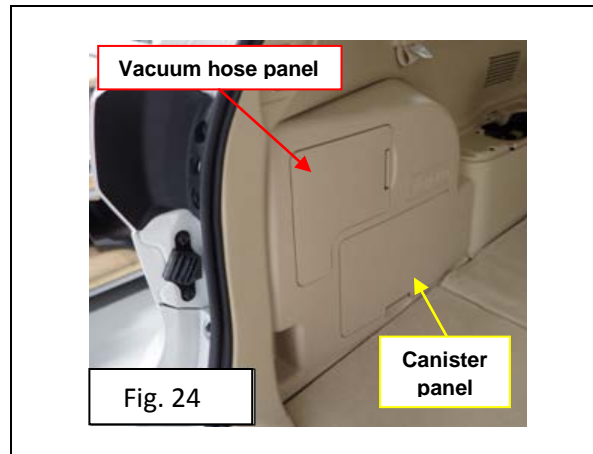
Fig. 24

10. Remove vacuum hose panel.
11. Remove hose assembly by unthreading nut on hose end onto hose attachment point inside hose storage cavity.
12. Remove vacuum canister panel and canister assembly.

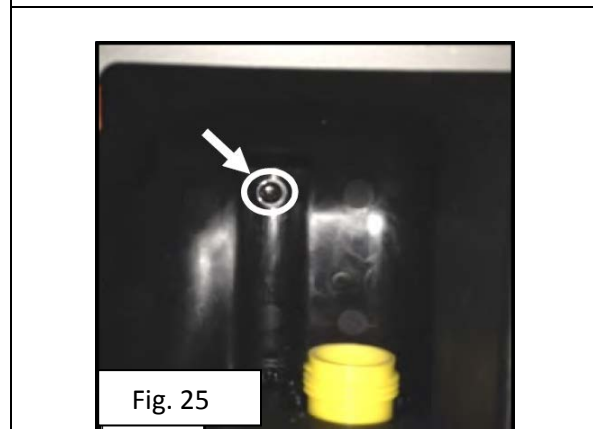
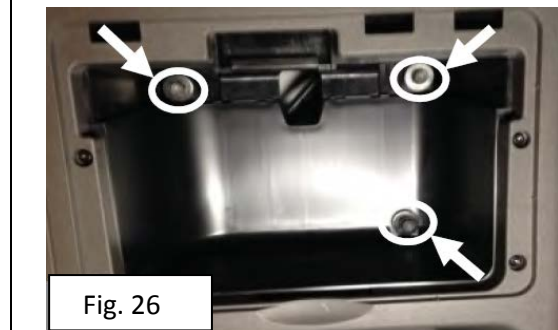
13. Remove 8mm screw in the hose storage compartment (Fig. 25) and 3 10mm bolts in the vacuum canister compartment (Fig. 26) holding on board vacuum to quarter panel trim panel as shown in illustration.

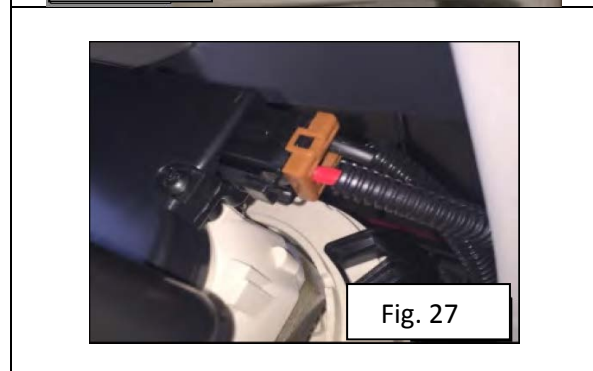
Fig. 27

14. Tilt vacuum inward and disconnect the electrical connector.

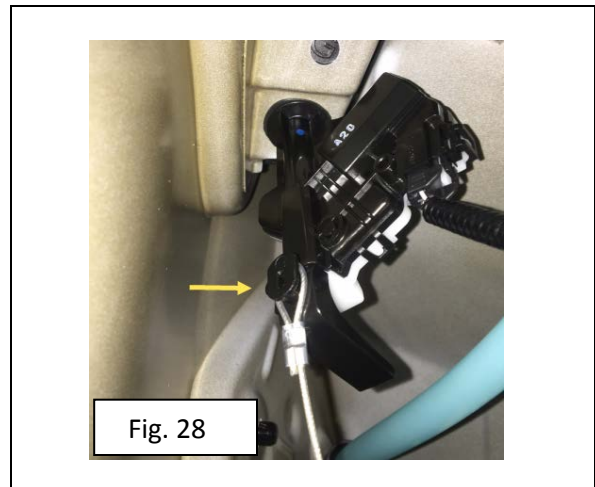
Fig. 28

15. Tilt vacuum inward and disconnect secondary fuel door release cable from fuel door solenoid.

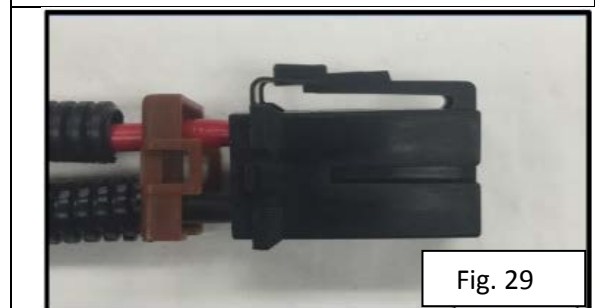
Fig. 29

16. Remove the wire retainer on the back of the harness power connector by prying clips away from housing body and sliding back.

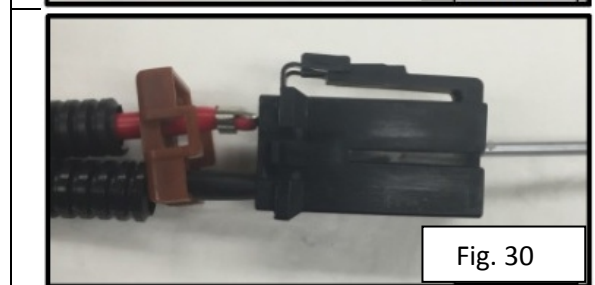
Fig. 30

17. Insert narrow flat blade screwdriver into mating end of connector, just under the top terminal. Apply pressure down and pull back on the top wire from the back of the housing.

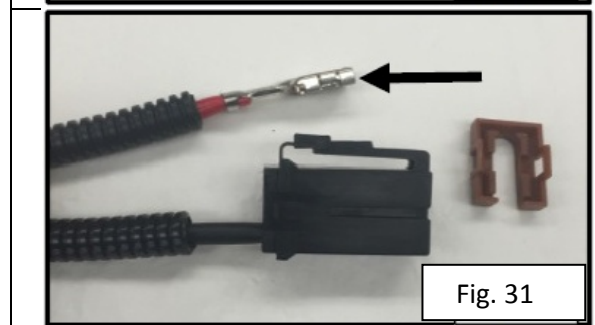
Fig.31

18. Fully remove the top wire from the connector housing.

19. Use Electrical tape to protect terminal during procedure.

Note: *Onboard vacuum power wire is connected to B+ and has 12V at all times. Battery cable must be disconnected to prevent damage.*

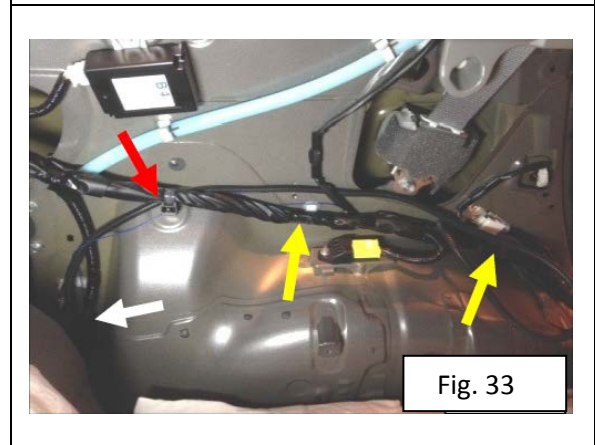
Fig. 33

21. Locate vacuum power harness behind left rear quarter panel interior trim routed along factory harness. Cut all cable ties securing harness.

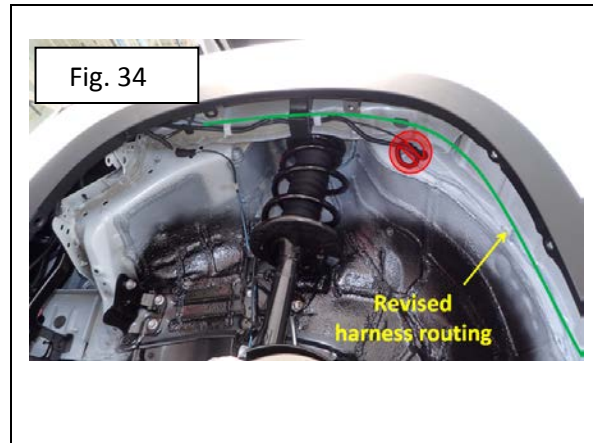
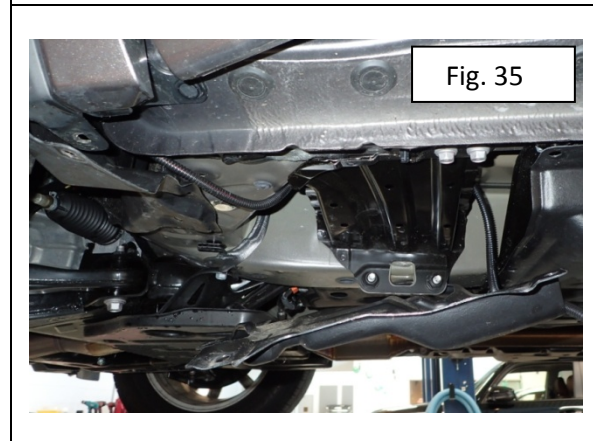
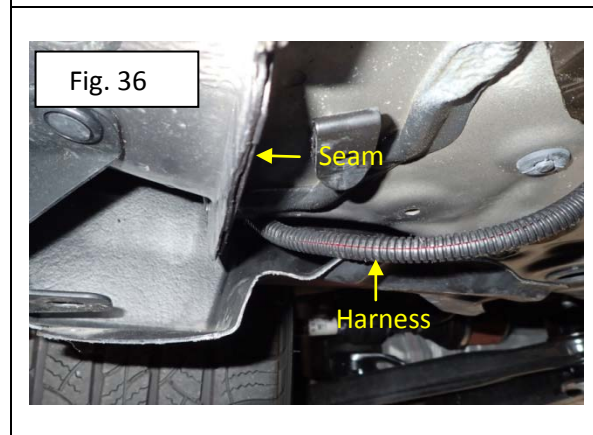
- OVERVIEW- The harness will run down the back of the wheel well. Then routed on to the inside of the body seam to a body plug in the driver's side floor board. Once inside the vehicle the harness is to be routed the driver's side of the vehicle to its original location. Vacuum harness is not to be routed through hood release cable grommet. Fig. 34

25. Loosen underbody splash shields behind left front tire.

26. Route harness down back of wheel well and to the inside of the body seam.

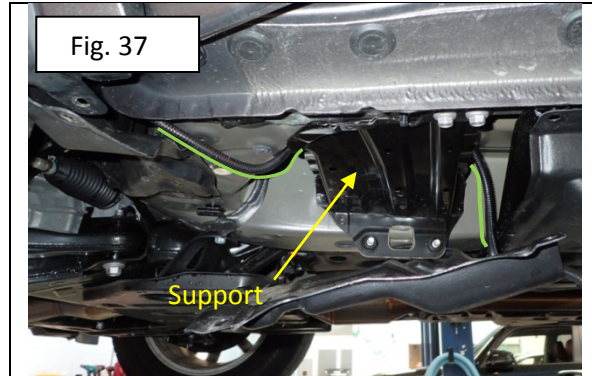
Fig. 37

27. Route harness above frame support.

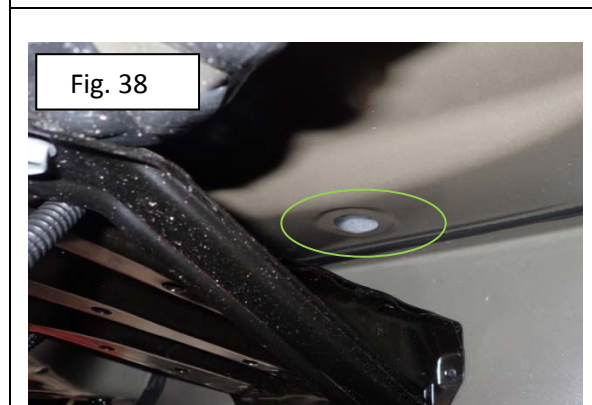
Fig. 38

28. Locate and temporarily remove floor pan plug above support.

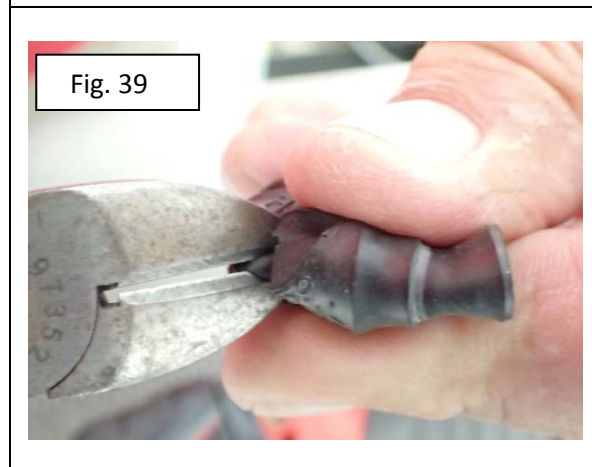
Fig. 39

29. Make a cut in the center of body plug by folding and using side cuts or equivalent to make an incision in center of plug.

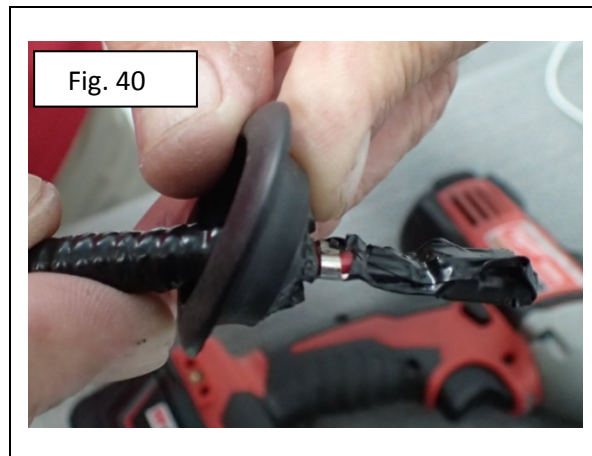
Fig. 40

30. Route Harness through body plug as shown. Pull harness through body plug.

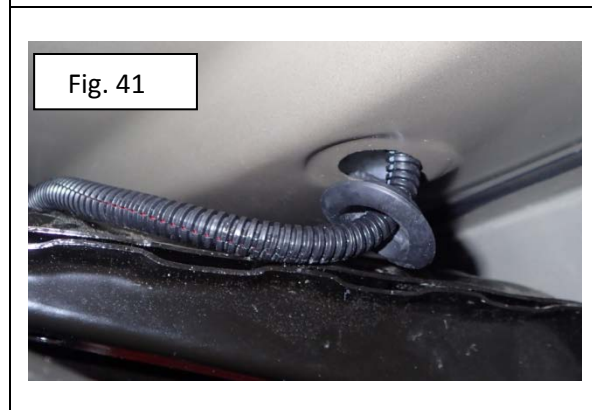
Fig. 41

31. Push Harness into body through body plug hole.

TIP: Mechanics wire or fish tool may be helpful in routing wire under floor insulation.

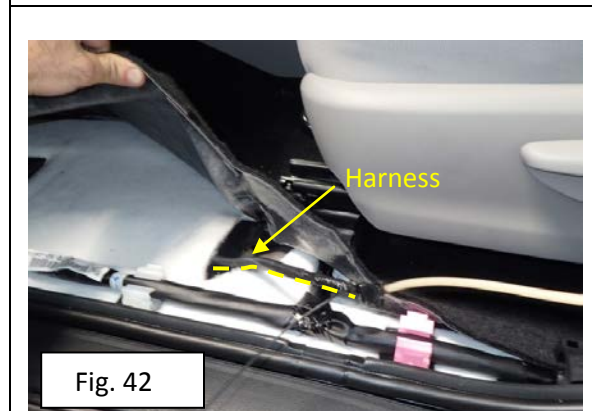
Fig. 42

32. Locate the harness in the driver's floor pan under carpet. Pull harness into vehicle.

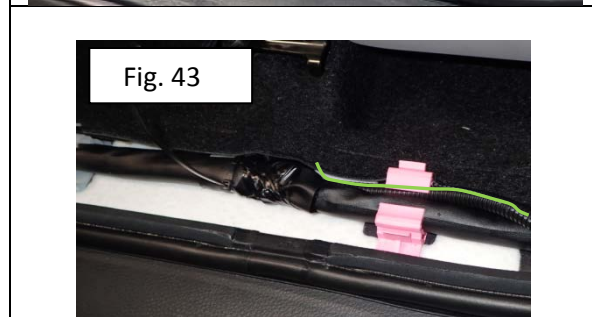
Fig. 43

33. Route Harness with factory harness along left side of vehicle to rear quarter on board vacuum location.

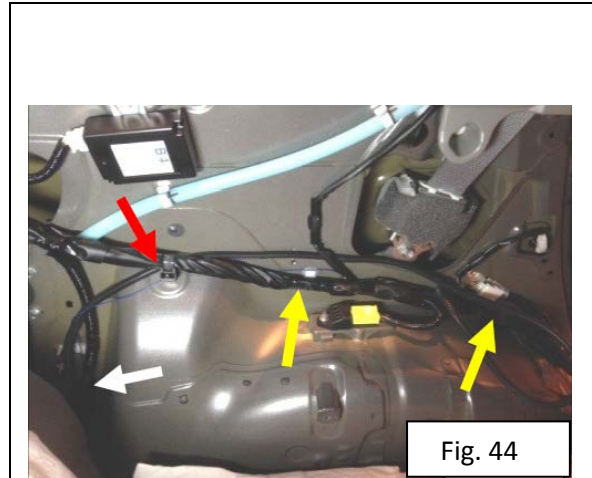
34. Route the harness up through the inner structure of the driver's side quarter panel, using 2 cable ties to secure to the existing harness. Continue routing the harness up over the wheel well, following the path of the existing harness. There will be extra harness length, so from the point marked by the red arrow, keep 3 feet of harness length for finishing the run. Attach a cable tie at the locations of the red and white arrows and tighten. The length of harness left over should be bunched up and secured between the areas marked by the two yellow arrows, which will be the two cable ties used to secure each end of the bunched harness to the existing harness. Fig 44

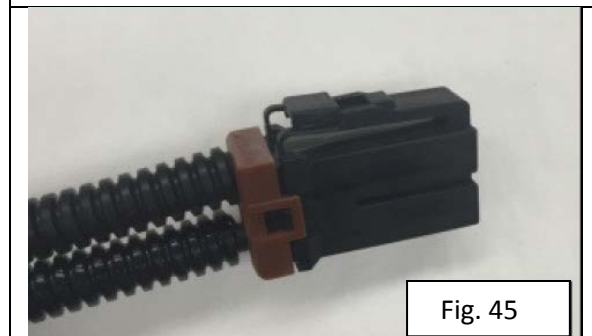
Fig. 45

35. Remove electrical tape from routed wire terminal. Connect positive wire back into wiring harness connector - terminal is polarized and will only latch in when inserted correctly. Pull back on wire once inserted to test connection. Replace wire retainer on back of connector

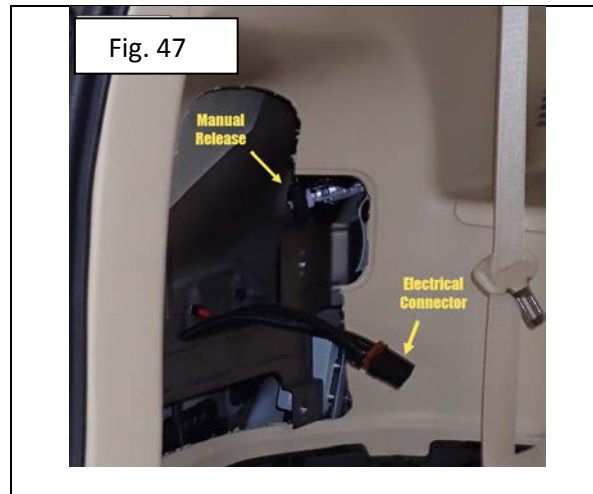
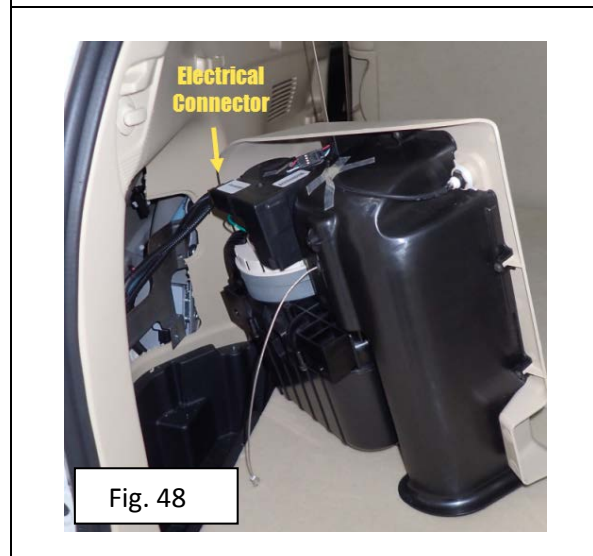
Fig. 48

TIP: Before proceeding with assembly, locate the manual fuel door release and electrical connector in the left rear interior trim panel. Fig. 47 Locate cable tab on manual release where cable is to be attached.

37. Position vacuum in rear of vehicle as pictured. Reconnect electrical connector.

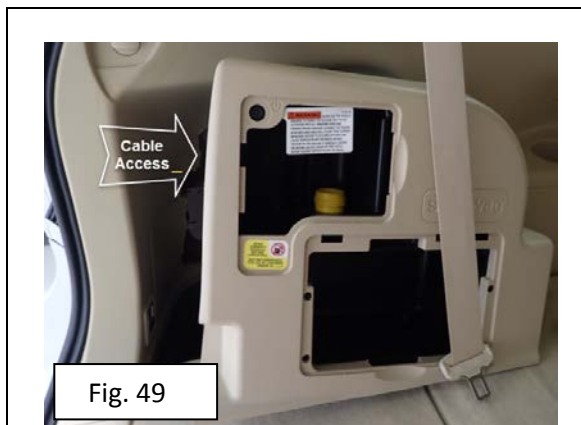
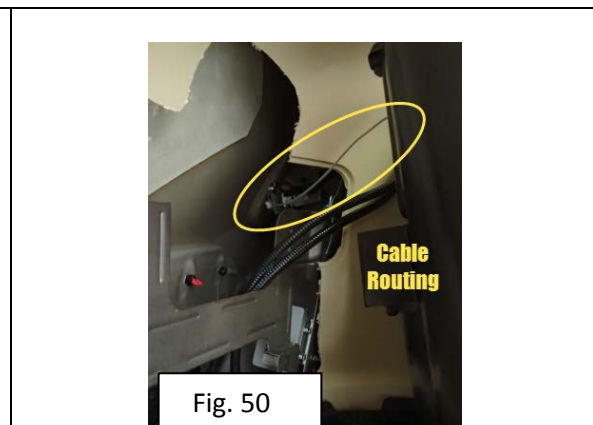
38. Slide vacuum towards panel and forward (Fig. 49) allowing access to route cable from rear of unit to manual release (Fig. 50).

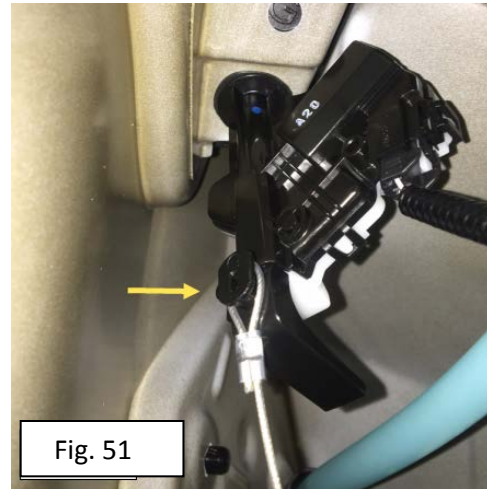
Fig. 51

39. Affix cable loop to tab on manual fuel door release lever.

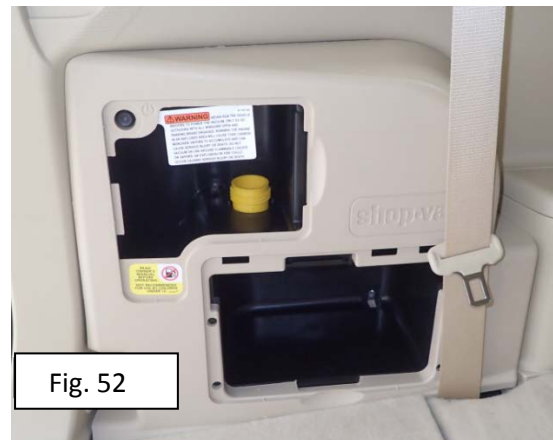
Fig. 52

40. Properly position on board vacuum in it's mounting position.

- Verify operation of fuel door release by pulling release cable
- Temporarily connect negative battery terminal and verify operation of vacuum by pressing the power button.

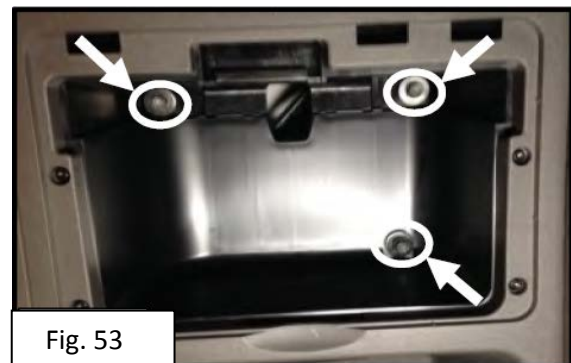
Fig. 53

41. Install vacuum assembly with 10mm socket and ratchet using hardware provided to mounting holes on bracket.

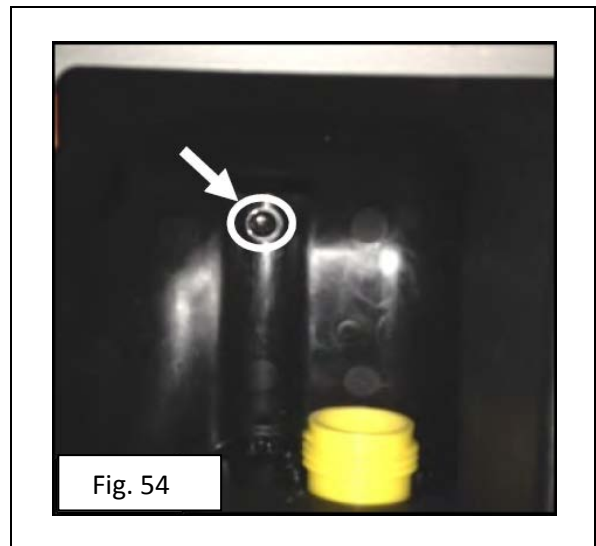
Fig. 54

42. Install self tapping screw in hole inside hose storage cavity. Tighten with 8mm socket.

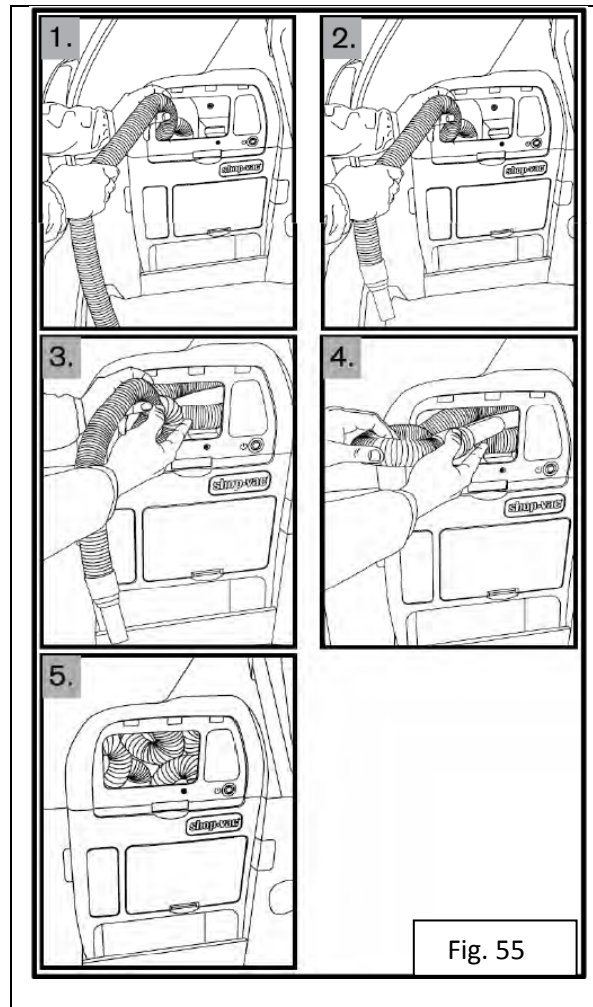
Fig. 55

- 44. Insert hose assembly into hose storage cavity following steps shown.

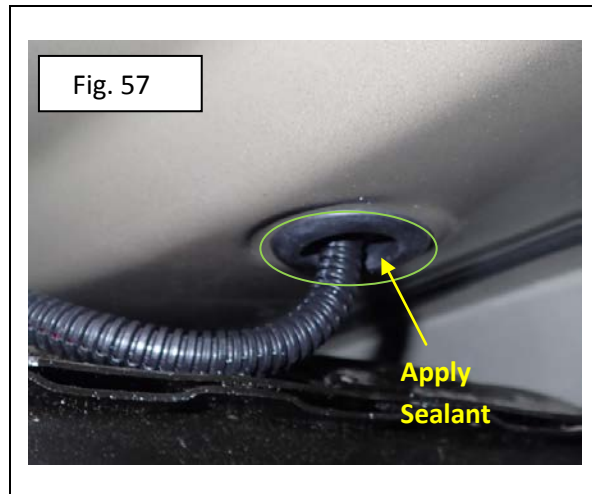
Fig. 57

50. Seat body plug in floor panel and seal with 3M silicone or equivalent.

- Apply silicone between harness and body plug.
- Ensure incision made to body plug is completely sealed.

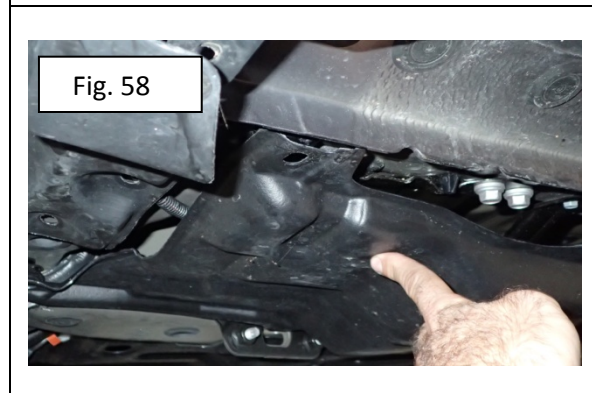
Fig. 58

51. Install and secure underbody splash shields.
