# Service Bulletin

## Milestone Equipment Company LLC

### Container Chassis Axle Wheel End Inspection

October 2016

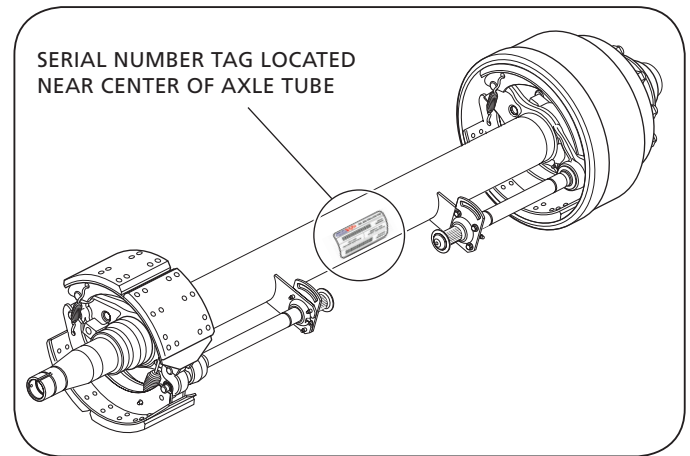
**Figure 1**

The location of the axle serial tag is found near the center of the axle (**Figure 1**). The sample tag shown (**Figure 2**) will help you interpret the information on the SAF-HOLLAND®, Inc. serial tag. The part number is on the first line. The axle beam rating is on the second line. The third line contains the serial number.

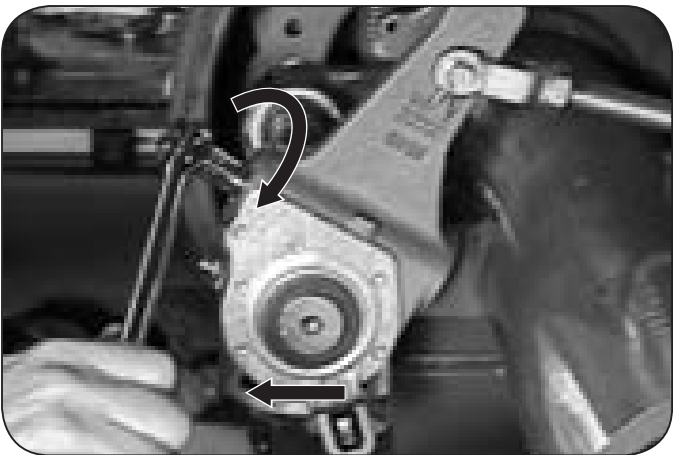
Figure 3 (Haldex ASA Shown for Example)

- b. The adjuster must be manually adjusted at this time. Adjust brakes by rotating the 7/16" adjusting hex clockwise until the lining **lightly** contacts the drum (**Figure 3**).

5. Make the required adjustment to your axle's slack adjuster as follows:
- a. The adjuster must be backed off by rotating the 7/16" adjusting hex counter-clockwise.

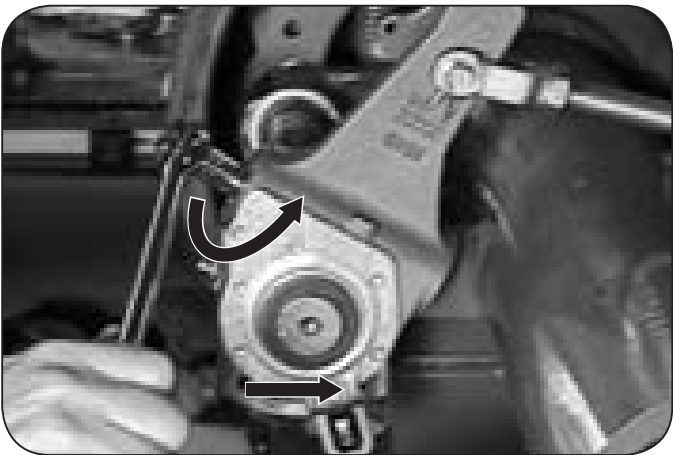
Figure 4 (Haldex ASA Shown for Example)

- c. Back-off the adjuster by rotating adjusting hex counter-clockwise 1/2 turn. A ratcheting sound will occur, which is normal. Never use an impact wrench or internal damage will occur (**Figure 4**).

7. Further re-adjust the slack adjuster like step 5 except rotate the adjusting hex counter clockwise an additional 1/4 turn (3/4 total).
8. Rotate the tire by hand. Ensure brake stroke is within the slack adjuster manufacturer's limit. Prepare to put the trailer back into service. Inspect brakes per the chart below.
