GROUP ELE	MODEL 2015 MY K900 (KH)
	NUMBER 103	DATE May 2016
TECHNICAL SERVICE BULLETIN		
SUBJECT: SERVICE ACTION: START STOP BUTTON (SSB) INSPECTION AND REPLACEMENT (SA 228)

SUBJECT: SERVICE ACTION: START STOP BUTTON (SSB) INSPECTION AND REPLACEMENT (SA 228)

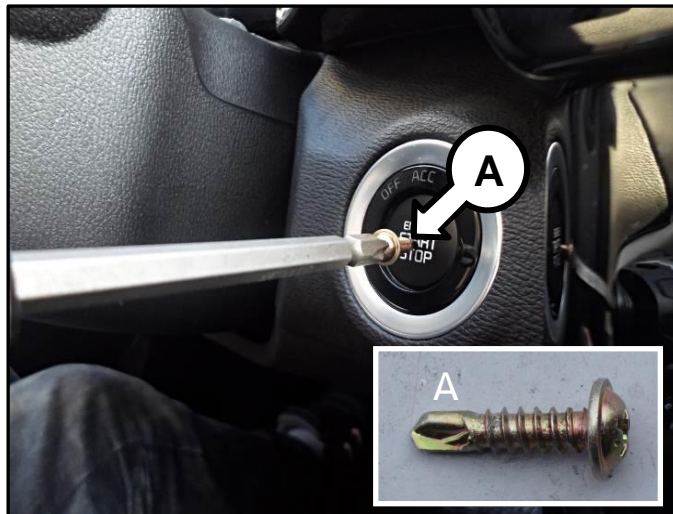
1. Record radio station presets. Disconnect the battery.
2. Use a Phillips head self-drilling screw (A), no more than 5/8" long, and carefully thread it into the center of the button cap.

Thread the screw into the center of the button enough to allow a pair of pliers to grip the head.

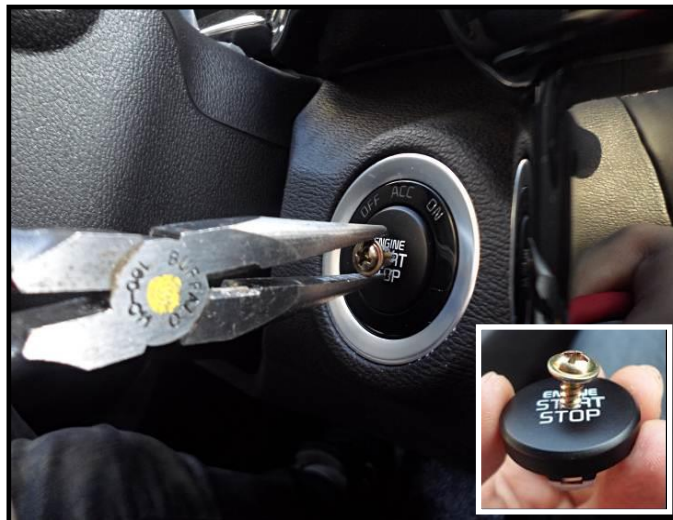
3. Use a pair of pliers to grip the screw and pull the SSB cap straight out.

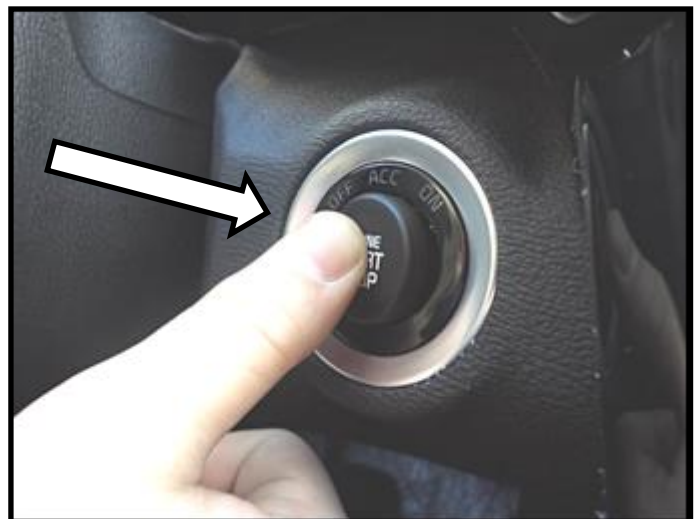
7. Align the new cap on the existing switch with **“ENGINE START STOP”** text horizontally aligned and press cap straight in until a snap is felt.
8. Connect the battery.
9. Confirm proper operation of SSB. Program previously recorded radio presets.
(No further action required)

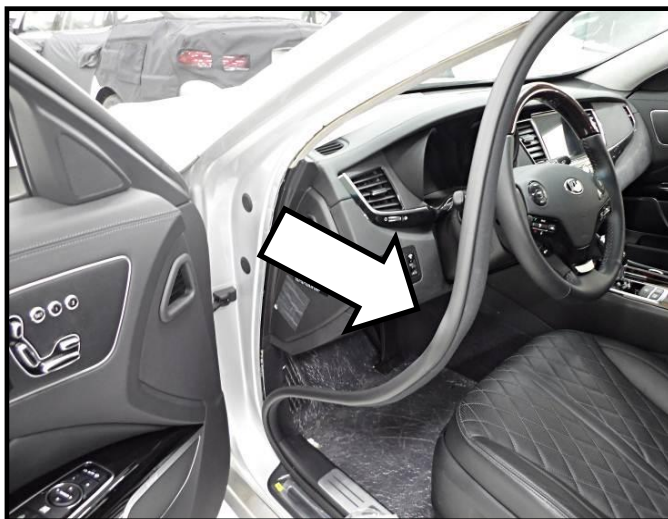
2. Use a non-marring trim panel tool to remove the trim cover (A) from the side of the crash pad.

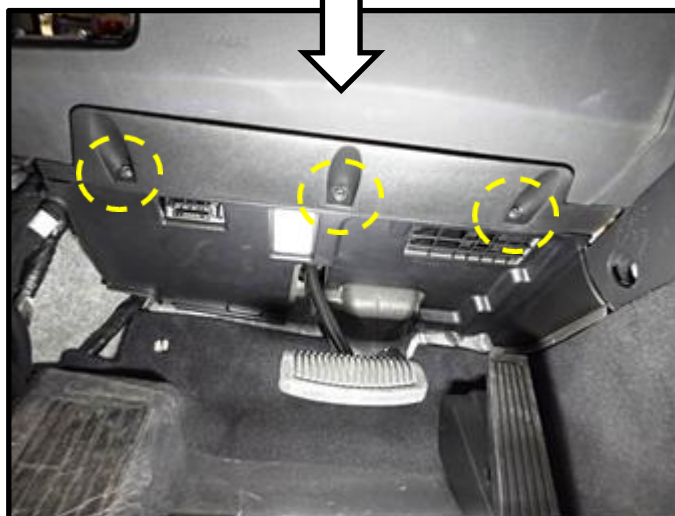
7. Remove the six screws securing the crash pad lower panel and remove the lower panel.

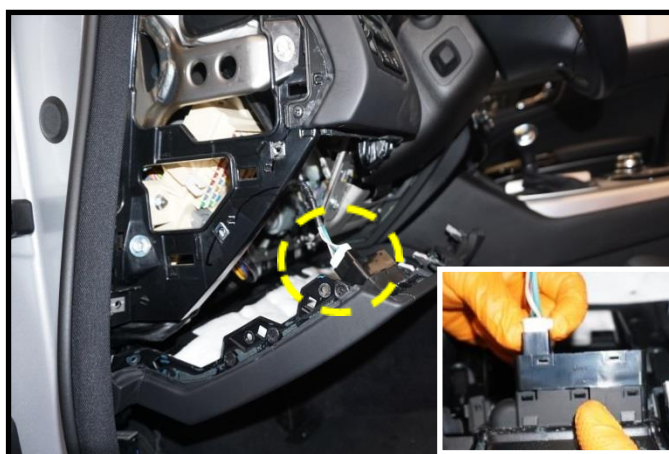
8. The lower crash panel is snapped into place and will need to be pulled away to remove. Then disconnect the connector from the lower crash panel pad switches.

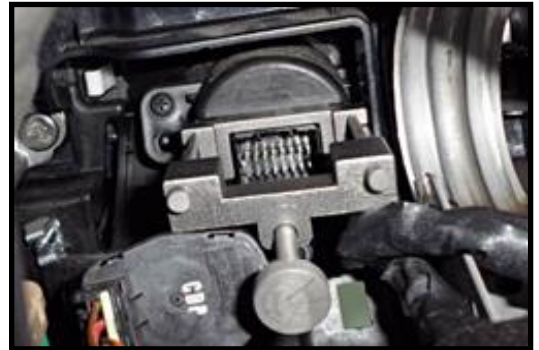
12. Mount the Button Start Remover Tool onto the SSB on the connector side at the back side of the crash pad. (It will only attach one way).

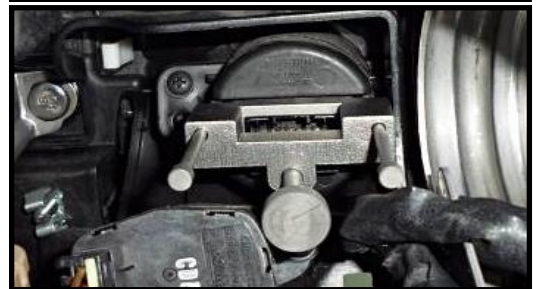
13. Engage the release fork to release the anchoring tabs of the switch.

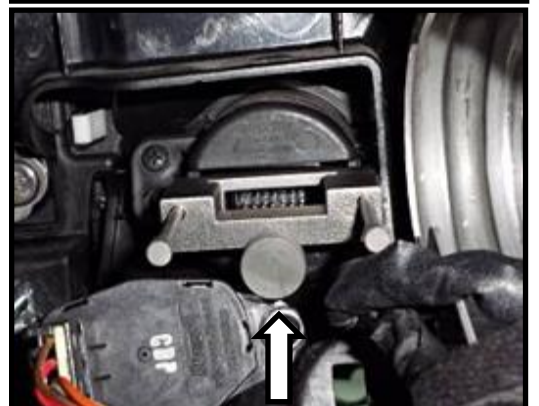
14. Press center plunger to eject the SSB assembly from the dash panel.

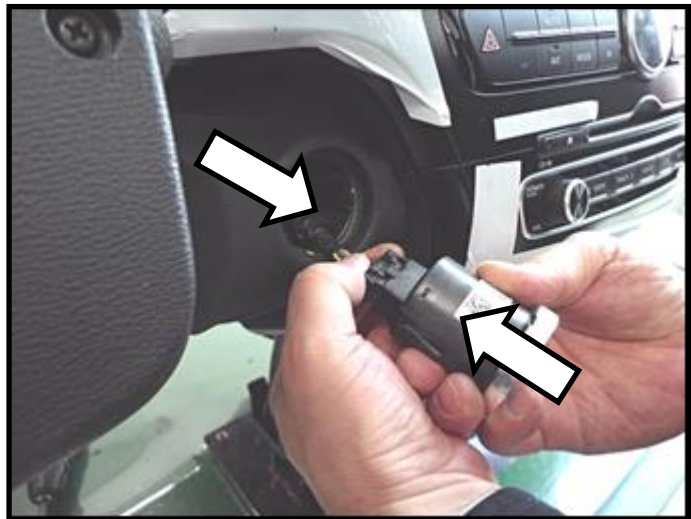
15. Push the SSB harness connector through the crash pad and connect to the improved SSB. Then insert the SSB into the crash pad. It will click into place and appear flush. See picture below.

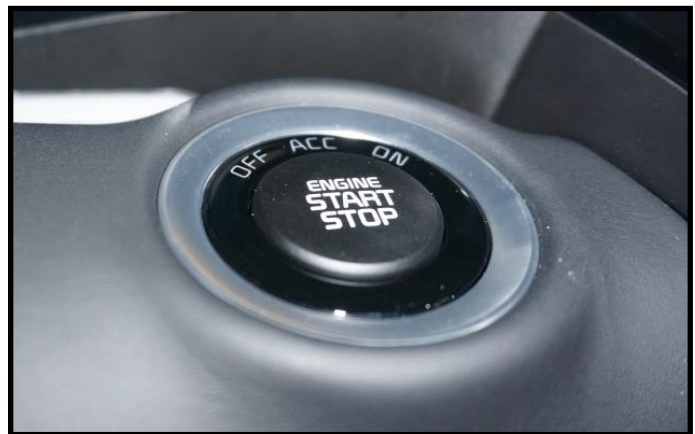
16. Install all removed parts in reverse order of disassembly.

17. Connect battery. Test operation of new SSB. Program previously recorded radio presets.
