## SERVICE BULLETIN

| Reference number: | SB-01-0430 | Issued: 26 February 2016 |
| Subject: | Squeak from the Outer Waist Seal on Rapide Rear Door | |
| Model(s): | Rapide and Rapide S | |

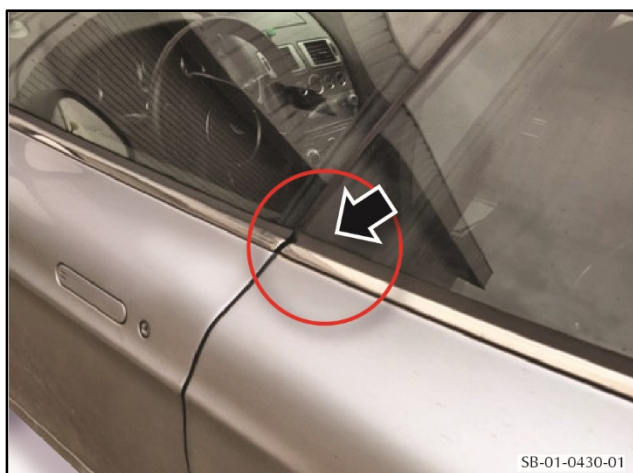
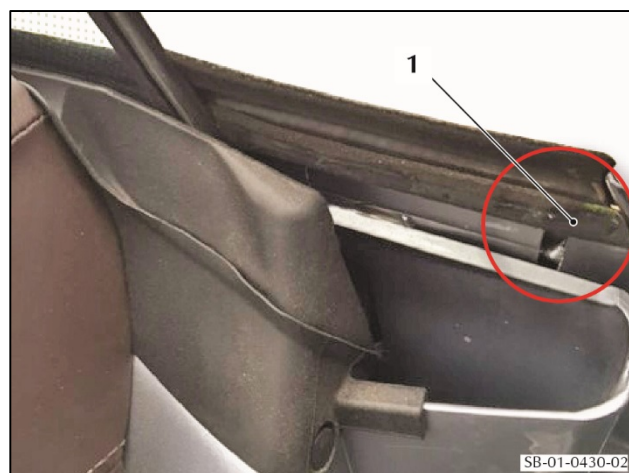
It is possible that when the windows on Rapide are operated, you can hear a squeak from the window glass. This occurs on the rear door glass especially during the short drop when you open a door.

The flocking on the end of the rear waist seal for the window can wear off and cause the rubber of the seal to rub against the glass and cause a squeak. The flocking only wears in this specific area because the rubber edge seal on the glass causes too much wear in this area. Refer to Figure 1 and Figure 2 for the area (1) where the problem occurs.

To correct this problem, do the procedure that follows to remove the area of the rear waist seal that causes the squeak.

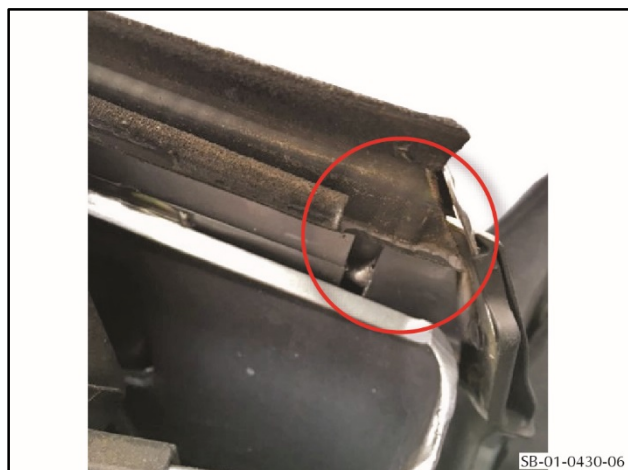
6. Figure 6 shows the outer waist finisher after the part of the seal has been removed.

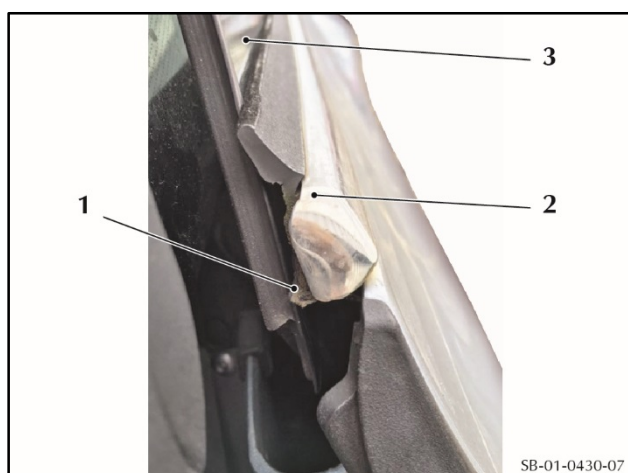
Figure 7

7. Open the adjacent front door.
8. Close the applicable rear door.
9. Look at the end of the outer waist finisher towards the rear of the vehicle. The seal (1) must look the same as shown in Figure 7.

10. Make sure that the end of the waist finisher (2) does not touch the glass (3). If the waist finisher (2) touches the glass (3), do not operate the glass and replace the waist finisher.
11. Do steps 1 thru 10 again for the opposite side of the vehicle.
