## Maserati Tech Tips 70

Date: August 22, 2016  
Bulletin No.: Tech Tips 70  
Quattroporte (M139)  
Windshield Seal

**Model Type:** M139

**Subject:** Correct the deformation of the windshield glass seal.

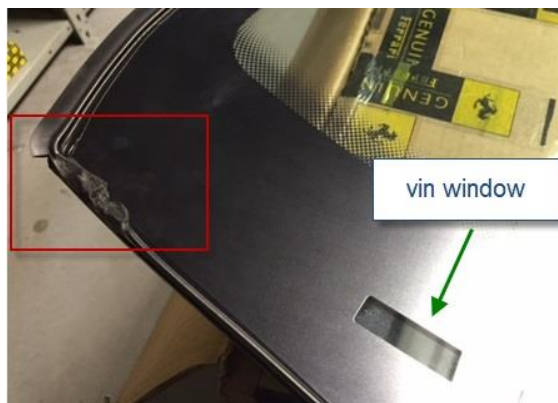
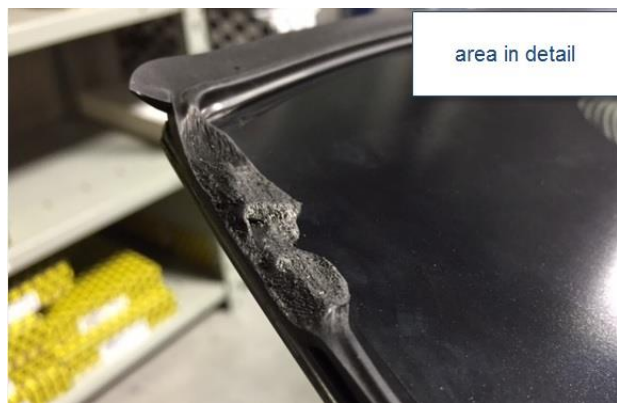
**Description:** Some windshields being ordered for replacement may have a deformation of the seal and are being refused claiming it is damaged. A repair procedure has been developed and is outlined with the pictures below.
