TECH TIP

Group:	22-FUEL SYSTEM
Bulletin No:	TT-16-007
Issue Date:	5-24-2016
Reference:	HMM-160524-J1

FUEL SYSTEM CONTAMINATION

SUBJECT VEHICLES: 2011 through 2017 model year Hino Conventional Trucks and 2013 through 2017 model year Hino COE(Cab over Engine) Trucks

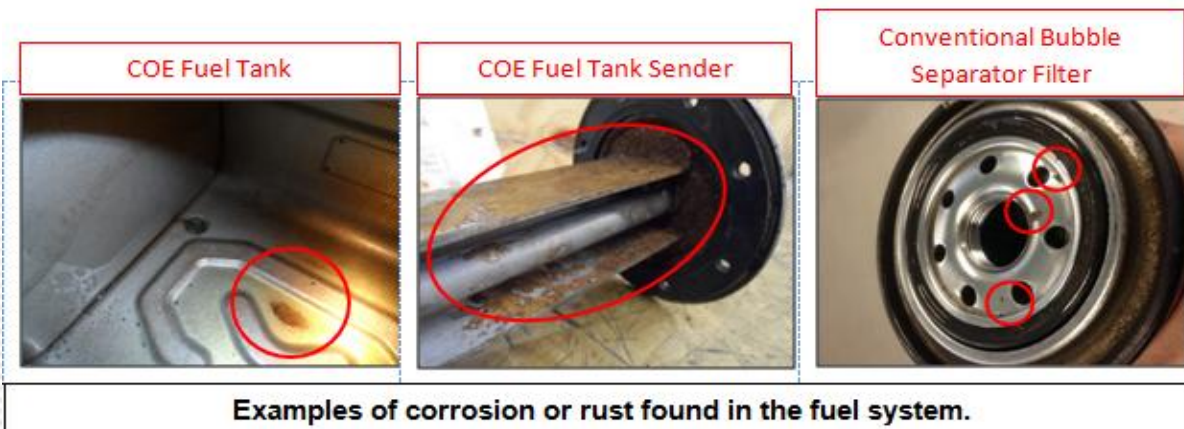
1. Inspect the fuel filter housing and fuel tank for signs of water, rust, algae, or black organic contamination (see examples below). Replacement of components that are internally corroded or restricted, including the bubble separator filter for the 15MY through 17MY conventional vehicles, is suggested. In addition, the fuel system should be flushed to prevent reoccurring fuel system failures. **Note: For 11MY-14MY, there is a filter screen located inside the banjo bolt at the pump.**

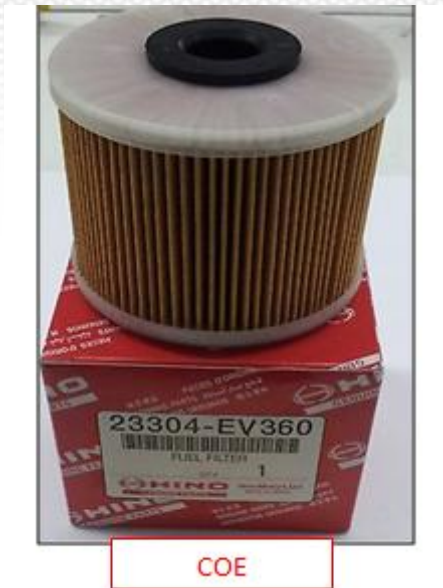
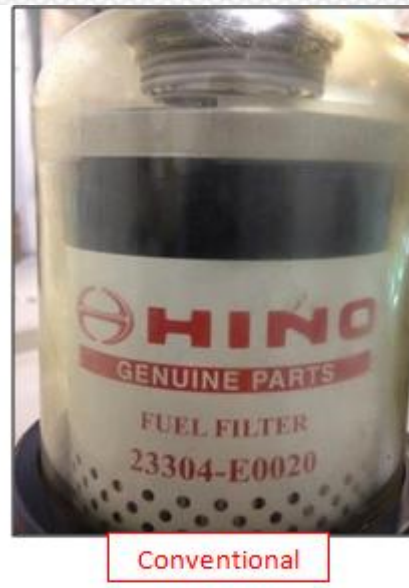
2. If no signs of contamination were found, verify that only Hino Genuine fuel filters, or equivalent 7 micron filters have been used. Some aftermarket fuel filter elements have a higher micron rating compared to genuine Hino fuel filters. This higher micron rating will allow debris or contamination to flow through the fuel filter into the primary fuel system. This will result in fuel system damage.

Regarding 2015 through 2017 model year conventional trucks, if debris or contamination is allowed into the primary fuel system, this can also lead to premature bubble separator filter restriction. If DTC's P20DE or P20DF has set, inspection of the fuel system is suggested prior to pressure sensor replacement. If the bubble separator filter has become restricted, this will result in reduced fuel pressure to the DPR (Diesel Particulate Reduction) 7th fuel injector.
