## ROADSTER 2014 SE6 Clutch Cover Oil Leak (Set Screw) (Spyder RT)\_000071521\_TST61Y014S01\_en

2014 Can-Am Spyder RT - SE6 Clutch Cover Oil Leak set screw

Campaign no.: **2014-0002**

Subject: **2014 Can-Am™ Spyder™ RT™ - SE6 Clutch Cover Oil Leak (set screw)**

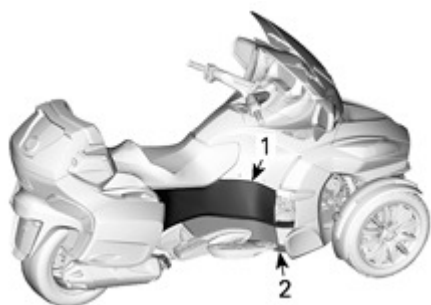
- 1. RH rear side panel
- 2. RH bottom side panel

1. To access the set screw, remove the following body parts.

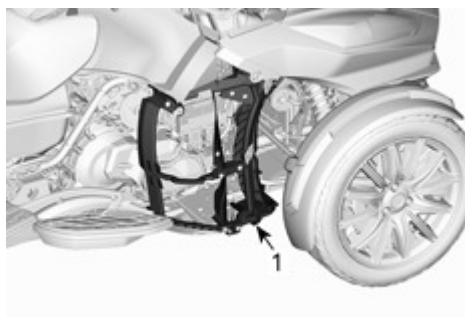
- 1. RH lateral panel support assembly

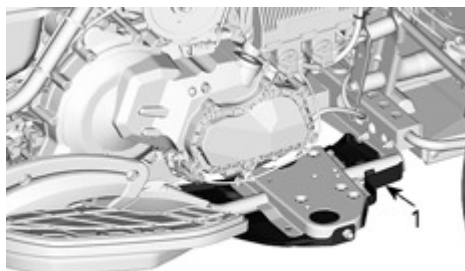
- 1. RH deflector panel

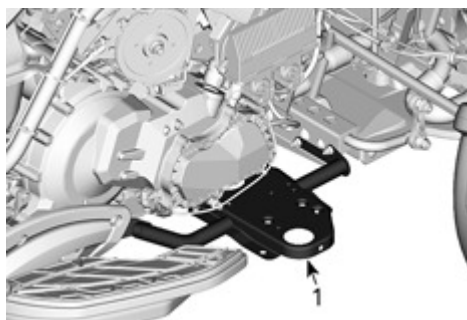
1. *RH lower lateral support.*
2. Disconnect and remove the oil pressure sensor (OPS).

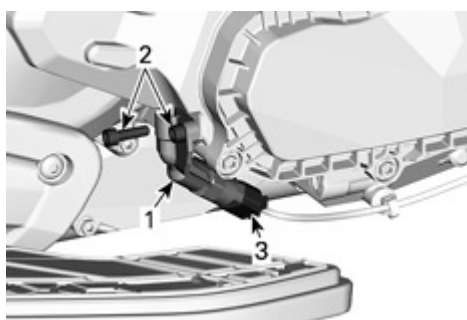
1. *OPS*
2. *OPS retaining screws*
3. *OPS connector*
3. Remove and discard the set screw.
- 3.1 Place a drain pan under set screw to catch the small amount of oil coming from clutch cover.
- 3.2 Remove the set screw. If difficult to remove, heat the set screw with a heat gun to break the Loctite.

8. Reinstall and reconnect the OPS.

| Tightening Torque | |
|---|---|
| OPS screw | $11 \pm 1 \text{ N}\cdot\text{m}$ ( $97 \pm 9 \text{ lbf}\cdot\text{in}$ ) |

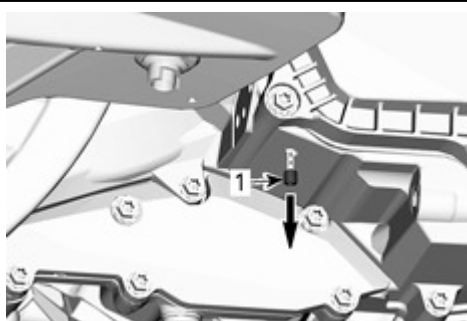
Due to a lack of bonding of the threadlocker, an oil leak from a set screw is possible. A new sealing procedure has been implement in production and an initial very limited quantity of vehicles may have been affected before the change.

1. *Set screw*
- 3.3 Wait 5 minutes in order to allow oil to drain.
4. Clean and dry the oil circuit.
- 4.1 Spray XPS BRAKES AND PARTS CLEANER (P/N 219 701 776) or an equivalent through OPS housing hole.
- 4.2 Dry using compressed air (blow air through OPS housing hole).
- 4.3 Repeat until set screw hole threads remain dry.

To correct this situation, remove and discard factory installed set screw. Install new set screw using sealing procedure defined in this document.

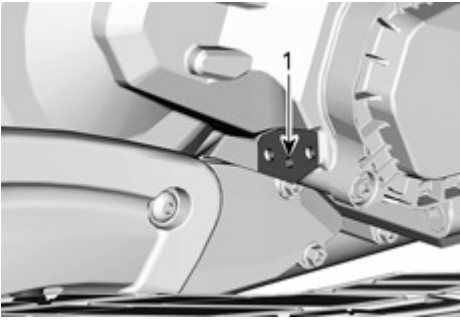
1. Use this hole to spray cleaner and dry set screw threaded hole

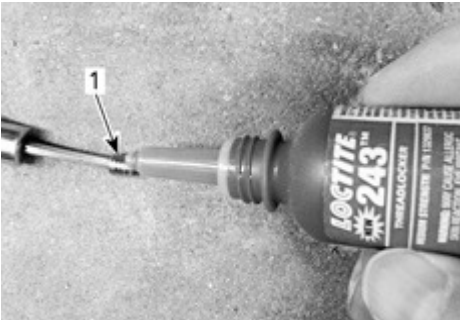
1. Set screw

6. Apply LOCTITE 243 (BLUE) (P/N 293 800 060) on set screw threads.

6.1 Apply enough threadlocker product on set screw threads to cover the entire threaded area.

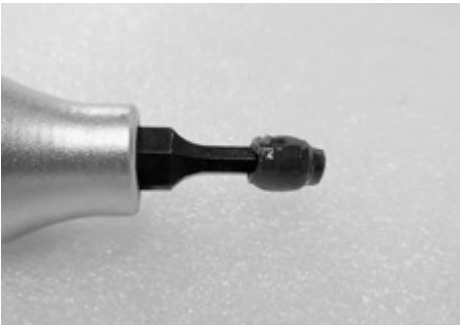
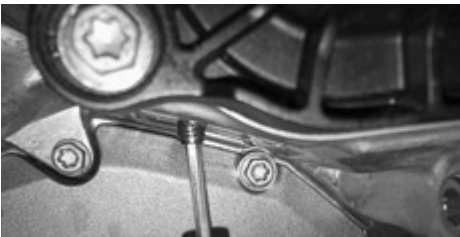
7. Installation of the set screw.

7.1 Install set screw within 60 seconds of application of threadlocker.

7.2 Start set screw by hand to avoid cross-threading due to cover angle.

| Set screw | $6 \pm 0.7 \text{ N}\cdot\text{m}$ ( $53 \pm 6 \text{ lbf}\cdot\text{in}$ ) |

**NOTICE** Allow threadlocker to cure for 5 minute minimum before attempting to start the engine.
