NUMBER: 08-061-16

Wire Termination Seal On 2.4L Engine Wiring Harness

2015	(BU)	Jeep Renegade
2016	(FB)	Fiat 500X

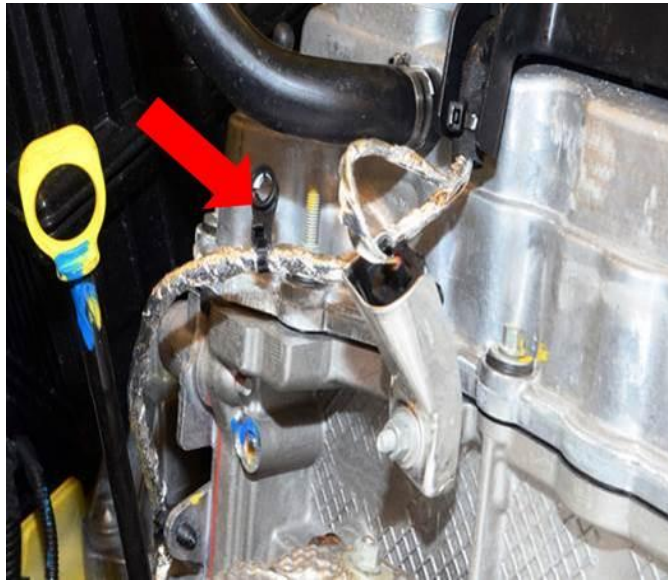
Fig. 1 White Witness Mark Placement

1. Open and support the hood.
2. Remove the engine cover. Refer to the detailed service procedures available in DealerCONNECT> TechCONNECT under: Service Info> Engine/Cover, Engine/Removal and Installation.
3. Inspect for a white witness mark on the plastic wire harness retainer (Fig. 1).
4. Is there a white witness mark on the harness retainer (Fig. 1)?
 - a. YES >>> This bulletin has been completed, use LOP (08-94-TF-90) to close the active RRT. Reinstall the engine cover.
 - b. NO >>> Proceed to [Step #5](#).

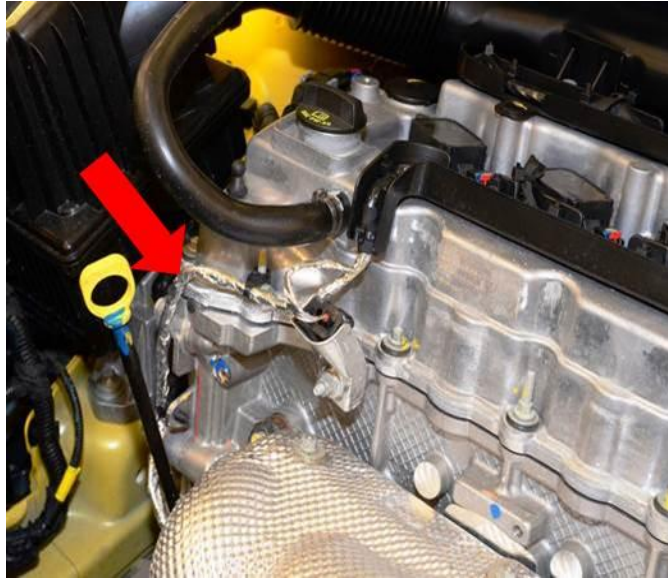
Fig. 2 Engine Harness

6. Locate the engine wiring harness (Fig. 2).
