SERVICE BULLETIN

| Classification: EL16-017a | Reference: NTB16-039a | Date: May 31, 2016 |

2015 PATHFINDER WITH 4WD; LOW POWER / STOP LAMPS STAY ON

APPLIED VEHICLE: 2015 Pathfinder (R52) 4WD with V6 engines only

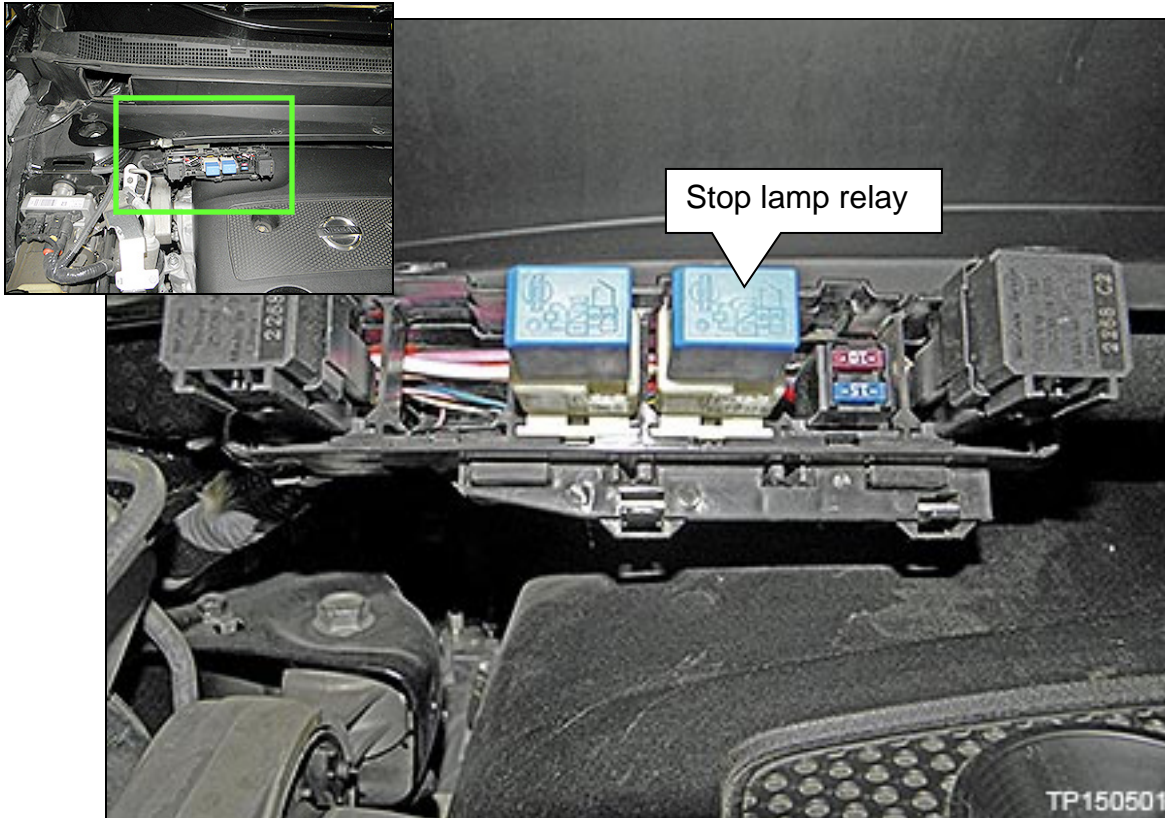
Figure 1

1. Remove the stop lamp fuse (#10) from the “junction box” fuse block in the Instrument panel.
2. Remove “fuse and relay box” (fuse box) cover and locate stop lamp relay (Figure 1).
 - Fuse box located on bulkhead (engine wall) above engine.

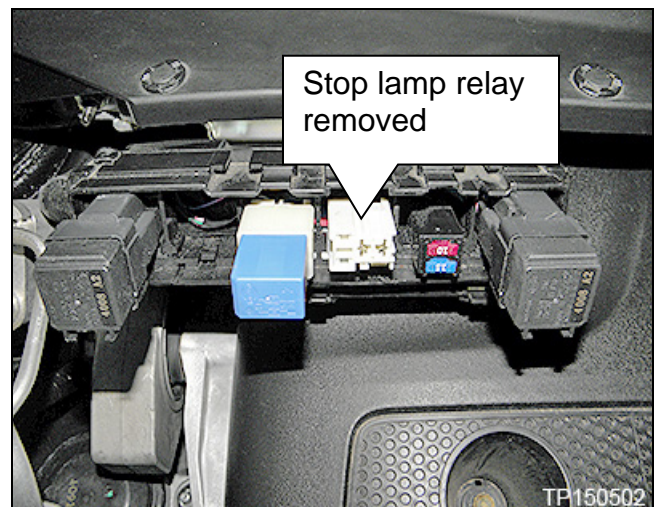
Figure 2

3. Remove the stop lamp relay (Figure 2).
NOTE: This relay will not be reinstalled.

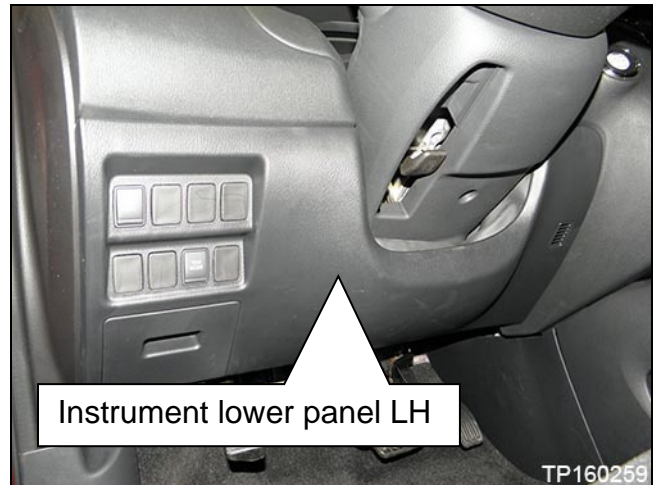
Figure 3

1. Remove instrument lower panel LH
 - Refer to the Electronic Service Manual (ESM), section **IP – Instrument Panel** for removal information.

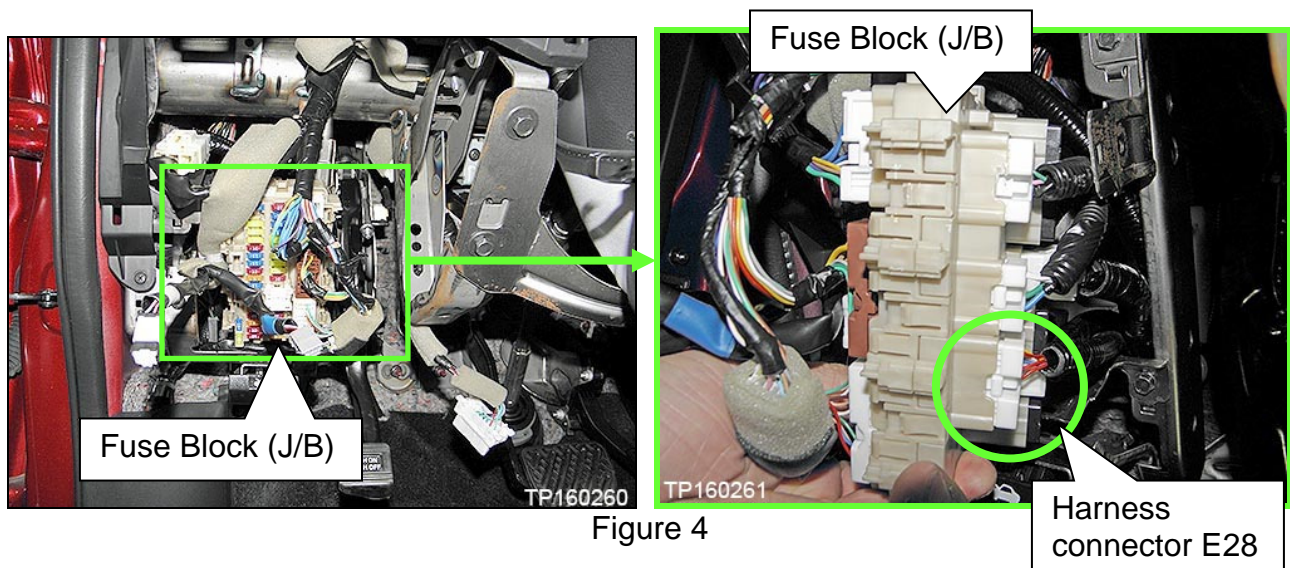
Figure 4

2. Disconnect harness connector E28, shown in Figure 4, from the back of Fuse Block (J/B).
 - If needed refer to the Electronic ESM, section **PG – Power Supply, Ground & Circuit Elements** for further information on harness connector E28 and Fuse Block (J/B).

NOTE: Fuse Block (J/B) is shown detached from support bracket. Harness connector E28 can be disconnected with Fuse Block (J/B) left in place.

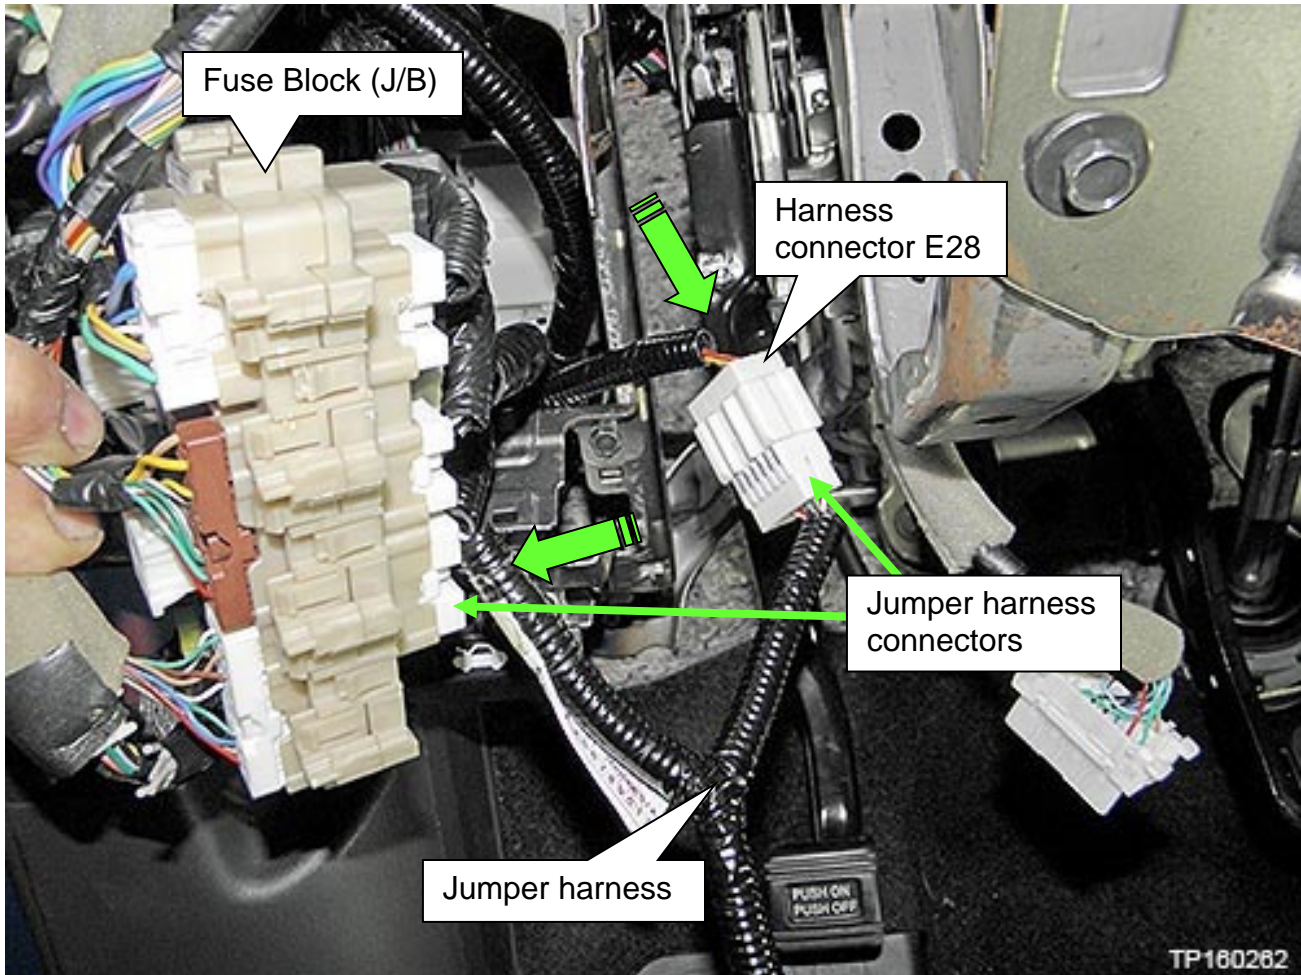
Figure 5

3. Connect jumper harness (part #: 24167-9PB1E) between Fuse Block (J/B) and harness connector E28 (Figure 5).

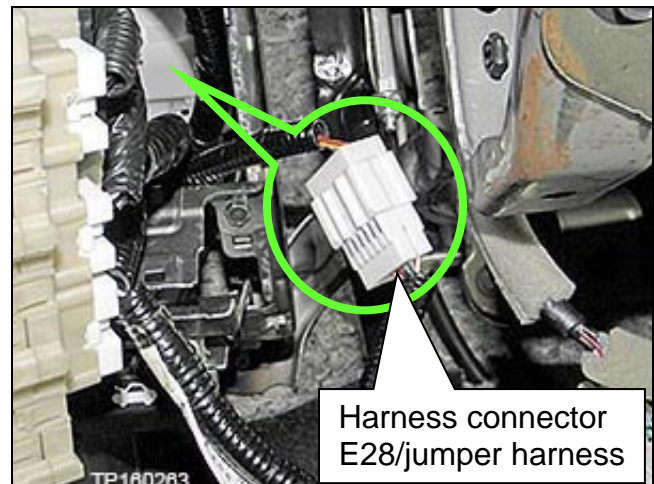
Figure 6

4. Tuck "harness connector E28/jumper harness" behind Fuse Block (J/B).

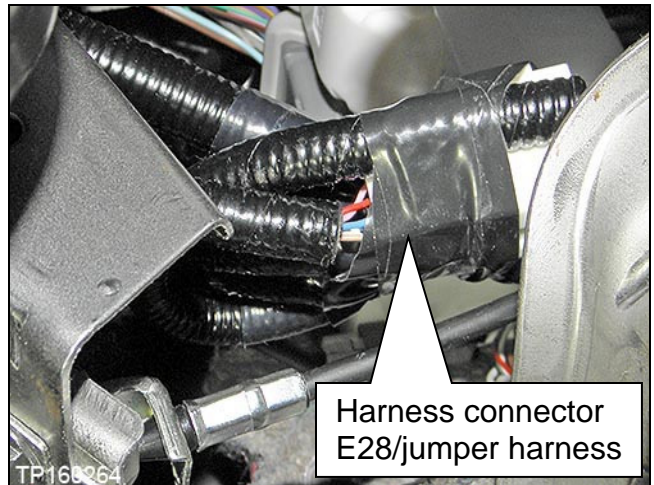
Figure 7

5. Tape harness connector E28/jumper harness to the main harness.

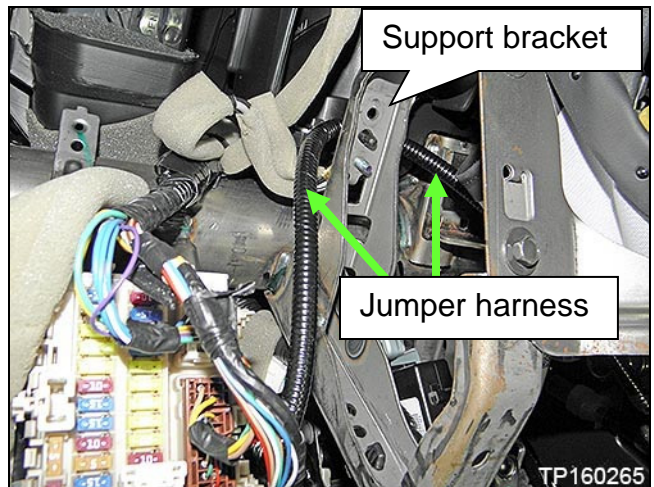
Figure 8

6. Route the jumper harness behind the support bracket as shown in Figure 8.

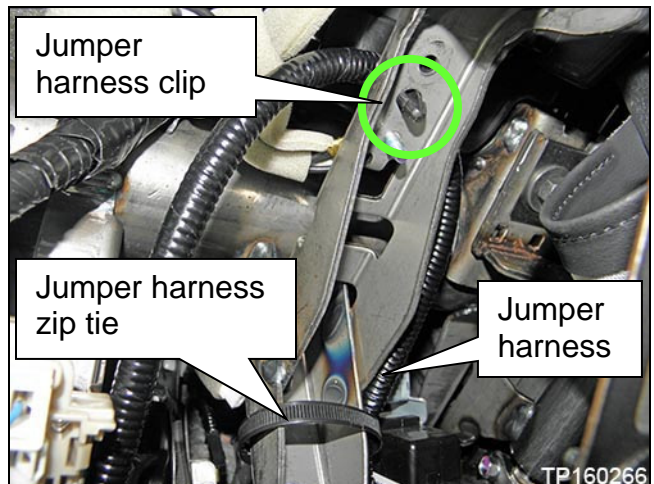
Figure 9

7. Clip the jumper harness to the support bracket (Figure 9).

8. Zip tie the jumper harness to the side of the support bracket (Figure 9).

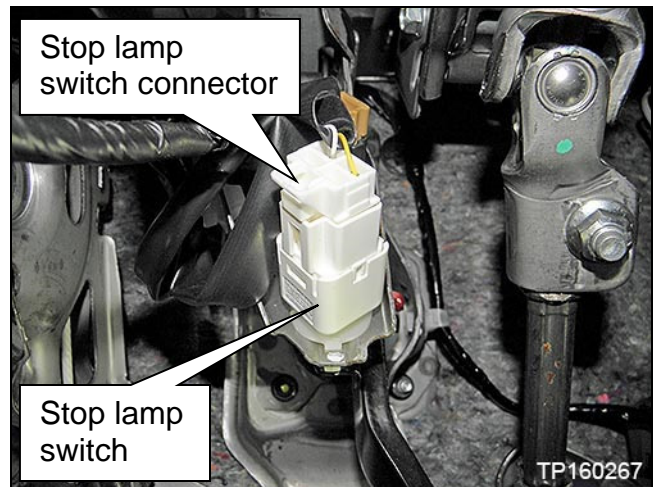
Figure 10

9. Locate the stop lamp switch connector and disconnect it from stop lamp switch.

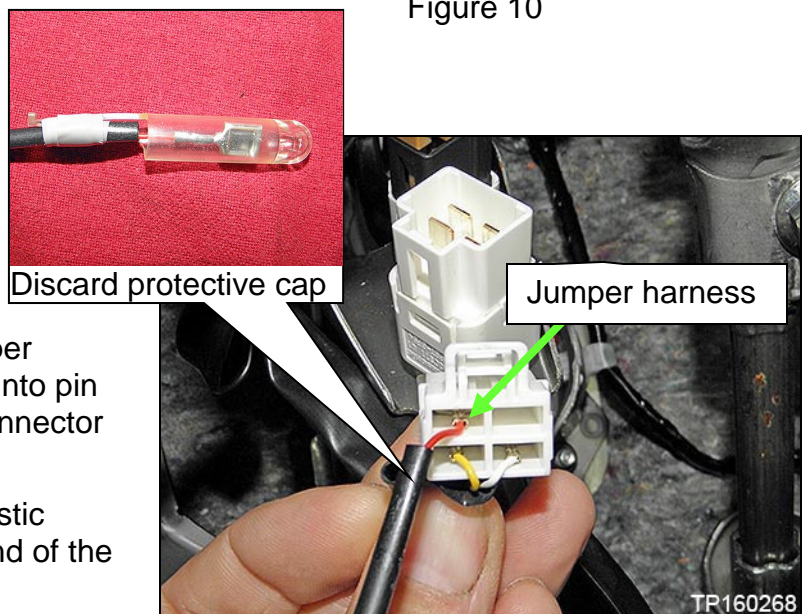
Figure 11

10. Insert the single wire of the jumper harness (part #: 24167-9PB1E) into pin No. 3 of the stop lamp switch connector in vehicle harness (Figure 11).

NOTE: Remove and discard plastic protective cap that covers the end of the single wire.

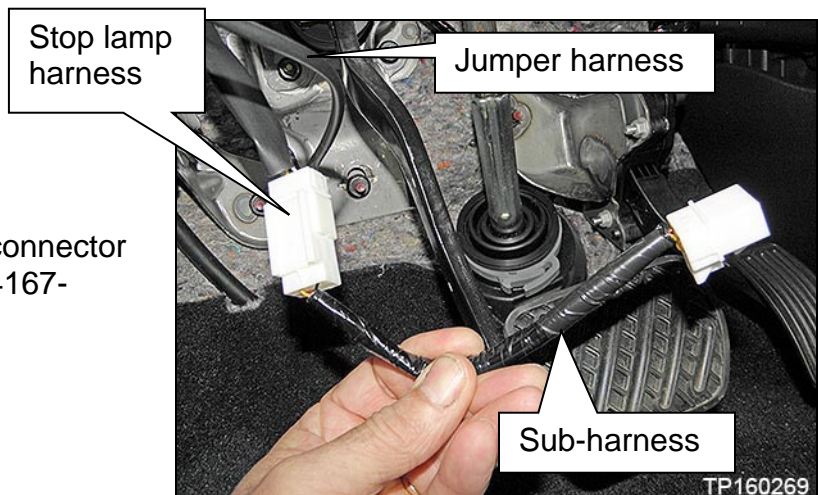
Figure 12

11. Connect the stop lamp switch connector into the sub-harness (part #: 24167-9PB2E).

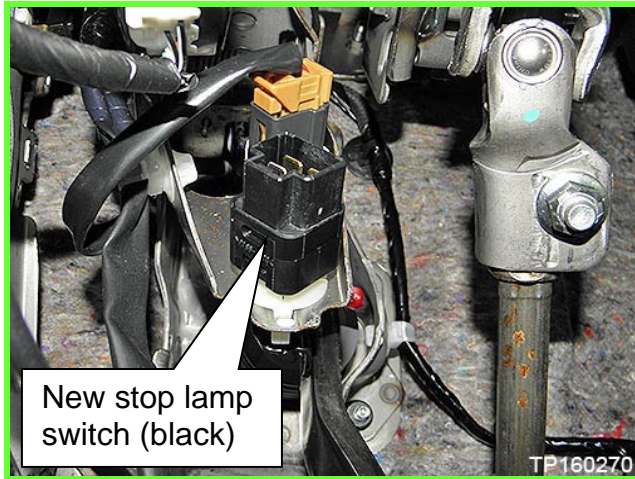
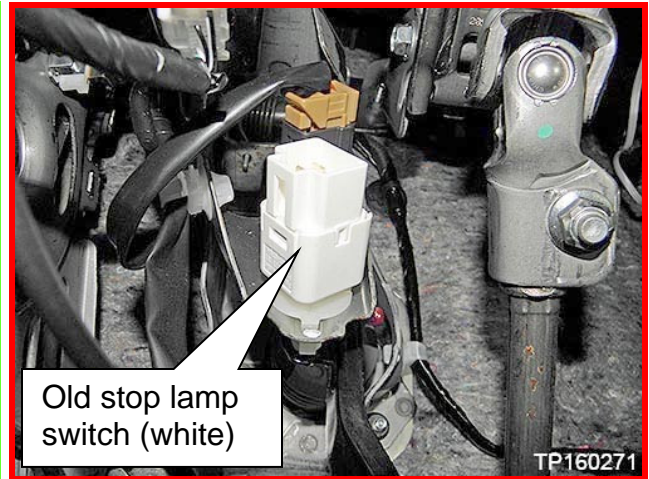
12. Replace the stop lamp switch with the part listed in **PARTS INFORMATION**.

- Refer to the ESM, section **BR – Brake System / Brake Pedal** for replacement information and adjustment.

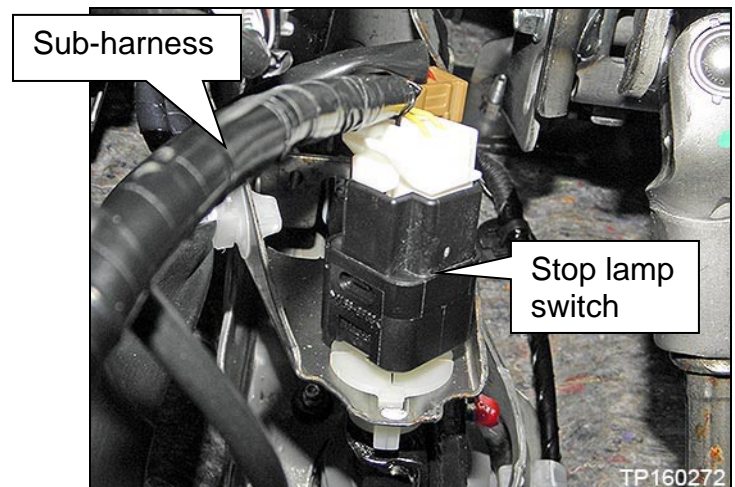
Figure 15

13. Connect the sub-harness to the stop lamp switch (Figure 15).

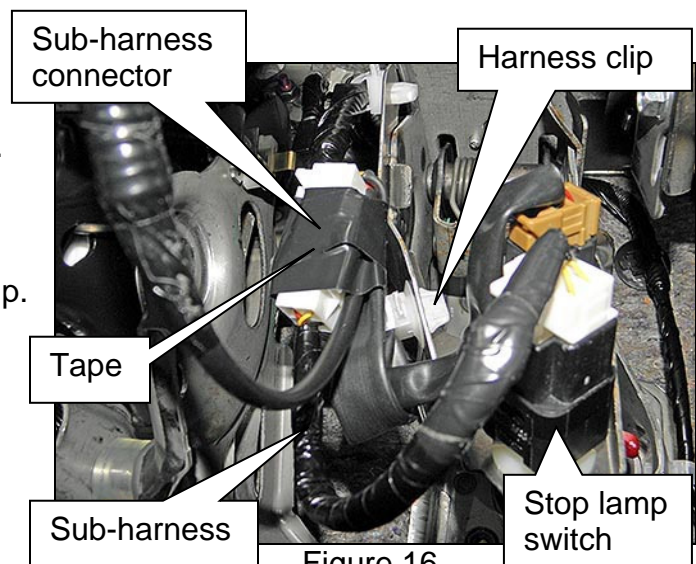
Figure 16

14. Unclip the stop lamp harness from the support bracket (Figure 16).

15. Tape the sub-harness connector to the adjacent stop lamp harness (Figure 16).

- Tape the harness so that the sub-harness is facing downward.
- Apply the tape above the harness clip.
