SERVICE BULLETIN

Classification: EL15-029a	Reference: NTB15-113a	Date: May 31, 2016
------------------------------	--------------------------	-----------------------

2013 ROGUE AND 2014 ROGUE SELECT; LOW POWER / STOP LAMPS STAY ON

APPLIED VEHICLE: 2013 Rogue (S35)
2014 Rogue Select (S35)

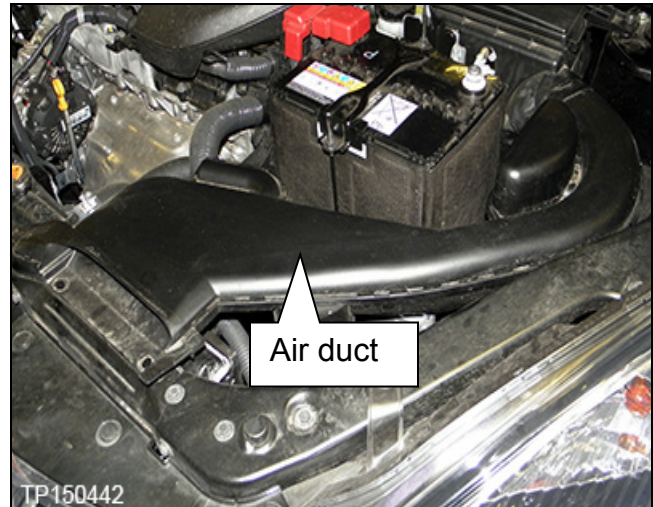
Figure 1

1. Remove the stop lamp fuse (#10) from the “junction box” fuse block in the Instrument panel.
2. Remove the air duct.
