SERVICE BULLETIN

EC14-010b

2014-2016 ROGUE; LACKS POWER DUE TO SNOW INGESTION

APPLIED VEHICLE: 2014-2016 Rogue (T32)

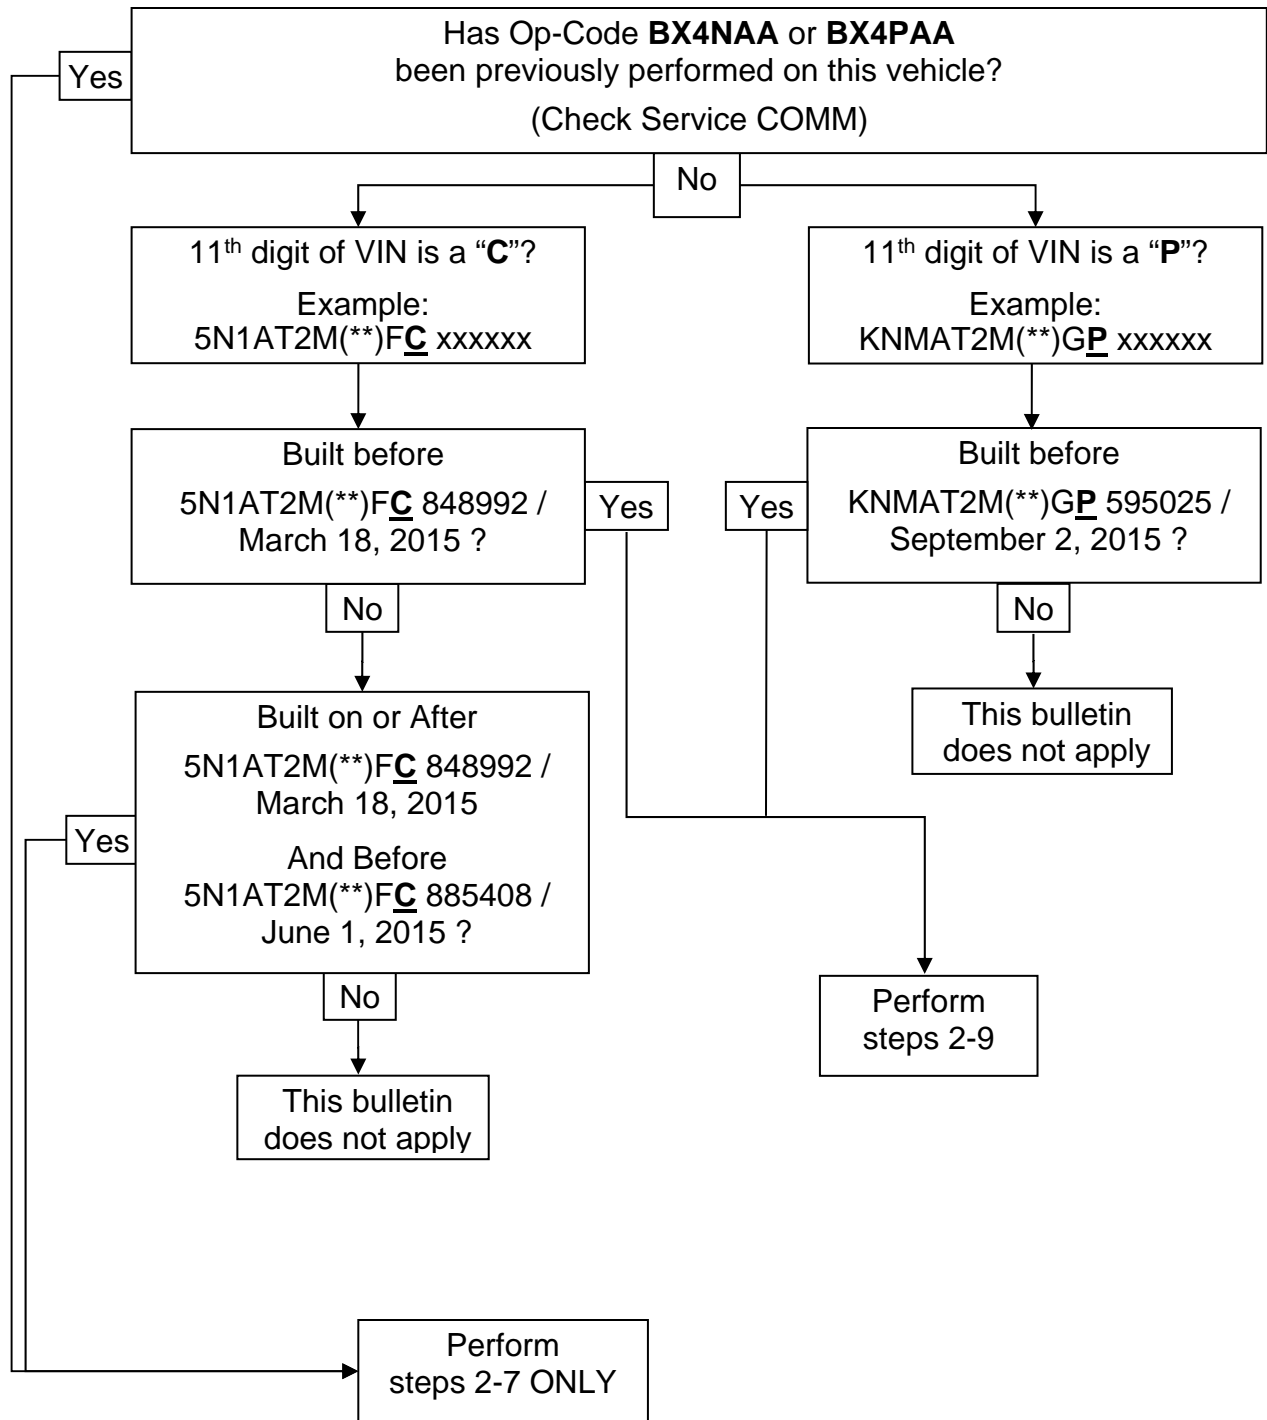
REPAIR FLOW CHART

APPLIED VIN & DATE: See Repair Flow Chart on page 2 for VIN and Date information.

See Repair Flow Chart on page 2 to confirm that this bulletin applies.

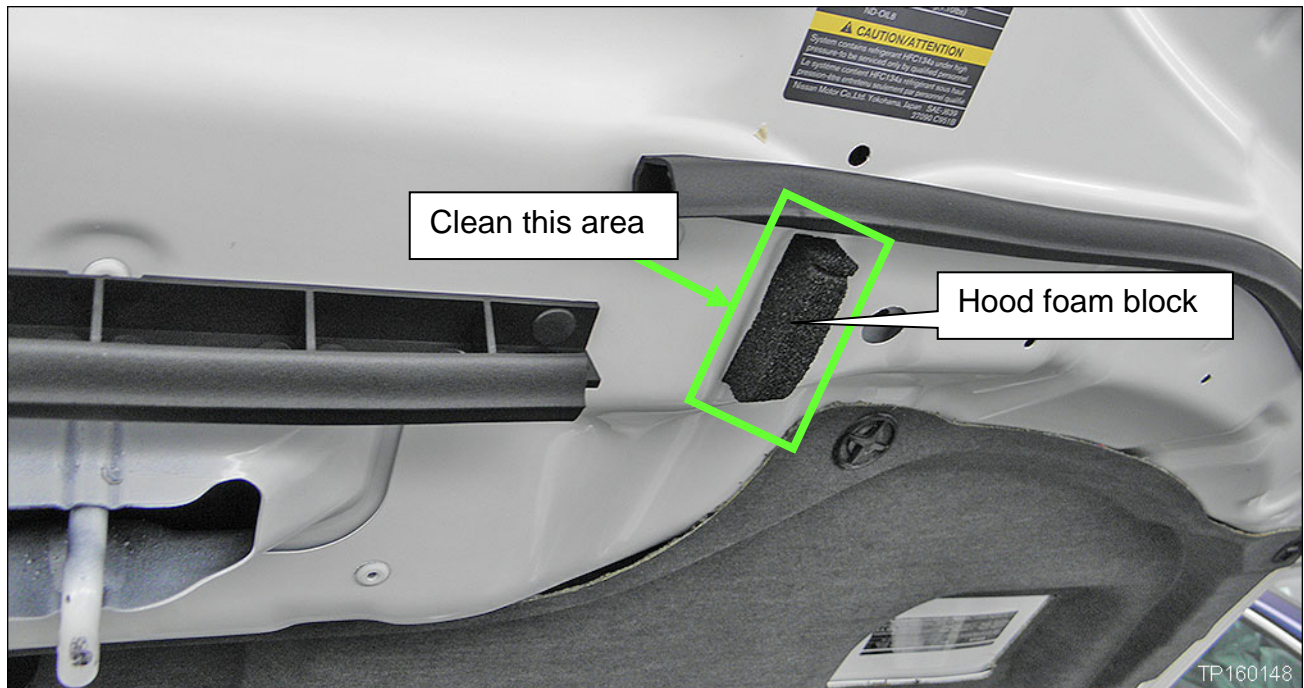
Figure 1

2. Open the engine hood.
3. Remove any snow from inside the air duct assembly, resonator, and air cleaner case.
4. Replace the air cleaner filter.
5. Clean the area of the hood with 50% isopropyl alcohol where the hood foam block will be attached (shown highlighted in Figure 1).
6. Install the hood foam block (Figure 1).
 - Hood foam block is listed in the Parts Information.

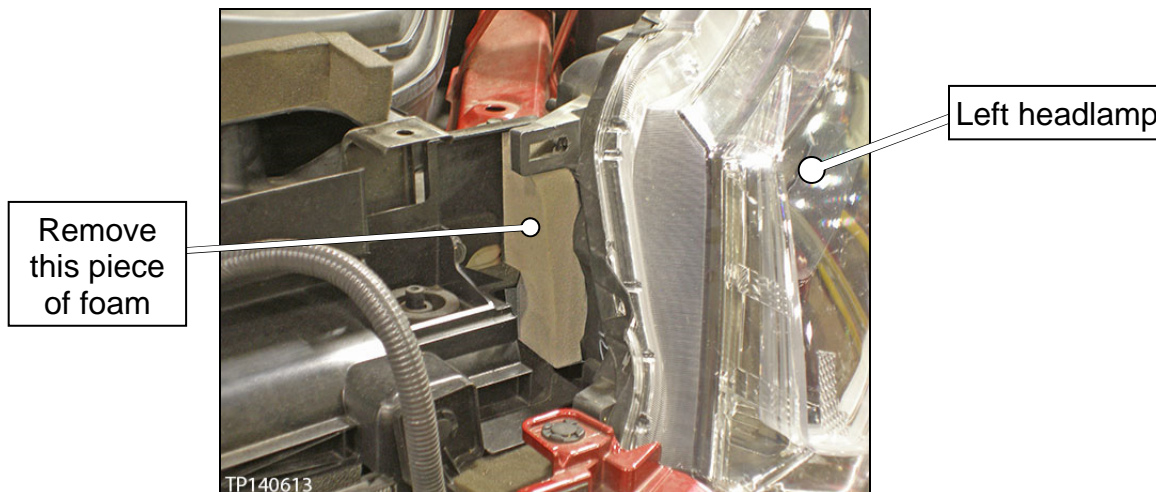
Figure 2

8. Remove the front grill, and then remove the foam near the driver side (left side) headlamp (see Figure 2).
- Refer to the Electronic Service Manual (ESM), section **EXT - Exterior**, for front grille removal information.
