Constellation
Heritage
> 4700 Models

Western Star
Service Bulletin

General Information

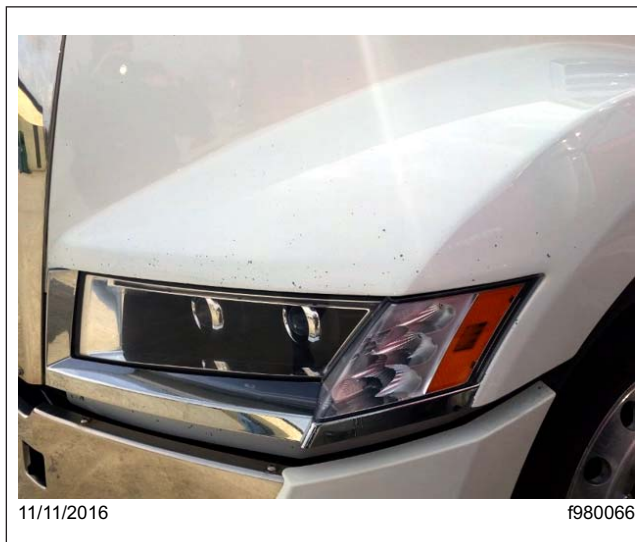
Fig. 1, Chipped Paint from Road Debris

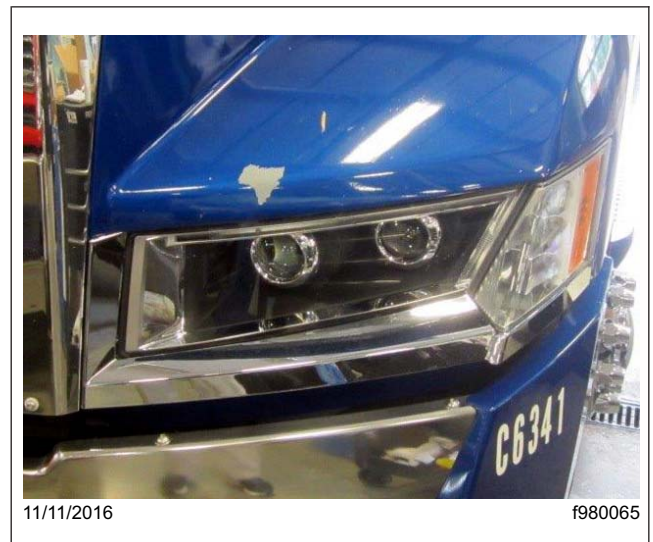
Hood paint is peeling on some 4700 models and 5700 models built from December 1, 2014 through August 1, 2016. This condition is caused by the use of 131S™ primer, that the paint did not adhere properly to. Follow the instructions below to correct this issue.

1. Photograph an area that **does not** already have paint damage.
2. Take a piece of regular masking tape and press it firmly to the area.
3. Pull (jerk) the tape off quickly.
4. Photograph any paint attached to the tape.
5. Photograph any paint missing from where the tape was applied.
6. Perform the tape test on multiple areas of the hood.
7. If paint is not pulled off when the tape is removed, there is no paint adhesion issue. See [Fig. 1](#).
If paint is pulled off when the tape is removed, the paint does not adhere properly. See [Fig. 2](#).

Fig. 2, Paint Does Not Adhere to the Hood

8. If a paint adhesion issue exists, completely sand the hood to remove all of the original primer.
9. Apply Axalta 1480S™ Spot Productive Primer following instructions in **Section 98.00 Paint, Axalta** in the *Western Star Workshop Manual*.
