ENTEGRA
COACH®

TECHNICAL SERVICE BULLETIN

TSB#: 16-027 Job Code: 9803312 Flat Rate: 2 hr

Inspect air box for obstruction.
Insert screws around duck bill at air intake hose

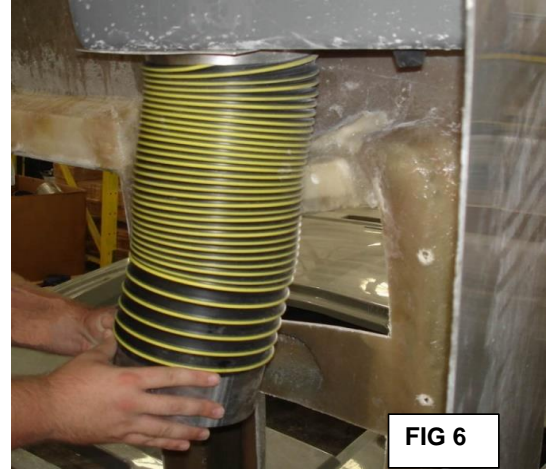
Fig 6: Take the hose out of the elbow. The hose fits VERY tight into the elbow and is not real flexible.

By using a flat blade screwdriver in the elbow GENTLY pry the hose out of the elbow.

The hose will be down in the elbow approximately 2 to 2-1/2 inches.

When the hose is free from the elbow reach up inside the pipe, or send a camera up inside the pipe to look for an obstruction

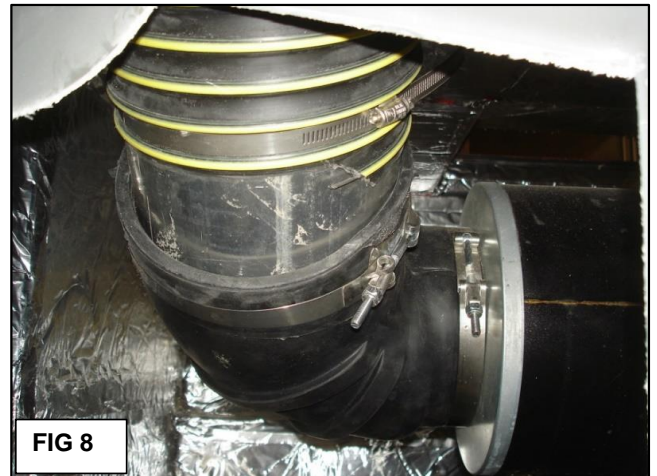
Fig 8: When air intake hose is cleared of any obstruction, re-install the hose back into the elbow and tighten the clamp.

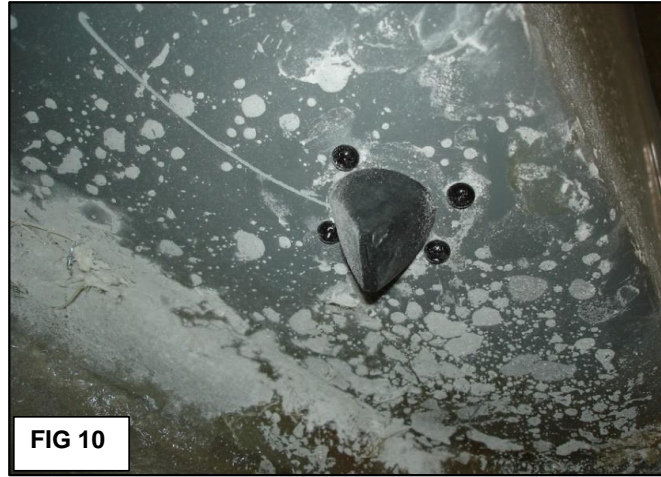
Fig 10: Install the 4 screws from the parts kit around the duckbill vent as shown in this photo.
