PIERCE MANUFACTURING INC.

# SERVICE BULLETIN

**TO:** Service Bulletin Distribution  
**FROM:** Pierce Customer Service  
**DATE:** 1-29-08 UPDATED 1/6/2016  
**RE:** SERVICE TOPIC# 256B Modine Radiator Service

**Modine radiator part number #1225672 installed in the Dash, Lance and Enforcer Chassis. Pages 1 and 2.**

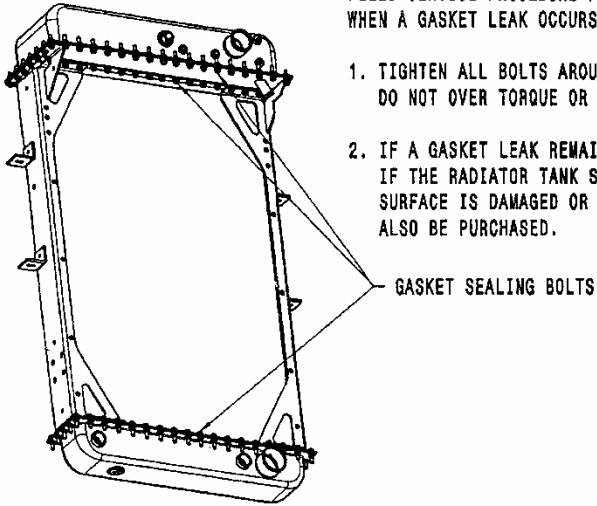
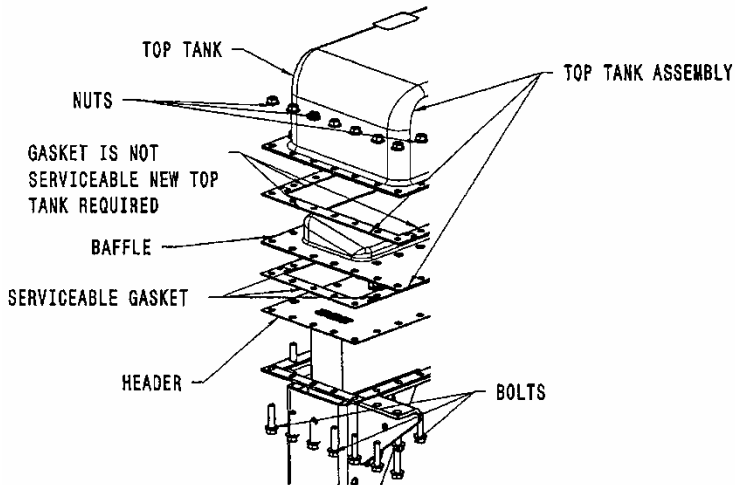
FIELD SERVICE PROCEDURE FOR TIGHTENING BOLTS ON THE 1225672 BOLTED RADIATOR WHEN A GASKET LEAK OCCURS.

1. TIGHTEN ALL BOLTS AROUND LEAK AREA TO 350 in-lbs. NO SPECIAL PATTERN IS REQUIRED, DO NOT OVER TORQUE OR DAMAGE TO THE GASKET WILL OCCUR.
2. IF A GASKET LEAK REMAINS, AT SERVICEABLE GASKET AREA YOU MUST PURCHASE NEW GASKETS. IF THE RADIATOR TANK SEALING SURFACE IS DAMAGED OR LEAK REMAINS AT THE NON SERVICEABLE GASKET, A SERVICE TANK ASSEMBLY MUST ALSO BE PURCHASED.

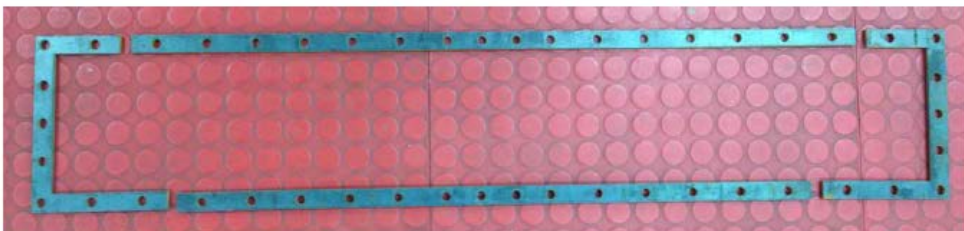
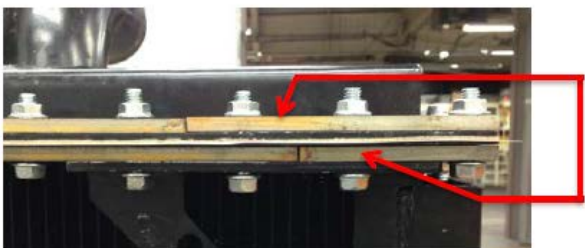
Image B: With C-Shaped Bolting Bars

C-Shaped Bars and Staggered Seams

1. When the radiator is determined to be leaking, and the radiator is not updated with the latest C-shape bolting bars (Image B), install service kit 2896576 (Kit, Gasket Service, Radiator) with C-shaped bolting bars and one piece gasket (Image B), torque the new bolts to 300 in-lbs.
2. If step one does not stop the leakage, remove and replace the radiator assembly with service part number 2896564 (Radiator,MOD,CU-BR,14-PLT CLR). This radiator includes the C-shaped bolting bars and one piece gasket installed directly from the supplier.
