Eliminating Symptoms in Body Interior: Replacing A-Pillar Trim Panel (A-pillar trim panel loose/SY0316)

Model Year: **As of 2015 up to 2016**

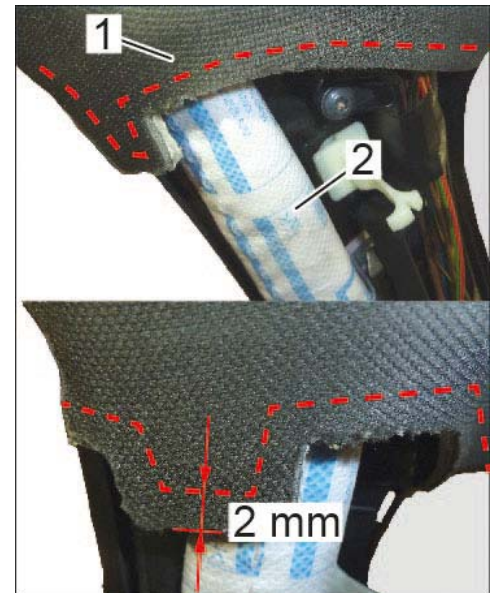
Cutting roof lining

- 2 Cut roof lining ⇒ *Cutting roof lining -1-* in the A-pillar/roof lining area.
 - 2.1 Insert a suitable base between the roof lining ⇒ *Cutting roof lining -1-* and wiring harness for curtain airbag ⇒ *Cutting roof lining -2-*.
 - 2.2 Draw a cut line ⇒ *Cutting roof lining -2 mm-* away from the edge of the roof lining ⇒ *Cutting roof lining -dashed line-*.
 - 2.3 Carefully cut the roof lining ⇒ *Cutting roof lining -1-* along the marking ⇒ *Cutting roof lining -dashed line-* using a scissors.
