## ROADSTER 2016-2 Relay Terminals Could Be Damaged at Fuse Boxes\_130124\_WCN61Y016S10\_en

Bulletin type: **Warranty Campaign**

Bulletin no: **2016-2** (rbg2016-002 en ML)

Subject: **Relay Terminals Could Be Damaged at Fuse Boxes**

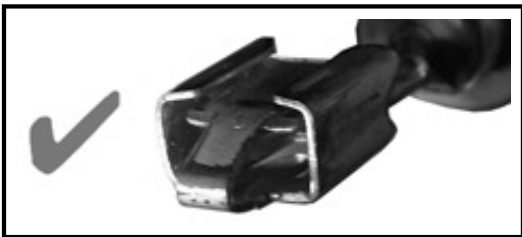
TERMINAL OUT OF FUSE BOX - GOOD

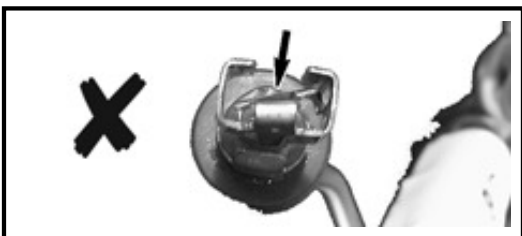
Damaged electrical terminals at the fuse boxes could lead to a non start engine or a radiator fan malfunction.

TERMINAL OUT OF FUSE BOX - DEFORMED

5. Use either the terminal tool or the screwdriver to straighten the contact part of the terminal.

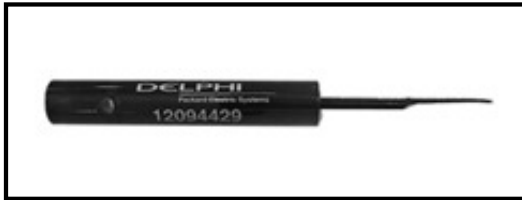
4. If the terminal is deformed, use an electric terminal tool or a small flat screwdriver to remove the terminal from the fuse box.

ELECTRIC TERMINAL TOOL

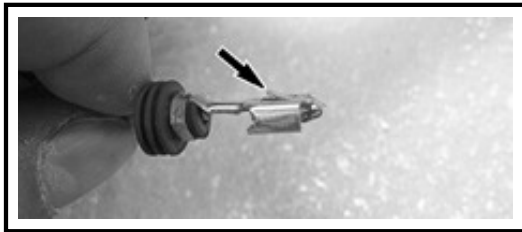
6. Ensure that the terminal locking tab exceeds the terminal surface.

TERMINAL LOCKING TAB EXCEEDING
