Coolant / Vacuum / Temperature fault codes - Check Engine Light with DTCs P003313, P0299FA, P0299FB, P226100, P261F71, P012800, and P012809

Topic number	LI07.09-N-063338
Version	5
Design group	07.09 Vacuum system
Date	11-07-2016
Validity	OM651
Reason for change	Title correction & remedy 4 & 5 updated
Reason for block

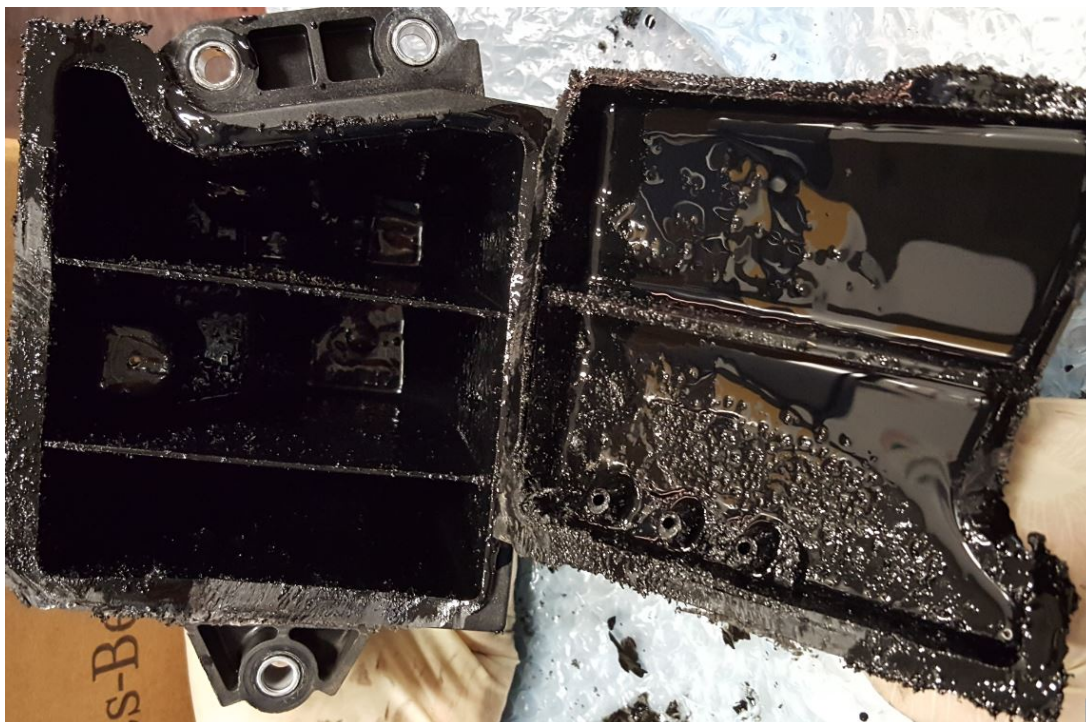
Vac Reservoir w oil.JPG:

Vac Reservoir w oil.JPG	Vacuum Reservoir with oil contamination
Brake Booster with oil.JPG	Brake booster with oil contamination

5 - If oil contamination is found in the vacuum system replace the vacuum pump, vacuum reservoir, brake booster and clean the vacuum lines.
