## Seat cover appears stained or soiled

| Topic number | LI91.18-P-063341 |
| Design group | 91.18 Seat covers |
| Validity | BR 166 as of facelift (code 806), saddle brown leather (equipment code 224A) up to cleanpoint 14.03.2016; C292 saddle brown leather (equipment code 224A) up to cleanpoint 15.04.2016 |

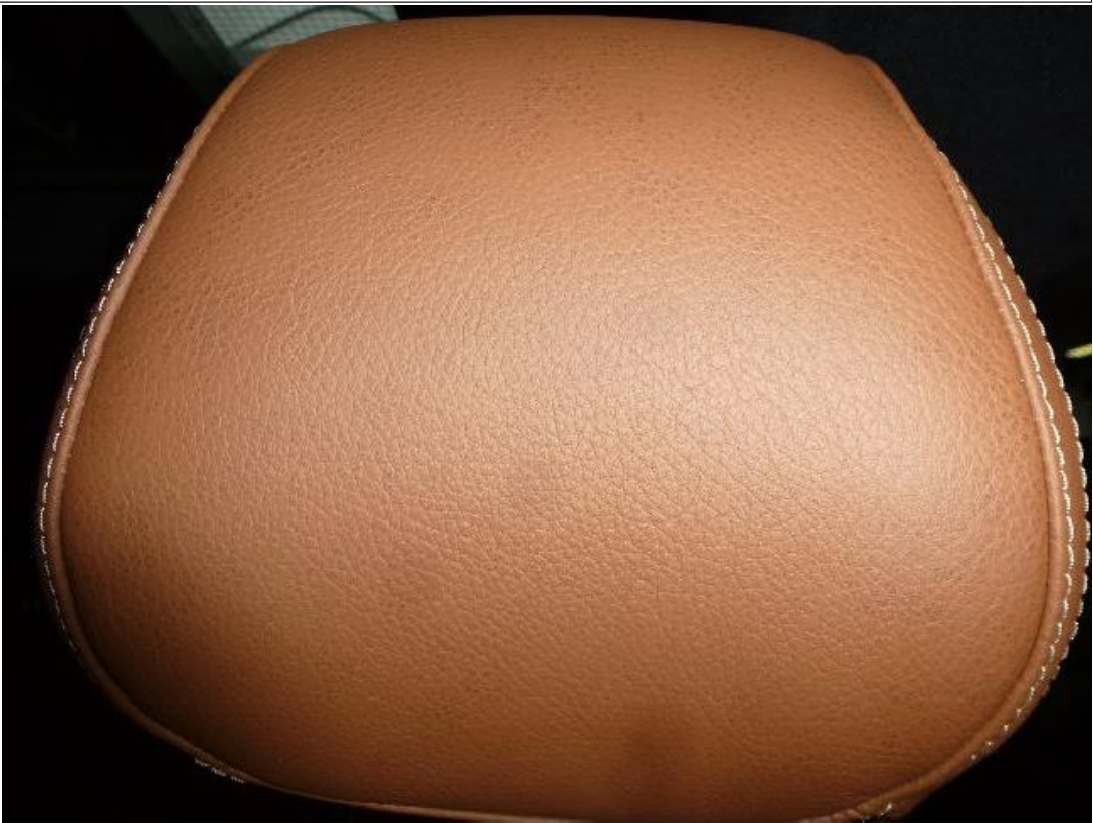
wolkendesign-1.JPG:

Blackish leather surfaces with equipment code 224A - Saddle brown (see photos in attachment).

| Attachments | |
|---|---|
| wolkendesign-1.JPG | Cloud design on head restraint |

To give the 'saddle brown' leather color shade a more lively appearance, Design has developed a cloud print for it. This simulates a certain depth effect and naturalness.

In isolated cases, the cloud print on the surface of the leather may be pronounced, which the customer may perceive as slight 'soiling'."

To evaluate the customer complaint, compare their seat's leather surfaces of the seat covers and head restraints of different, new vehicles.

If the complaint is justified, replace the affected seat covers (determine object numbers in EPC!)

IMPORTANT: Never attempt to remove the supposed staining. This may result in intensifying the effect because the basic brown tone is washed out.

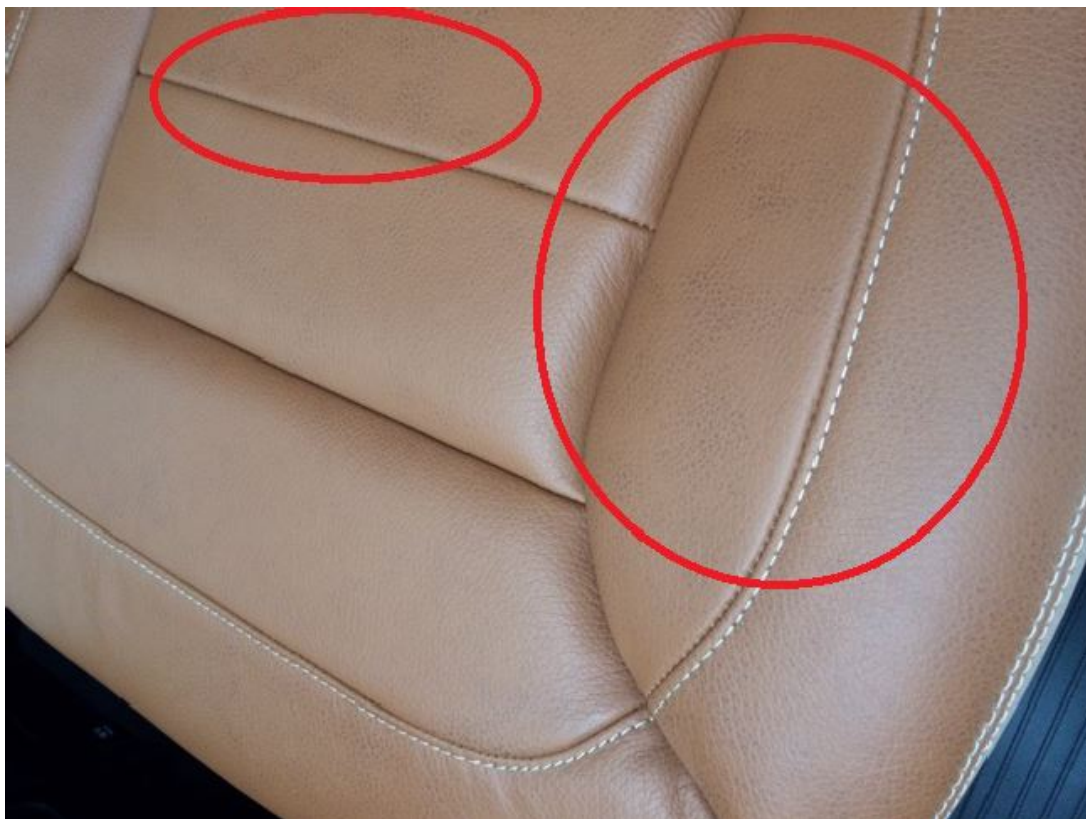
wolkendesign-2.JPG:

| Attachments | |
|---|---|
| wolkendesign-2.JPG | Cloud design on seat surface |
