Technical Bulletin

Model(s)	Year	Eng. Code	Trans. Code	VIN Range From	VIN Range To
Golf/GTI, Golf SportWagen	2015-2016	All	All	All	All

87 16 01 January 8, 2016 **2038368** Supersedes Technical Bulletin V871518 dated December 16, 2015 to update Noise dampening pan labor operation.

Air Conditioning Does Not Cool and or Compressor is Noisy

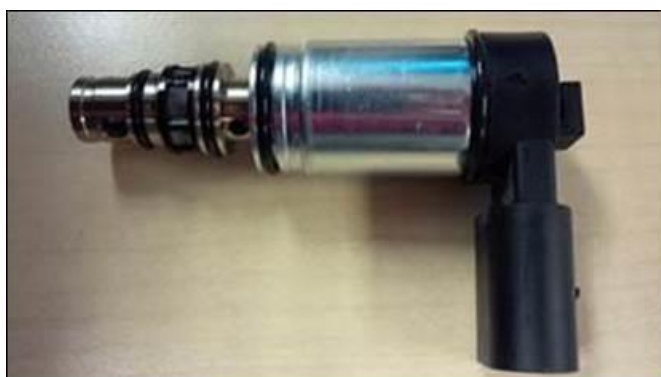
Figure 1 N280 Refrigerant Regulating Valve
5Q0260839A

The condition may be caused by a faulty N280 valve (Figure 1). The internal components of the valve can be obstructed and incapable of full function. This loss of refrigerant regulation from N280 can cause noise from the A/C compressor and/or affect the HVAC cooling.

The condition may be caused by a faulty A/C compressor regulator valve N280 (Sanden). The internal components of the valve can be obstructed and incapable of full function. This loss of refrigerant regulation from N280 can cause noise from the air conditioning compressor and/or affect the HVAC cooling.

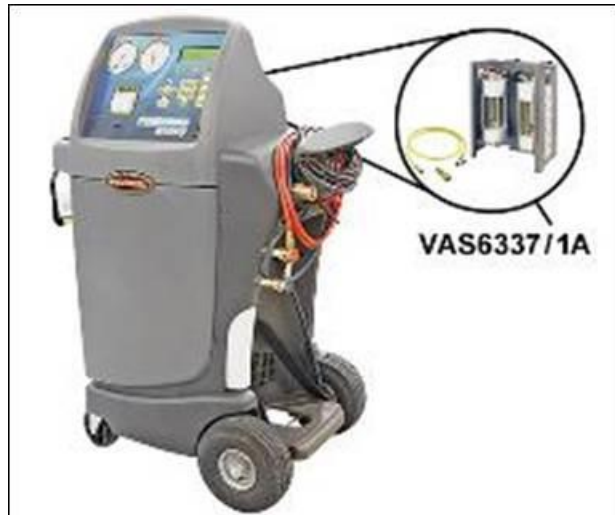
Figure 4. Robinair A/C Service Unit.

Connect both the refrigerant service station (Figure 4) and the diagnostic tester to the vehicle.

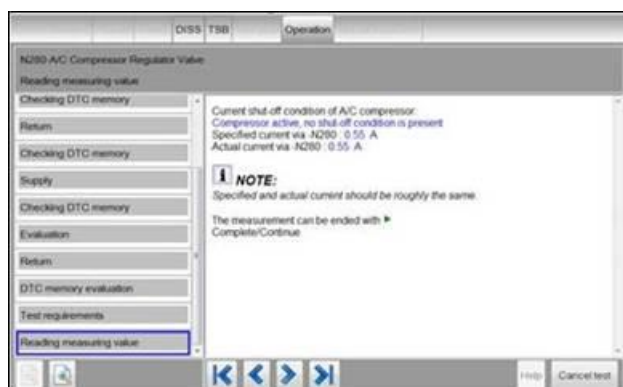
Figure 5. Checking N280 signal value Measuring Value Block.

Monitor the measuring value for the air conditioner compressor regulating valve N280 signal (Figure 5).

The actual and specified values will be plausible and will show a normal regulating range of current for cooling request (0.400 A – 0.820 A).

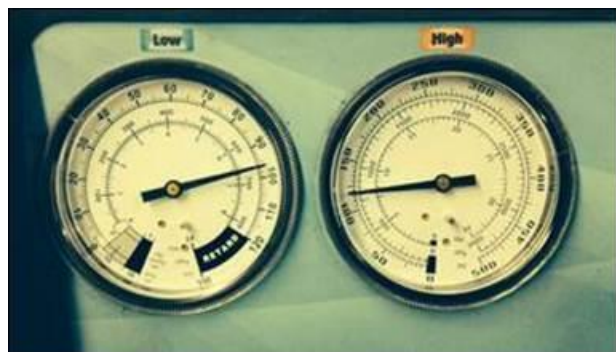
Figure 6. Equalized pressure condition.

After verifying the compressor should be on and operating. Check the gauge readings on the Robinair service station to verify equalized pressure readings on the high and low sides of the circuit (no pressure generation from the compressor) (Figure 6).

⚠ Note: If the gauge readings are showing normal compressor operation per the Elsa Repair Manual, this bulletin does not apply and further diagnosis is required.

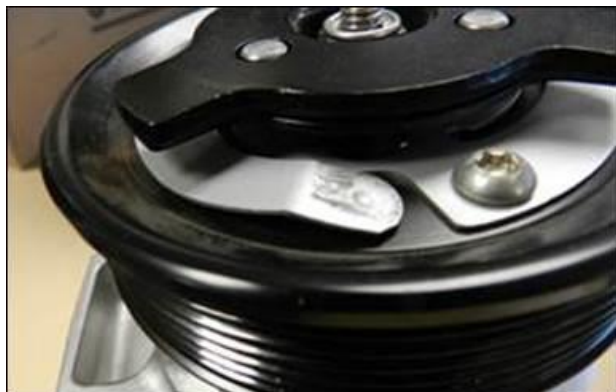
Figure 7a. Example of torque limiter over load protection activated.

! Note: If the torque limiter has been released the N280 regulating valve is not at fault. The compressor needs to be replaced.

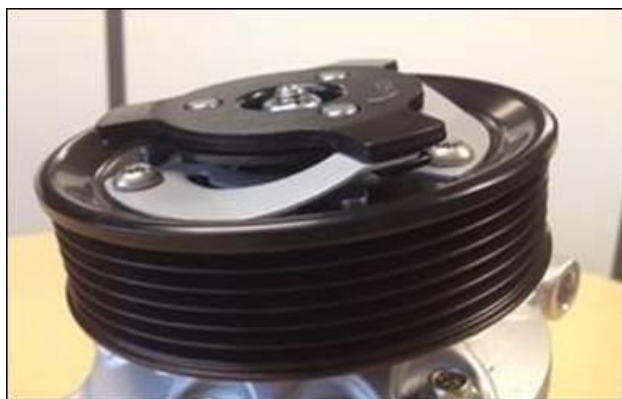
Check that the compressor torque limiter has not been activated (Figure 7b).

Figure 7b. Example of torque limiter over load protection still intact.

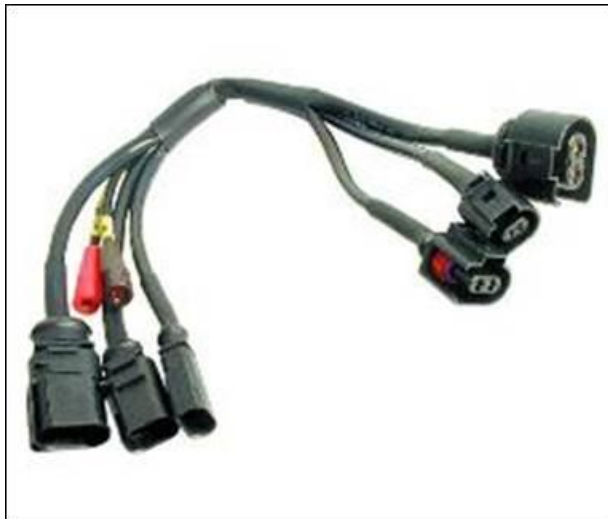
Figure 8. VAS 5256 breakout harness.

Shut off the engine. Connect the breakout harness VAS 5256 (Figure 8) between the N280 valve and its connector.

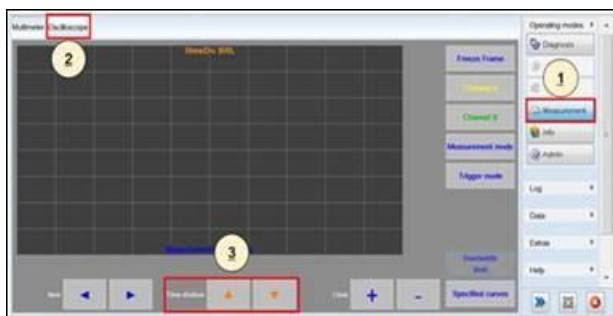
Figure 9. Select Measurements from operating mode menu”.

Go to Operating Mode “Measurements” to check the N280 signal from the control module.

Select Measurements.

Select oscilloscope.

Change time division to 2ms/Div (Figure 9).

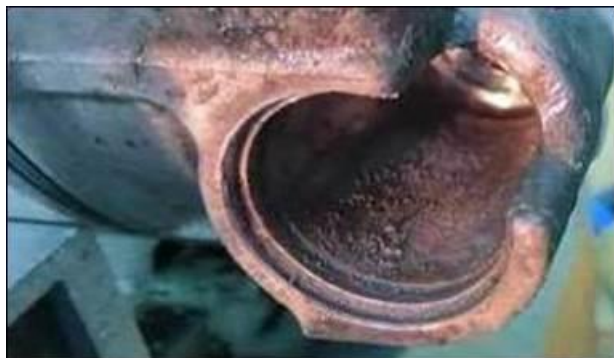
Figure 13. Corrosion in the N280 valve bore.

Assess the condition of the N280 valve bore and the valve filter screen (Figure 13). If severe contamination is found in valve bore there is a risk of damaging the replacement valve on installation. In these cases the A/C compressor must be replaced.

A slight amount of debris or corrosion does not present a risk and does not justify replacement of the AC compressor.

- If little or no corrosion or contamination is found perform Repair Procedure A: Replacing the N280 regulating valve.
- If corrosion and contamination is found, perform Repair Procedure B: A/C compressor replacement.
- Document the all workshop findings of this procedure on the repair order.

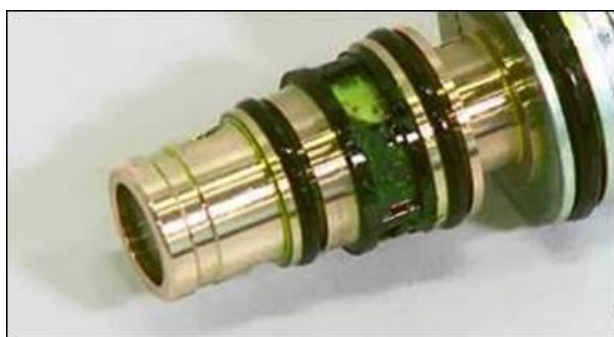
Figure 14: Severe contamination at the N280 valve filter screen.

Should severe contamination be found at the valve filter screen (Figure 14) and A/C compressor replacement becomes necessary, ensure that the refrigerant circuit is flushed in the course of repair.

Small random particles on the filter screen does not constitute “severe” contamination and does not justify replacement of the A/C compressor.

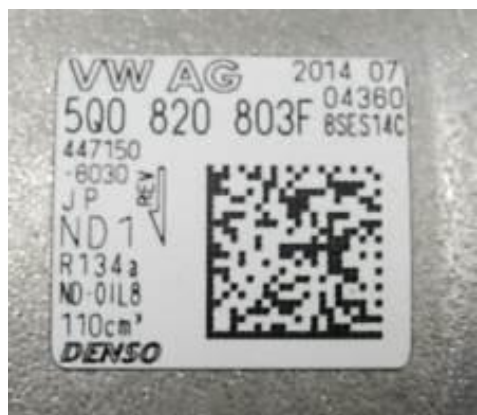
Figure 14: Denso compressor 5Q0820803F

MY2015 GTI/Golf, SportWagen production have Sanden compressors 5Q0820803C, 5Q0820803E and 5Q0820803G.

The replacement compressor is Denso 5Q0820803F

The refrigerant circuit must be flushed every time the A/C compressor is replaced. The replacement A/C compressor comes with a full charge of oil for the entire refrigerant system. Therefore the A/C circuit must be flushed of all original oil form the entire refrigerant circuit.

For this procedure always replace the receiver drier and expansion valve after flushing the refrigerant circuit.

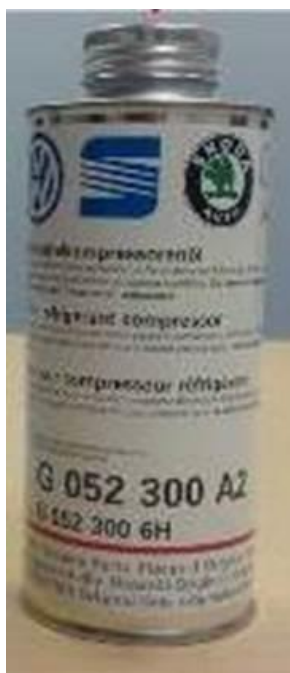
Figure 16: Denso compressor manufacturer PAG oil G 052 300 A2.

The replacement Denso compressor will come with the specified type of PAG oil G 052 300 A2 (Figure 16).

The compressor comes with a full charge of oil for the entire refrigerant circuit. However the amount of PAG oil supplied with the replacement compressor may not be the exact amount to replenish the refrigerant circuit. Drain and measure the PAG oil in the replacement compressor to determine the required amount. If the amount needs to be adjusted, do so using the correct type of PAG oil specified in ETKA. Refer to Elsa for the correct oil capacity for the compressor being installed.
