NUMBER: 09-004-16 REV. A

Cummins Service Engine Replacement

This bulletin involves replacing the engine assembly.

NOTE: This bulletin applies to vehicles equipped with 6.7L I6 Cummins Turbo Diesel Engine (Sales Code ETK).

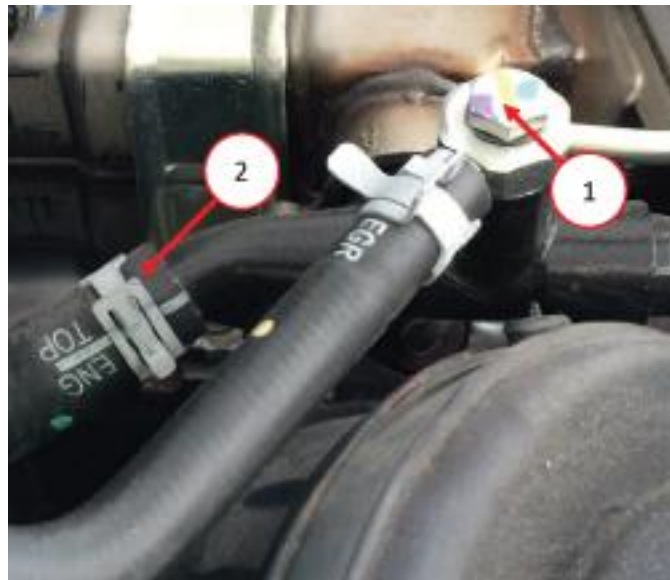
Fig. 1 Hoses

1 - Coolant Vent Hose Banjo Bolt

2 - Cab Heater Return Hose

1. ****While engine is removed from chassis, the ECM/PCM and the Exhaust Gas Recirculation (EGR) cooler water outlet, will need to be transferred from the original engine to the replacement engine.****
2. Is the vehicle a Cab Chassis?
 - a. YES>>> Continue with [Step #3](#).
 - b. NO>>> Continue with [Step #18](#).
3. Remove the banjo bolt securing the coolant vent hoses and cab heater return hose ([Fig. 1](#)).

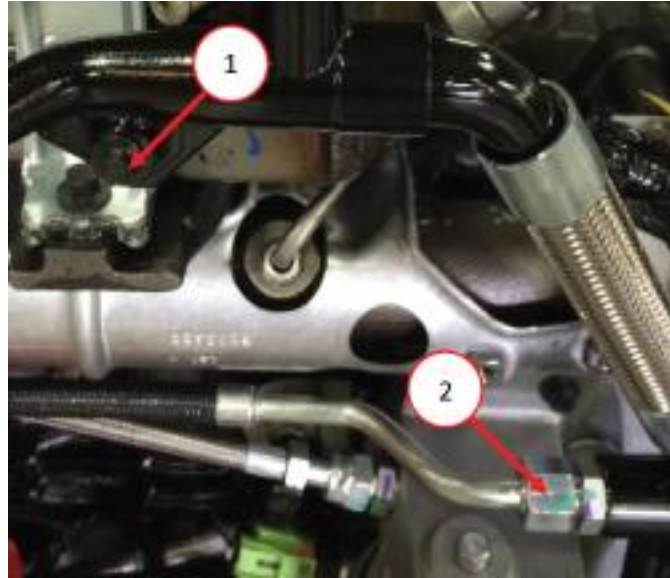
Fig. 2 EGR Cooler-Bolt

- 1 - EGR Cooler
- 2 - Turbo Coolant Return Hose

4. Remove turbo coolant return hose and bolt at the EGR cooler (Fig. 2).

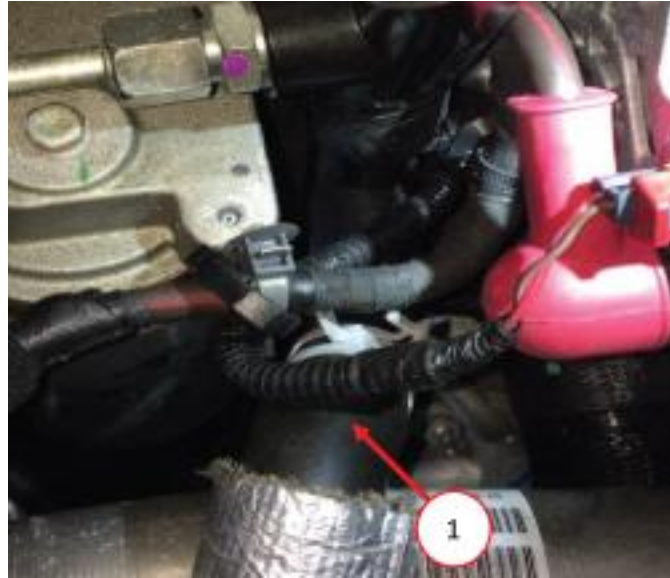
Fig. 3 Reservoir and Return Hoses

1 - Reservoir Return Hose

7. Remove reservoir return hose (Fig. 3).

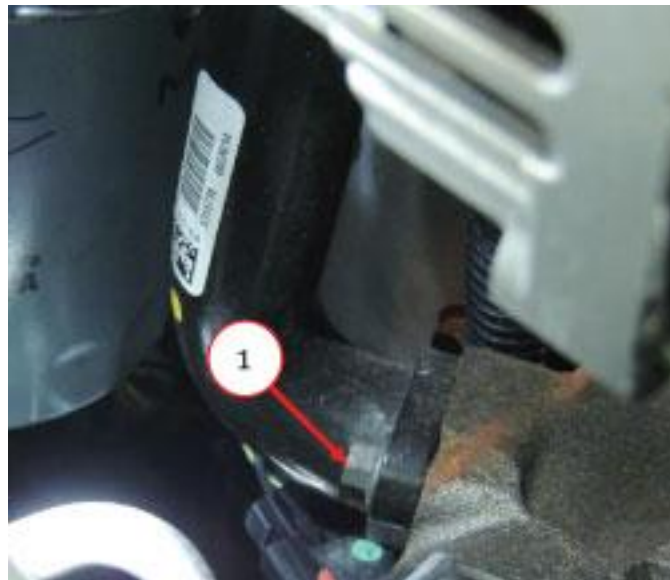
Fig. 4 Coolant Inlet

1 - Coolant Inlet Bolt

8. Remove bolt at the coolant inlet connection (Fig. 4).

10. Install bolt at the coolant inlet and torque to 10 N·m (89 in. lbs.).
11. Connect reservoir return hose.
12. Install the coolant outlet tube into the EGR cooler.
13. Install EGR coolant inlet connection into the EGR cooler.
14. Install bolt at EGR cooler and torque to 10 N·m (89 in. lbs.).
15. Connect turbo coolant return hose.
16. Connect cab heater return hose.
17. Install banjo bolt with new sealing washers on to coolant outlet tube and torque to 15 N·m (11 ft. lbs.). Proceed to [Step #32](#).
18. Remove coolant vent hose, cab heater return hose and bolt to EGR cooler ([Fig. 5](#)).

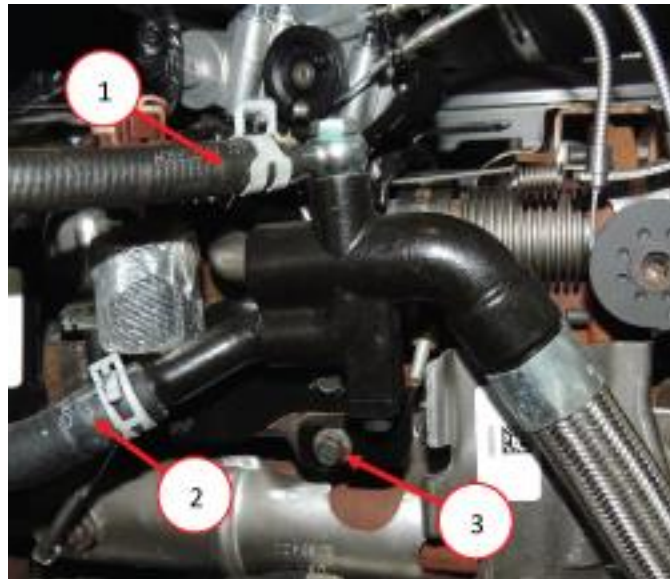
Fig. 5 EGR Cooler

- 1 - Coolant Vent Hose
 - 2 - Cab Heater Return Hose
 - 3 - EGR Cooler Bolt
-

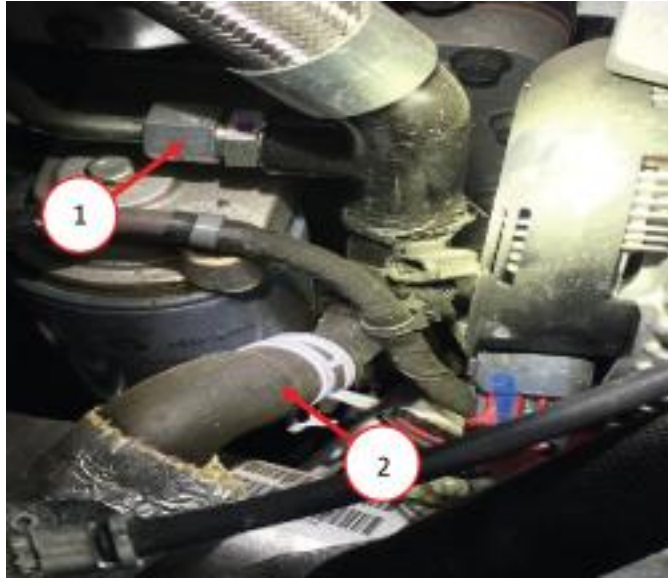
Fig. 6 Return Hoses

- 1 - Reservoir Return Hose
- 2 - Turbo Coolant Return Hose

19. Remove reservoir return hose and turbo coolant return hose (Fig. 6).

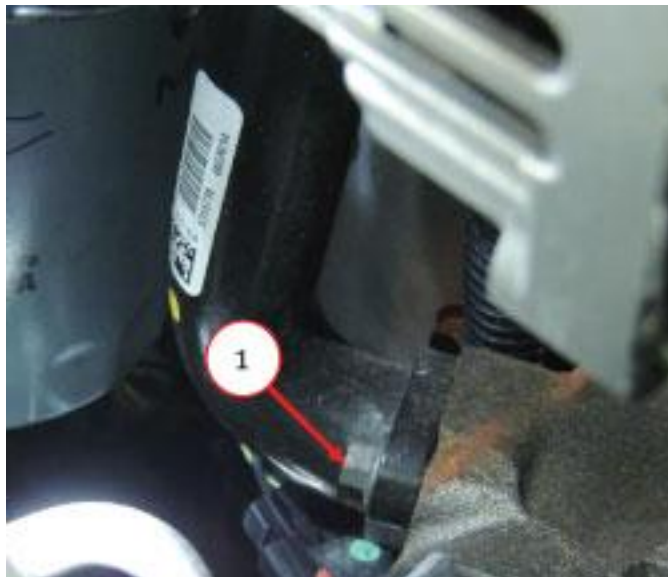
Fig. 7 Coolant Inlet

- 1 - Coolant Inlet Bolt

20. Remove bolt at coolant inlet (Fig. 7).

- 24. Install EGR water outlet tube into the water inlet housing.
- 25. Install the EGR cooler water outlet tube to the EGR cooler.
- 26. Install bolt at the water inlet and torque to 10 N·m (89 in. lbs).
- 27. Connect Turbo Coolant Return Line.
- 28. Connect reservoir return hose.
- 29. Install bolt to EGR cooler and torque to 9.5 N·m (84 in. lbs).
- 30. Connect cab heater return hose.
- 31. Connect coolant vent hose.
- 32. Install air inlet tube to turbo charger.
- 33. Install the air cleaner body (DealerCONNECT> TechCONNECT under: Service Info> 09 - Engine/Air Intake System/BODY, Air Cleaner - Installation) .
- 34. Connect negative battery cables.
- 35. Fill engine coolant (DealerCONNECT> TechCONNECT under: Service Info> 07 - Cooling - Standard Procedure) .
- 36. Check the cooling system for leaks and proper operation.
