Service Bulletin

Object: **Clutch update**

Product: **Turismo Veloce (all versions)**

CLUTCH UPDATE PROCEDURE – TURISMO VELOCE - (SB168)

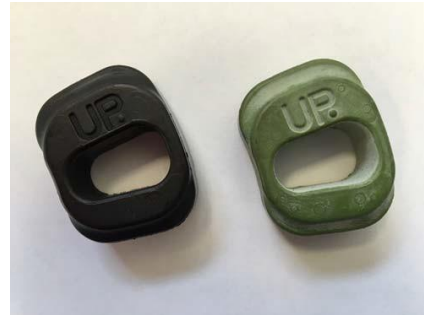
- *Remove the clutch (it is NOT necessary to remove the engine oil)*
- *Place on the workbench the clutch housing and remove the six screws that hold the mounting plate*
- *Replace the rubber cush drive (lubricating them with engine oil to facilitate the insertion) with new type ones, black and green included in the kit as shown in the picture:*

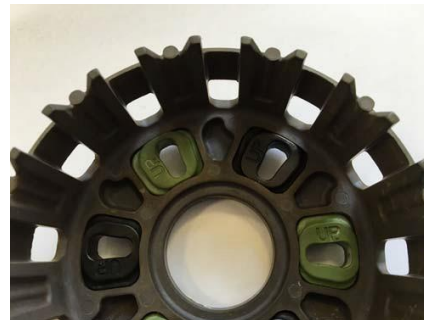
- *Place the new rubber cush drive on the clutch housing with the inscription "UP" upwards, and alternating the two colors (black - green) as in the picture:*

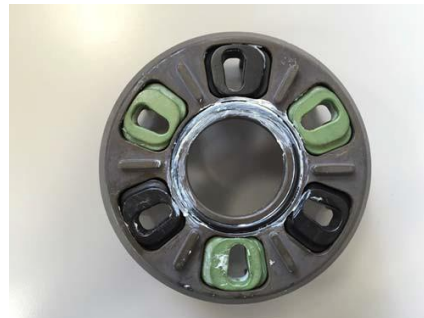
- *Assemble the clutch housing making sure that the O-ring does not get pinched in between, using some grease in order to keep it in place as pictured:*

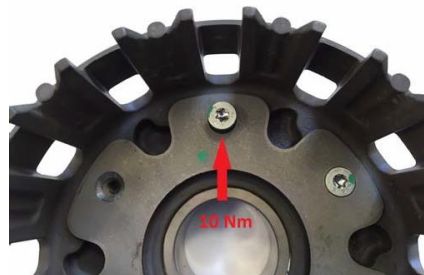
- *Reassemble the clutch housing, fixing the plate with the 6 screws and using some medium Loctite on the thread tightening them to 10 Nm as picture:*
