**NUMBER:** 23-003-16

Transit Film Removal

This bulletin involves properly removing the vehicles transit film.

RAM ProMaster City

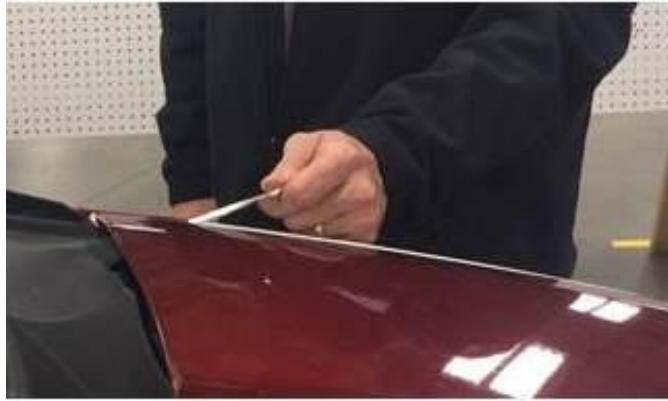
***Fig. 1 Wrap Removal***

3. Pull the transit film at an angle of 120 degrees for easy removal. Use even strength/force during removal (Fig. 1).

1. Avoid extreme temperatures when removing the transit film; room temperature is recommended 20°C - 30°C (68°F - 86°F).
2. Allow the vehicle to acclimate for a minimum of 2 hours at the recommended temperature.
