NUMBER: 23-005-16

GROUP: Body

Poor Adhesion Of Jeep Emblem To Liftgate

2016 (BU) Jeep Renegade

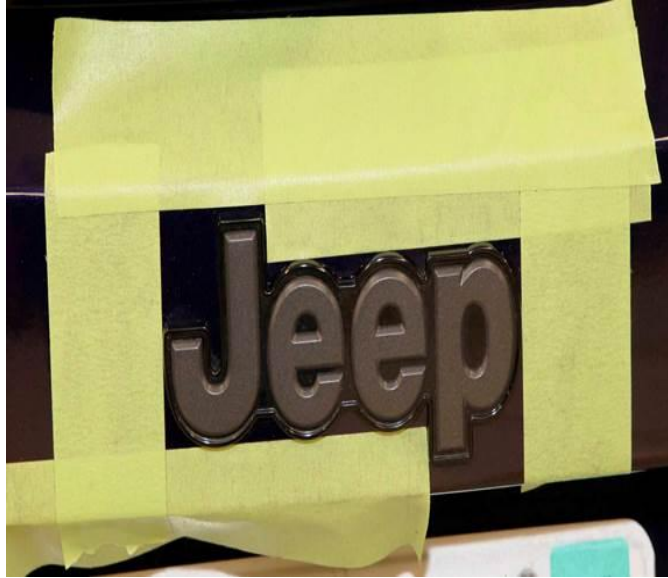
Fig. 1 Marking Location

1. If the Jeep emblem shows signs of visible separation at the liftgate, the emblem will need to be replaced.
2. Was any separation found at the emblem?
 - a. YES>>> Replace the affected emblem as required if it shows signs of separation. Proceed to [Step #3](#).
 - b. NO>>> Jeep emblem separation was not found. This bulletin has been completed. Use LOP (23-03-08-9B) to close the active RRT.
3. Apply a length of masking tape on the body parallel to the top edge of the nameplate as a guide if necessary ([Fig. 1](#)).

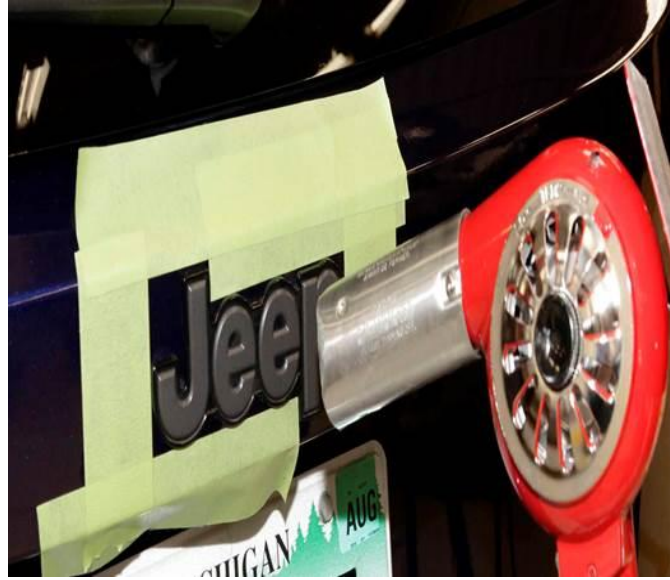
Fig. 2 Heat Gun

4. If temperature is below 21°C (70°F), warm emblem with a heat lamp or gun. Do not exceed 52°C (120°F) when heating emblem for removal (Fig. 2).

CAUTION: Do not exceed 52° C (120° F) when heating name plates, decals or body panels. Failure to follow this caution may result in damage to the name plates, decals and/or the vehicle paint finish.

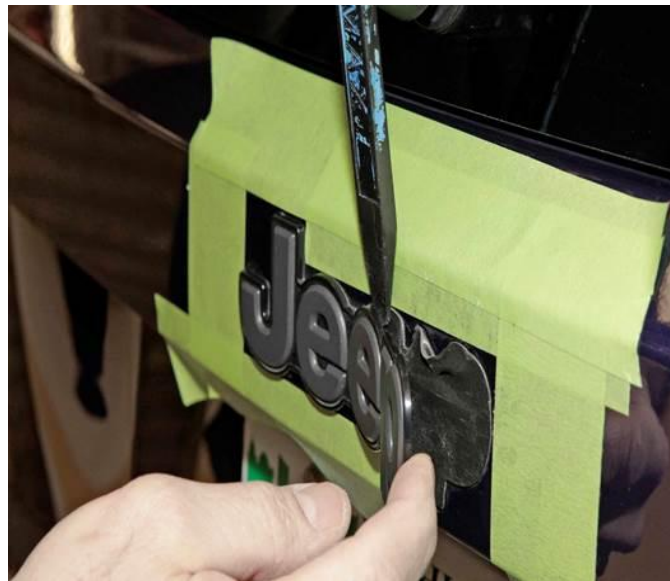
Fig. 3 Trim Stick

5. Using a trim stick or equivalent, carefully remove the name plate or decal from the body panel, as necessary (Fig. 3).

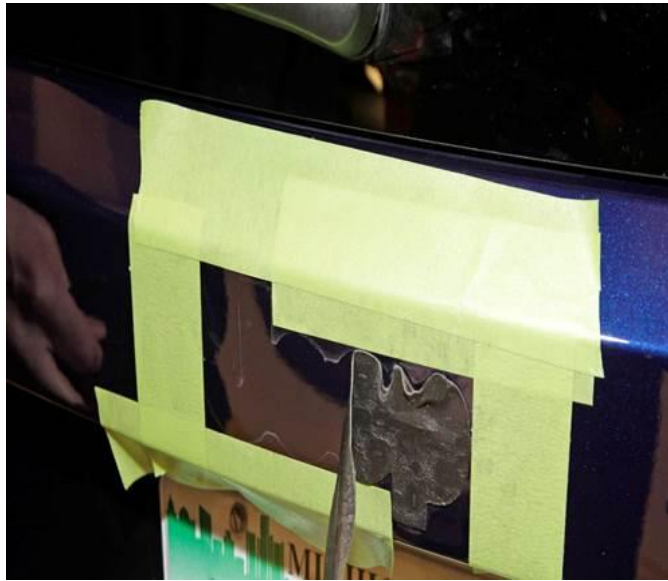
Fig. 4 Removing Adhesive

6. Thoroughly clean all residue from the name plate attachment areas of the body (Fig. 4).

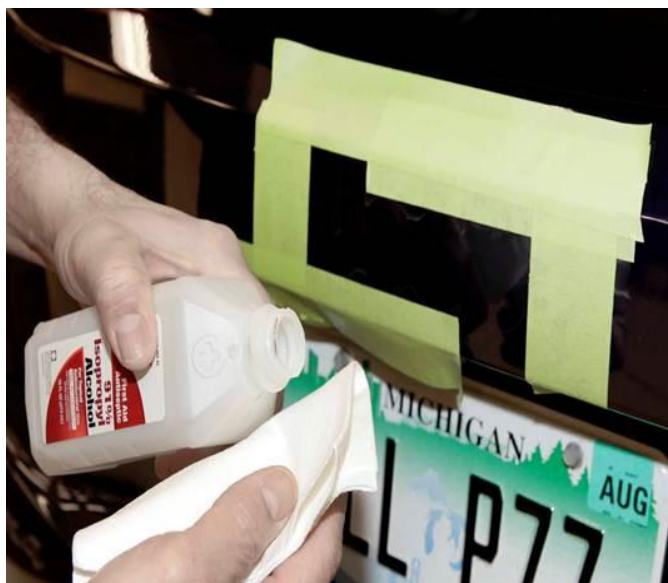
Fig. 5 Cleaning The Area

7. Wipe the attachment areas with a clean, lint-free cloth, moistened with a 50% solution of water and alcohol, Wipe dry the areas immediately with a dry, lint-free cloth (Fig. 5).

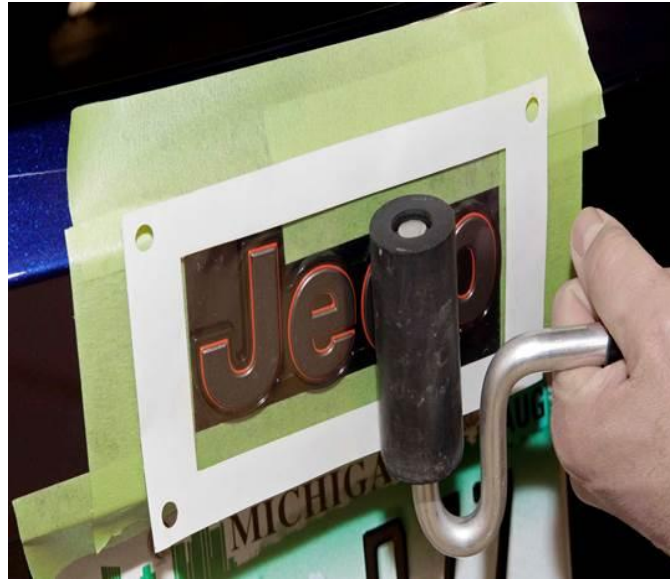
Fig. 6 Applying Pressure

8. Remove the protective covering from the back of the name plate and position the name plate onto the body using the previously installed guide tape (Fig. 6).

NOTE: To ensure proper name plate or decal adhesion, apply consistent and uniform pressure of approximately 40 p.s.i. over the entire surface of each name plate or decal.

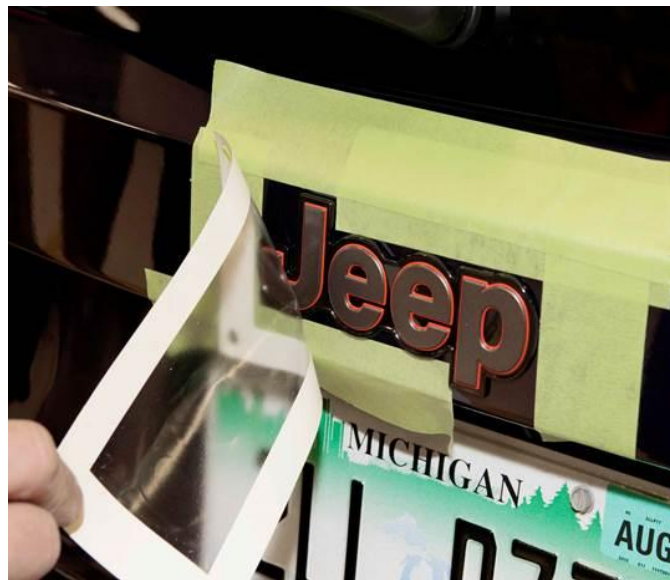
Fig. 7 Removing Protective Cover

9. Remove the protective covering from the name plate and remove the guide tape (Fig. 7).
